## Profile/Photo Observation Report

Street:	<b>Capitol</b>	Flow Control:	<b>Not Controlled</b>
City:	<b>Hobart, IN</b>	Year Renewed:	
Location:	<b>Light Highway</b>	Tape/Media #:	
Purpose:	<b>Maintenance Related</b>	Dia/Height:	<b>8"</b>
Use:	<b>Sanitary</b>	Material:	<b>PVC</b>
Drain Area:	<b>NA</b>	Lining:	<b>Cured in Place</b>
Category:	<b>NA</b>		
Comment:

Location Details:		Direction of Survey:	<b>Downstream</b>
US MH:	<b>M-706-061</b>	DS MH:	<b>M-706-059</b>
		Total Length Surveyed (ft):	<b>349.3</b>

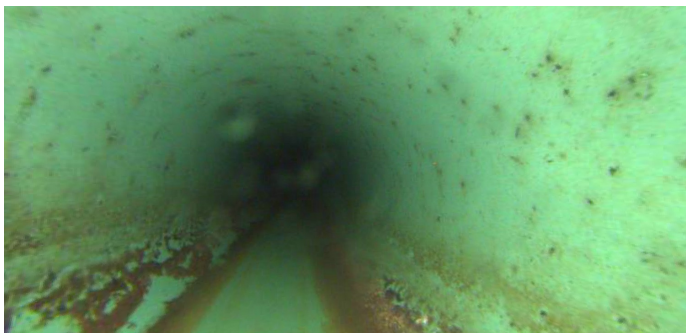
Code: **AMH**  
Description: **Manhole**

Distance (ft): **.0**  
Structural Grade: **0**  
O&M Grade: **0**  
Clock Start/From:  
Clock To:  
1st Value:  
2nd Value:  
Value Percent:  
Continuous Index:  
Within 8" of Joint: **NO**  
Remarks: **M-706-061**

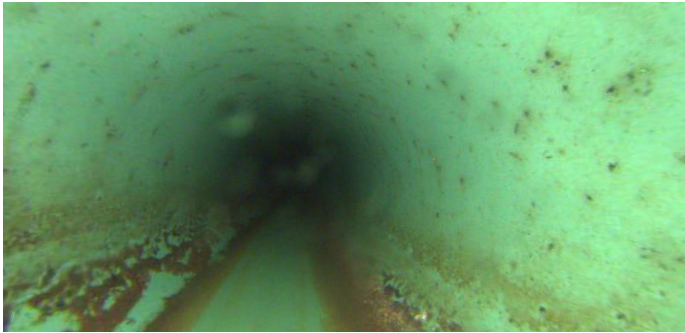
Code:	<b>MWL</b>
Description:	<b>Water Level</b>

Distance (ft):	<b>.0</b>
Structural Grade:	<b>0</b>
O&M Grade:	<b>0</b>
Clock Start/From:	
Clock To:	
1st Value:	
2nd Value:	
Value Percent:	<b>5.000</b>
Continuous Index:	
Within 8" of Joint:	<b>NO</b>
Remarks:

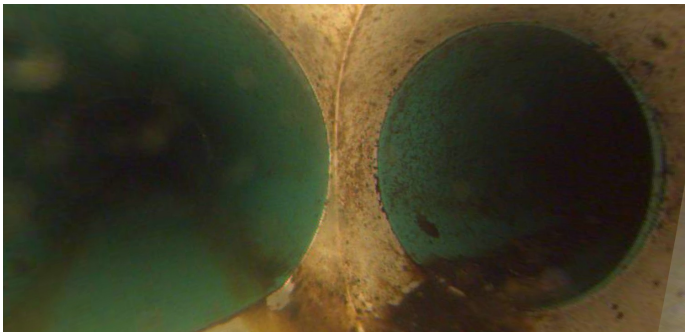
Code:	<b>TFA</b>
Description:	<b>Tap Factory Active</b>

Distance (ft):	<b>38.8</b>
Structural Grade:	<b>0</b>
O&M Grade:	<b>0</b>
Clock Start/From:	<b>3</b>
Clock To:	
1st Value:	<b>4.000</b>
2nd Value:	
Value Percent:	
Continuous Index:	
Within 8" of Joint:	
Remarks:

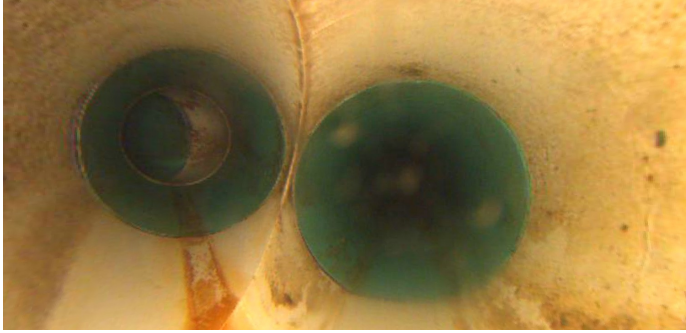
Code: **TF**  
Description: **Tap Factory**

Distance (ft): **153.7**  
Structural Grade: **0**  
O&M Grade: **0**  
Clock Start/From: **9**  
Clock To:  
1st Value: **4.000**  
2nd Value:  
Value Percent:  
Continuous Index:  
Within 8" of Joint:  
Remarks:

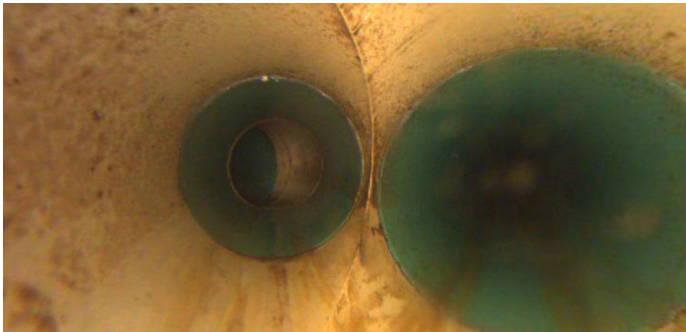
Code: **TF**  
Description: **Tap Factory**

Distance (ft): **179.6**  
Structural Grade: **0**  
O&M Grade: **0**  
Clock Start/From: **9**  
Clock To:  
1st Value: **4.000**  
2nd Value:  
Value Percent:  
Continuous Index:  
Within 8" of Joint:  
Remarks:

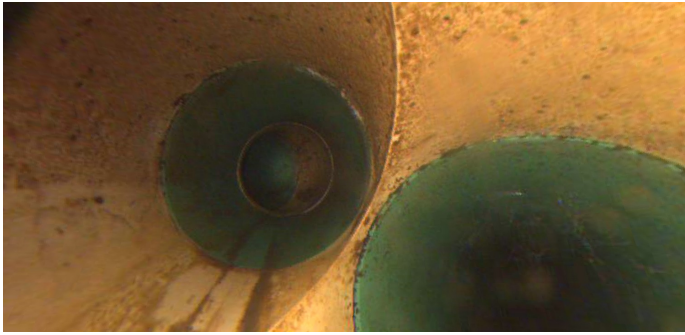
Code: **TF**  
Description: **Tap Factory**

Distance (ft): **202.6**  
Structural Grade: **0**  
O&M Grade: **0**  
Clock Start/From: **10**  
Clock To:  
1st Value: **4.000**  
2nd Value:  
Value Percent:  
Continuous Index:  
Within 8" of Joint:  
Remarks:

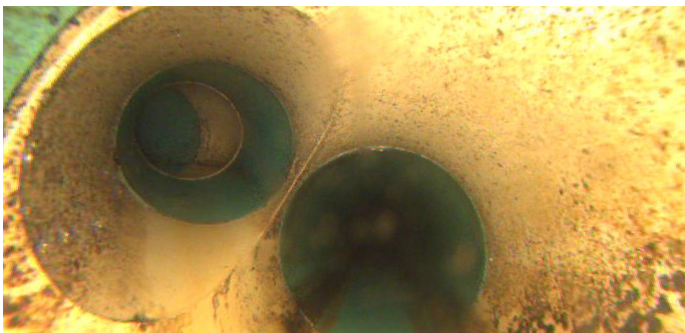
Code: **TFA**  
Description: **Tap Factory Active**

Distance (ft): **224.0**  
Structural Grade: **0**  
O&M Grade: **0**  
Clock Start/From: **10**  
Clock To:  
1st Value: **4.000**  
2nd Value:  
Value Percent:  
Continuous Index:  
Within 8" of Joint:  
Remarks:

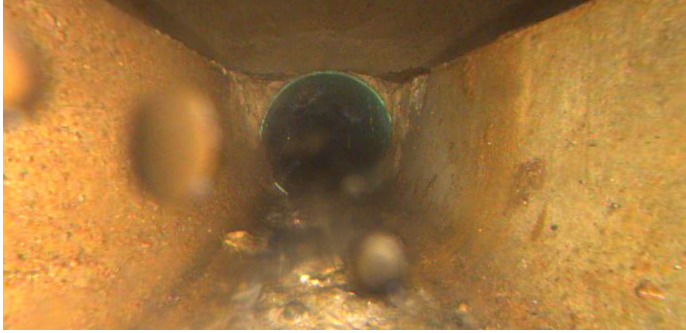
Code:	AMH
Description:	Manhole
Distance (ft):	349.3
Structural Grade:	0
O&M Grade:	0
Clock Start/From:	
Clock To:	
1st Value:	
2nd Value:	
Value Percent:	
Continuous Index:	
Within 8" of Joint:	NO
Remarks:	M-706-059
