## Profile/Photo Observation Report

| P.O.#: | | Surveyor: | <b>Jen Costello</b> | PSR: | <b>P-706-062-063</b> |

| Street: | <b>FOXCROFT STREET</b> | Flow Control: | <b>Not Controlled</b> |

| US MH: | <b>M-706-063</b> | DS MH: | <b>M-706-062</b> |

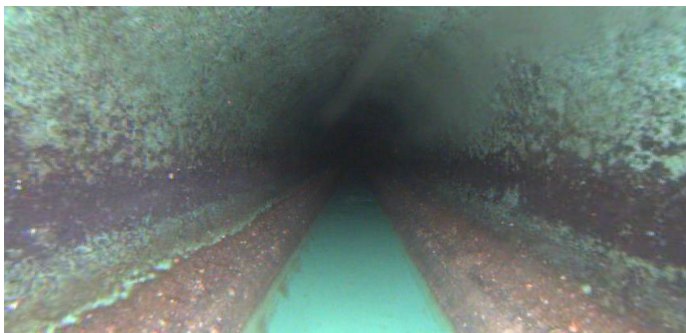
Code: **AMH**  
Description: **Manhole**

Distance (ft): **.0**  
Structural Grade: **0**  
O&M Grade: **0**  
Clock Start/From:  
Clock To:  
1st Value:  
2nd Value:  
Value Percent:  
Continuous Index:  
Within 8" of Joint: **NO**  
Remarks: **M-706-063**

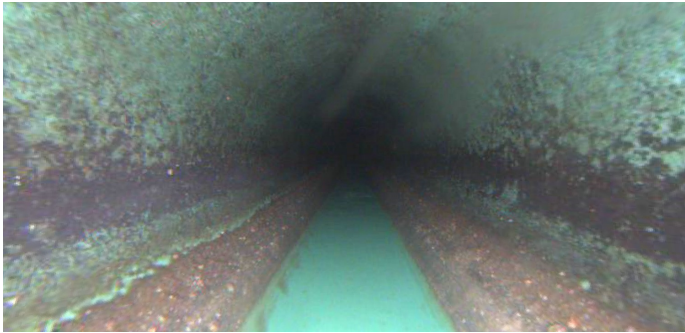
| Code: | <b>MWL</b> |

| Description: | <b>Water Level</b> |

| Value Percent: | <b>5.000</b> |

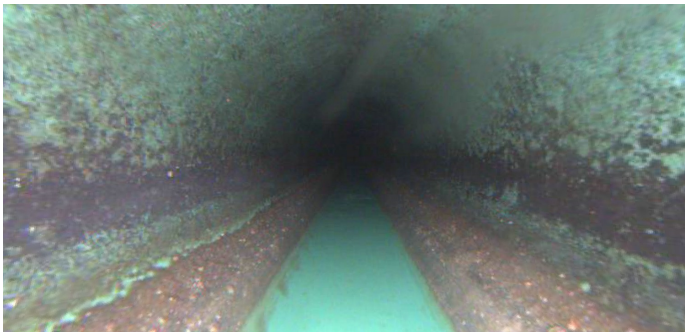
| Code: | <b>DAGS</b> |

| Description: | <b>Deposits Attached Grease</b> |

| O&M Grade: | <b>2</b> |
| Clock Start/From: | <b>5</b> |
| Clock To: | <b>7</b> |
| Value Percent: | <b>5.000</b> |

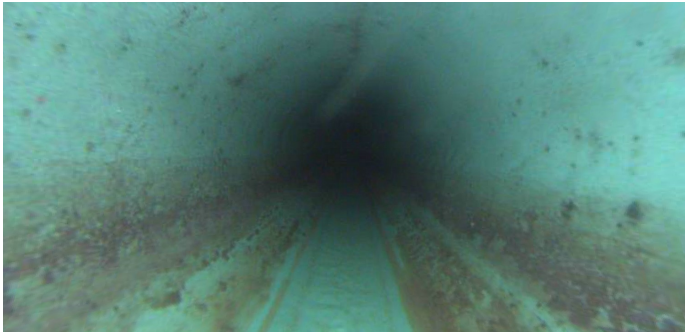
Code: **DAGS**  
Description: **Deposits Attached Grease**

Distance (ft): **15.9**  
Structural Grade: **0**  
O&M Grade: **2**  
Clock Start/From: **5**  
Clock To: **7**  
1st Value:  
2nd Value:  
Value Percent: **5.000**  
Continuous Index: **F01**  
Within 8" of Joint: **NO**  
Remarks:

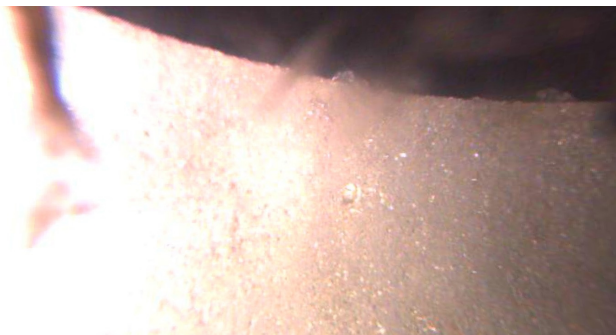
Code: **AMH**  
Description: **Manhole**

Distance (ft): **74.8**  
Structural Grade: **0**  
O&M Grade: **0**  
Clock Start/From:  
Clock To:  
1st Value:  
2nd Value:  
Value Percent:  
Continuous Index:  
Within 8" of Joint: **NO**  
Remarks: **M-706-062**
