Profile/Photo Observation Report

Street:	Middle School Lot	Flow Control:	
City:	Hobart, IN	Year Renewed:	
Location:	Parking Lot	Tape/Media #:	929
Purpose:	Routine Assessment	Dia/Height:	10"
Use:	Sanitary	Material:	VCP
Drain Area:		Lining:	
Category:	NA		
Comment:

Location Details:		Direction of Survey:	Downstream
US MH:	M-706-65	DS MH:	M-706-17
		Total Length Surveyed (ft):	93.2

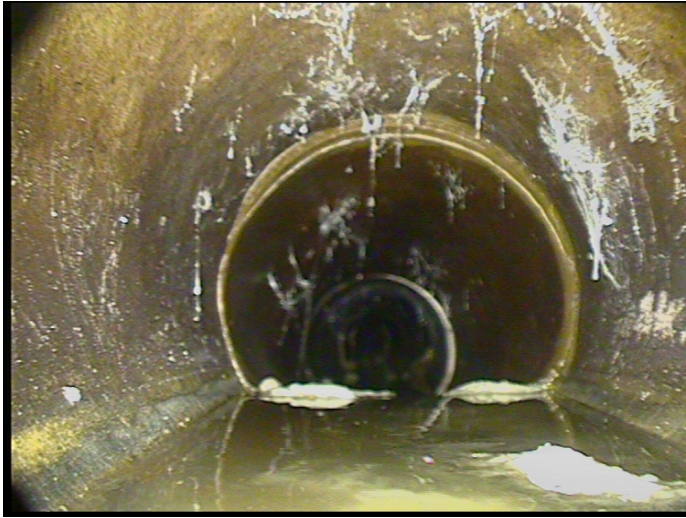
Code: **MWL**
Description: **Water Level**

Distance (ft): **.0**
Structural Grade: **0**
O&M Grade: **0**
Clock Start/From:
Clock To:
1st Value:
2nd Value:
Value Percent: **10.000**
Continuous Index:
Within 8" of Joint: **NO**
Remarks:

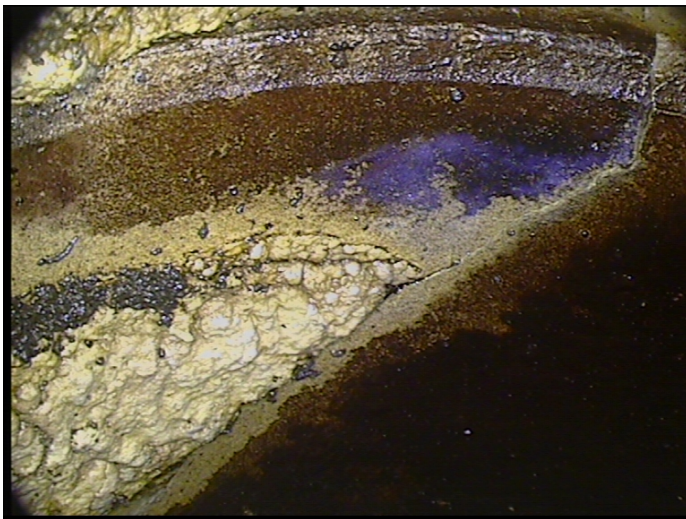
Code: **CM**
Description: **Crack Multiple**

Distance (ft): **9.2**
Structural Grade: **3**
O&M Grade: **0**
Clock Start/From: **7**
Clock To: **11**
1st Value:
2nd Value:
Value Percent:
Continuous Index:
Within 8" of Joint: **YES**
Remarks:

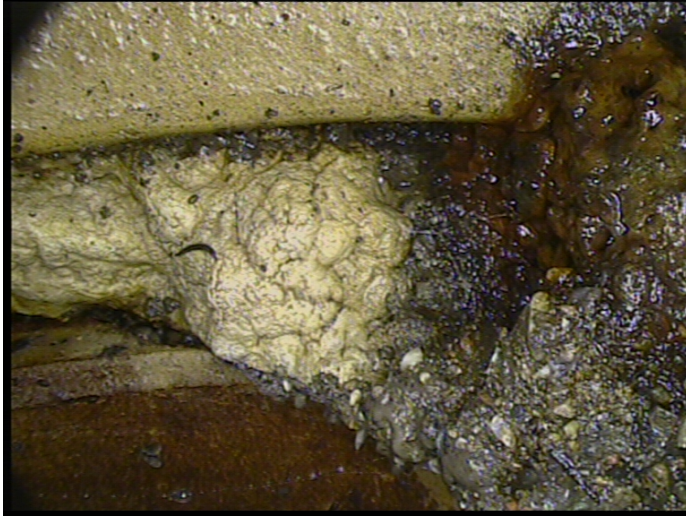
Code:	DAE
Description:	Deposits Attached Encrustation
Distance (ft):	9.2
Structural Grade:	0
O&M Grade:	2
Clock Start/From:	7
Clock To:	5
1st Value:	
2nd Value:	
Value Percent:	5.000
Continuous Index:	
Within 8" of Joint:	YES
Remarks:

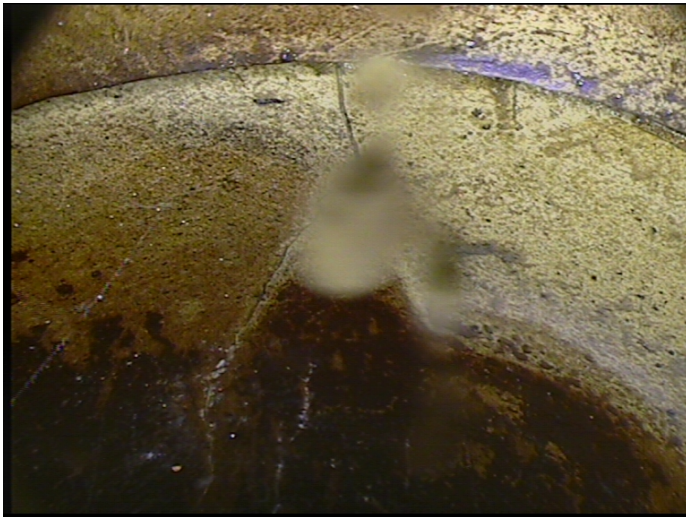
Code:	CL
Description:	Crack Longitudinal
Distance (ft):	59.9
Structural Grade:	2
O&M Grade:	0
Clock Start/From:	12
Clock To:	
1st Value:	
2nd Value:	
Value Percent:	
Continuous Index:	
Within 8" of Joint:	YES
Remarks:

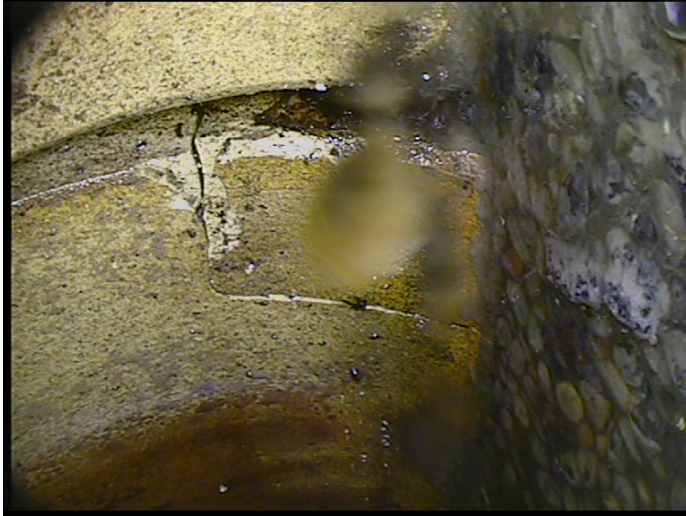
Code:	CC
Description:	Crack Circumferential
Distance (ft):	59.9
Structural Grade:	1
O&M Grade:	0
Clock Start/From:	4
Clock To:	5
1st Value:	
2nd Value:	
Value Percent:	
Continuous Index:	
Within 8" of Joint:	YES
Remarks:

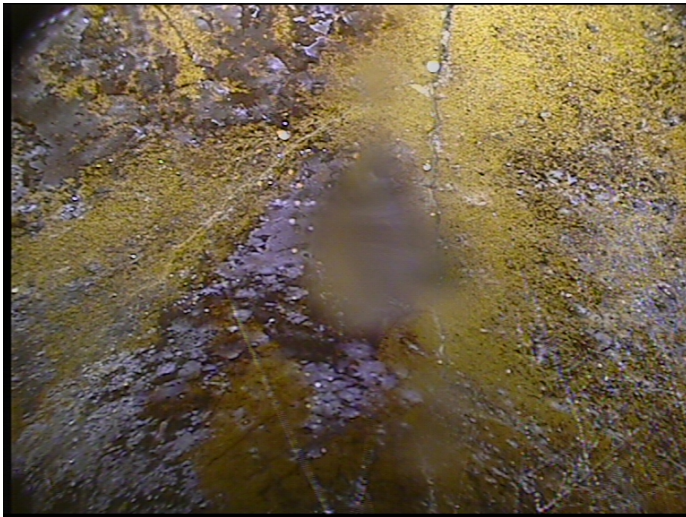
Code:	CM
Description:	Crack Multiple
Distance (ft):	75.9
Structural Grade:	3
O&M Grade:	0
Clock Start/From:	10
Clock To:	1
1st Value:	
2nd Value:	
Value Percent:	
Continuous Index:	
Within 8" of Joint:	YES
Remarks:

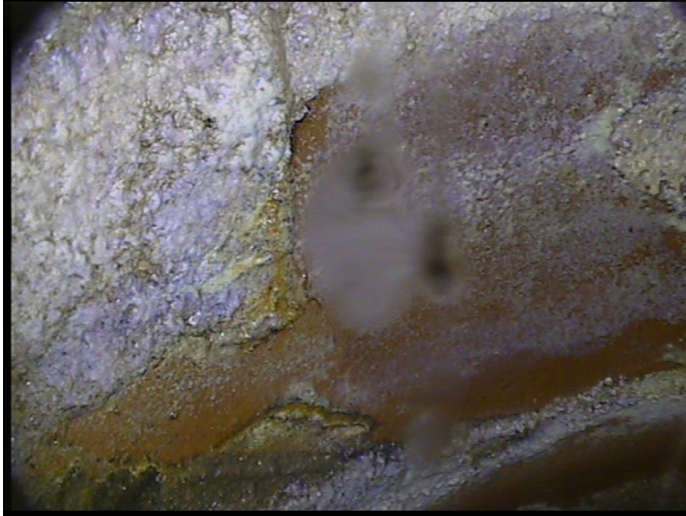
Code: **CM**
Description: **Crack Multiple**

Distance (ft): **90.6**
Structural Grade: **3**
O&M Grade: **0**
Clock Start/From: **7**
Clock To: **11**
1st Value:
2nd Value:
Value Percent:
Continuous Index:
Within 8" of Joint: **YES**
Remarks:
