## Profile/Photo Observation Report

Date:	09/16/2022	Weather:		Coding:	PACP 7.0
Pipe Length (ft):	132.7	Owner:	City of Hobart	Pre Clean:	Heavy Cleaning
P.O.#:	YES502259	Surveyor:	S. Bucklin	PSR:	M-706-065-M-706-064
Customer:	City of Hobart	Clean Date:	08/15/2022	Shape:	C

Street:	West 8th Street	Flow Control:	Not Controlled
City:	Hobart, IN	Year Renewed:	
Location:	Parking Lot	Tape/Media #:	
Purpose:	Routine Assessment	Dia/Height:	8"
Use:	Sanitary Sewage Pipe	Material:	VCP
Drain Area:		Lining:	None
Category:	NA		
Comment:			
Location Details:	MIDDLE SCHOOL DRIVE WAY	Direction of Survey:	Downstream
US MH:	M-706-065	DS MH:	M-706-064
		Total Length Surveyed (ft):	130.2

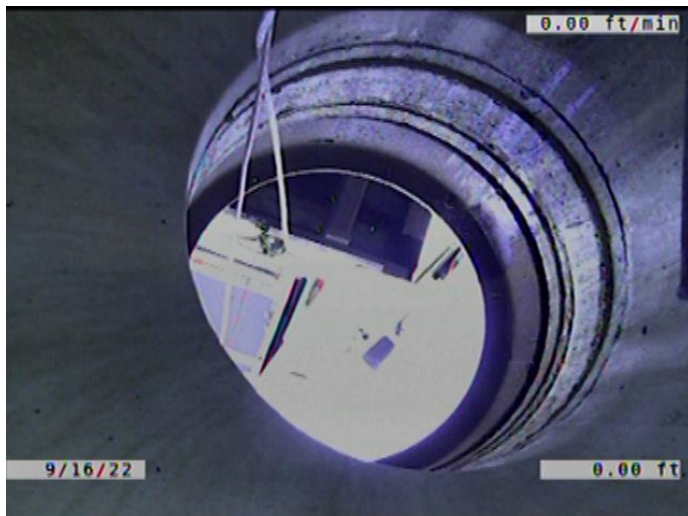
Code: **AMH**  
 Description: **Manhole**

Distance (ft): **.0**  
 Structural Grade: **0**  
 O&M Grade: **0**  
 Clock Start/From:  
 Clock To:  
 1st Value:  
 2nd Value:  
 Value Percent:  
 Continuous Index:  
 Within 8" of Joint: **NO**  
 Remarks: **M-706-065**

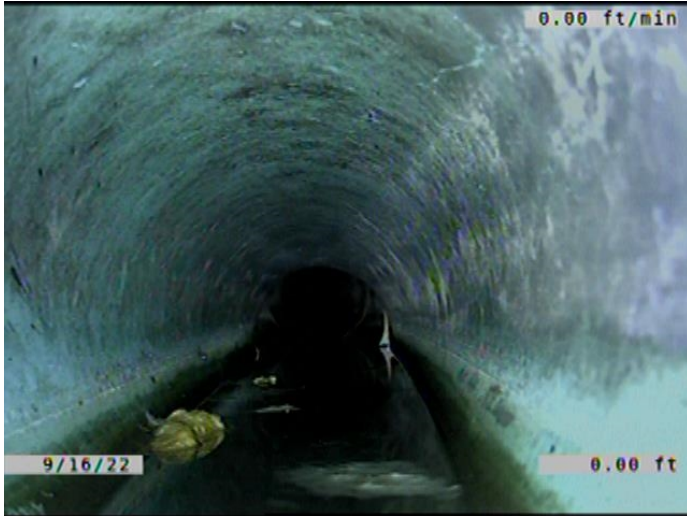
Code:	<b>MWL</b>
Description:	<b>Miscellaneous Water Level</b>
Distance (ft):	<b>.0</b>
Structural Grade:	<b>0</b>
O&M Grade:	<b>0</b>
Clock Start/From:	
Clock To:	
1st Value:	
2nd Value:	
Value Percent:	<b>10.000</b>
Continuous Index:	
Within 8" of Joint:	<b>NO</b>
Remarks:

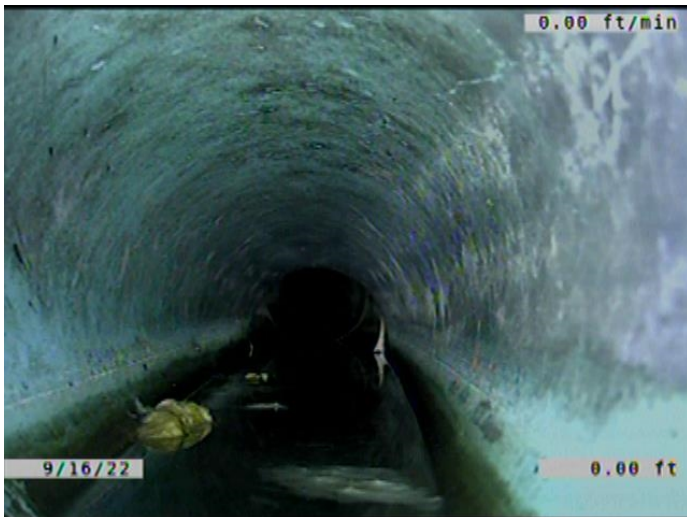
Code:	<b>DSF</b>
Description:	<b>Deposits Settled Fine</b>
Distance (ft):	<b>.0</b>
Structural Grade:	<b>0</b>
O&M Grade:	<b>2</b>
Clock Start/From:	<b>5</b>
Clock To:	<b>7</b>
1st Value:	
2nd Value:	
Value Percent:	<b>5.000</b>
Continuous Index:	<b>S01</b>
Within 8" of Joint:	<b>YES</b>
Remarks:

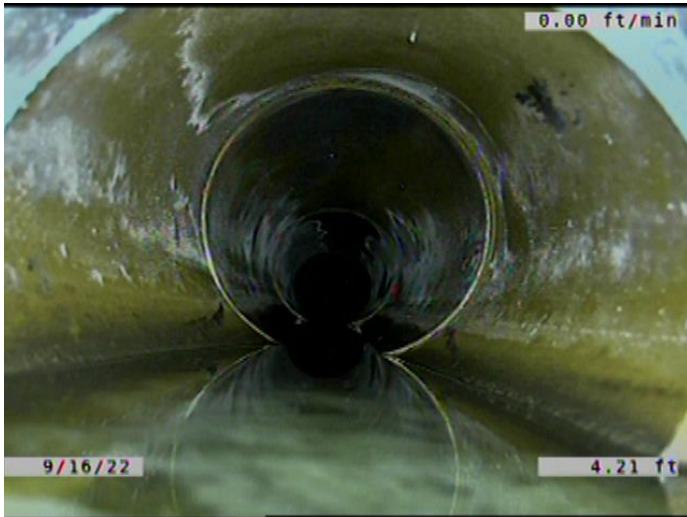
Code: **MWLS**  
 Description: **Miscellaneous Water Level Sag**

Distance (ft): **4.2**  
 Structural Grade: **2**  
 O&M Grade: **0**  
 Clock Start/From:  
 Clock To:  
 1st Value:  
 2nd Value:  
 Value Percent: **15.000**  
 Continuous Index:  
 Within 8" of Joint: **NO**  
 Remarks:

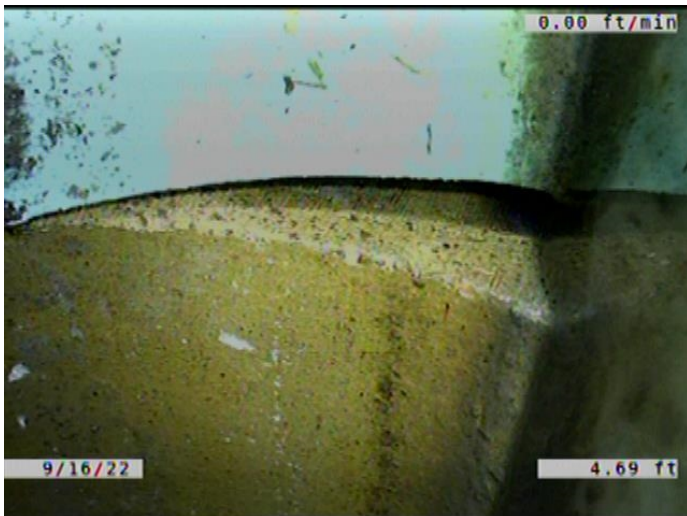
Code: **JOMD**  
 Description: **Joint Offset Medium Defective**

Distance (ft): **4.7**  
 Structural Grade: **3**  
 O&M Grade: **0**  
 Clock Start/From:  
 Clock To:  
 1st Value:  
 2nd Value:  
 Value Percent:  
 Continuous Index:  
 Within 8" of Joint: **NO**  
 Remarks:

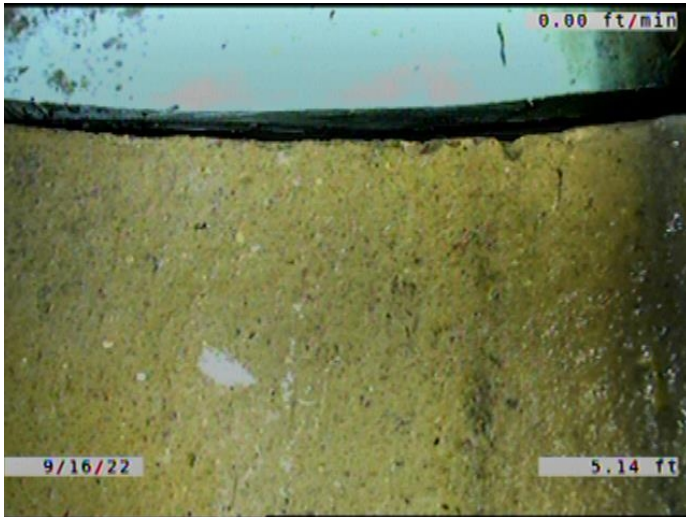
Code: **MMC**  
Description: **Miscellaneous Material Change**

Distance (ft): **5.1**  
Structural Grade: **0**  
O&M Grade: **0**  
Clock Start/From:  
Clock To:  
1st Value:  
2nd Value:  
Value Percent:  
Continuous Index:  
Within 8" of Joint: **NO**  
Remarks: **PVC TO VCP**

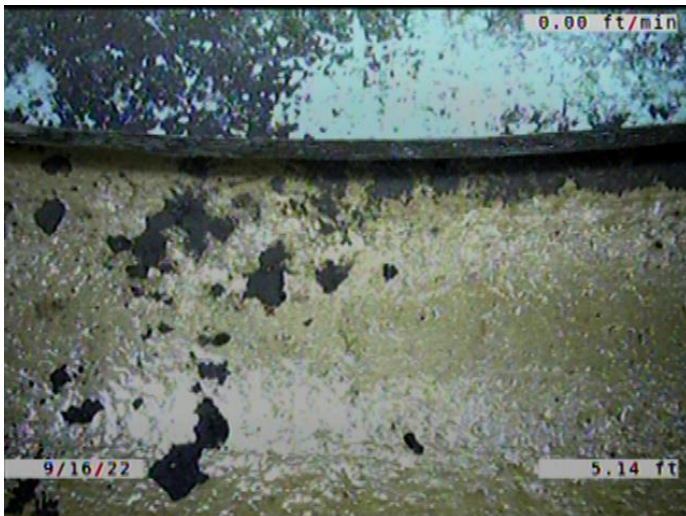
Code: **JAM**  
Description: **Joint Angular Medium**

Distance (ft): **5.1**  
Structural Grade: **3**  
O&M Grade: **0**  
Clock Start/From:  
Clock To:  
1st Value:  
2nd Value:  
Value Percent:  
Continuous Index:  
Within 8" of Joint: **NO**  
Remarks:

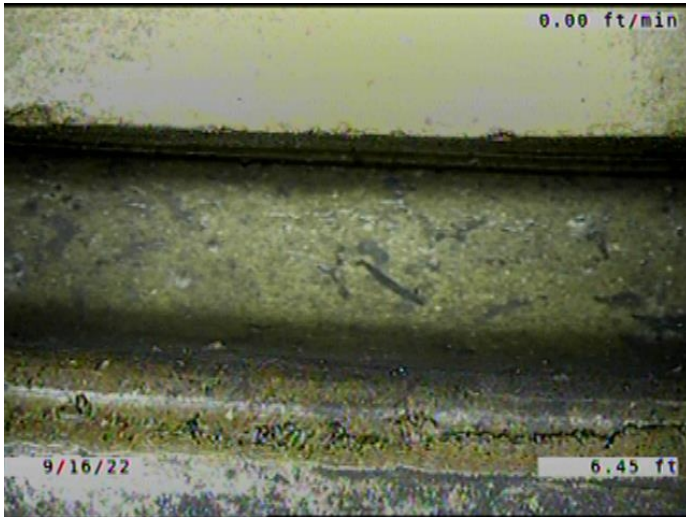
Code: **JAL**  
Description: **Joint Angular Large**

Distance (ft): **6.4**  
Structural Grade: **4**  
O&M Grade: **0**  
Clock Start/From:  
Clock To:  
1st Value:  
2nd Value:  
Value Percent:  
Continuous Index:  
Within 8" of Joint: **NO**  
Remarks:

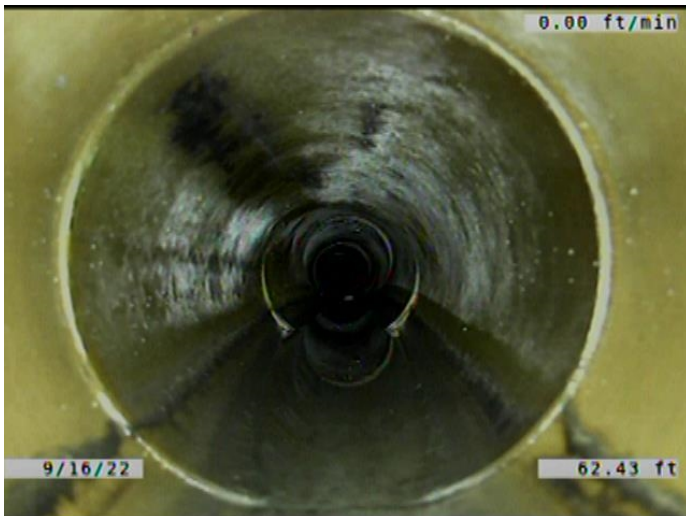
Code: **MWLS**  
Description: **Miscellaneous Water Level Sag**

Distance (ft): **62.4**  
Structural Grade: **2**  
O&M Grade: **0**  
Clock Start/From:  
Clock To:  
1st Value:  
2nd Value:  
Value Percent: **10.000**  
Continuous Index: **S02**  
Within 8" of Joint: **NO**  
Remarks:

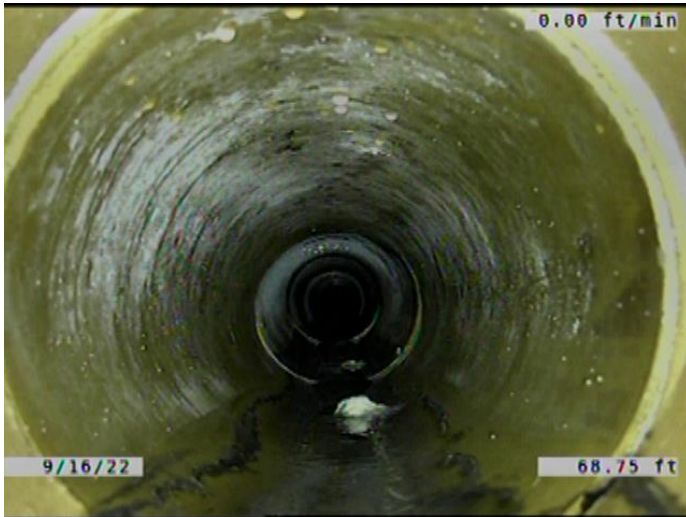
Code: **MWLS**  
Description: **Miscellaneous Water Level Sag**

Distance (ft): **68.7**  
Structural Grade: **2**  
O&M Grade: **0**  
Clock Start/From:  
Clock To:  
1st Value:  
2nd Value:  
Value Percent: **10.000**  
Continuous Index: **F02**  
Within 8" of Joint: **NO**  
Remarks:

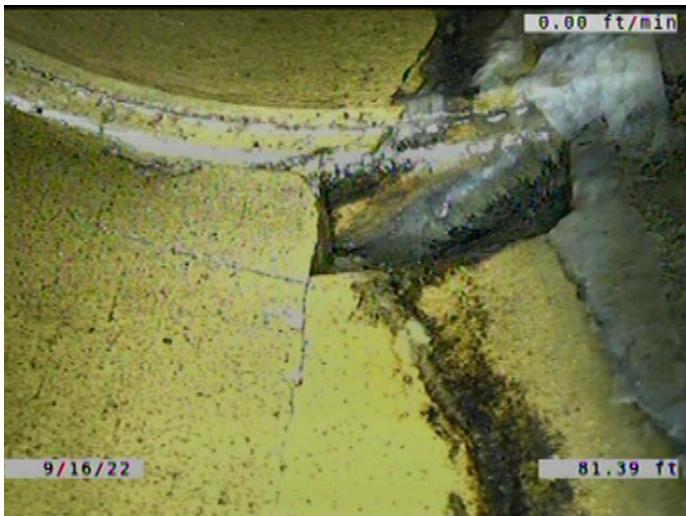
Code: **B**  
Description: **Broken**

Distance (ft): **81.4**  
Structural Grade: **4**  
O&M Grade: **0**  
Clock Start/From: **7**  
Clock To: **9**  
1st Value:  
2nd Value:  
Value Percent:  
Continuous Index:  
Within 8" of Joint: **YES**  
Remarks:

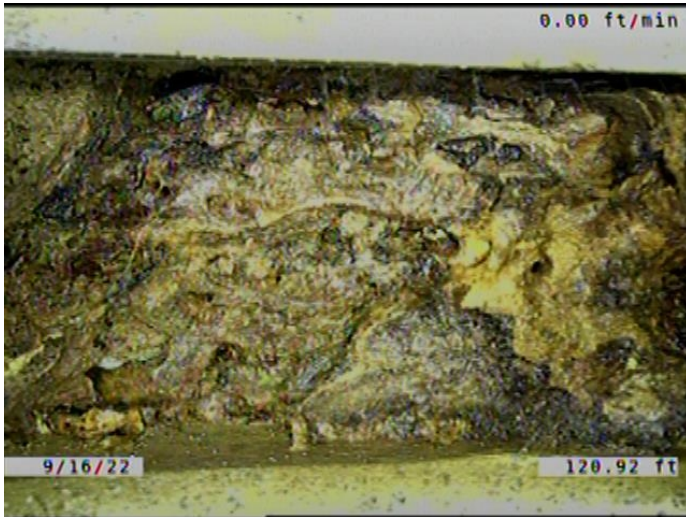
Code: **DAE**  
Description: **Deposits Attached Encrustation**

Distance (ft): **120.9**  
Structural Grade: **0**  
O&M Grade: **2**  
Clock Start/From: **8**  
Clock To: **4**  
1st Value:  
2nd Value:  
Value Percent: **5.000**  
Continuous Index:  
Within 8" of Joint: **YES**  
Remarks:

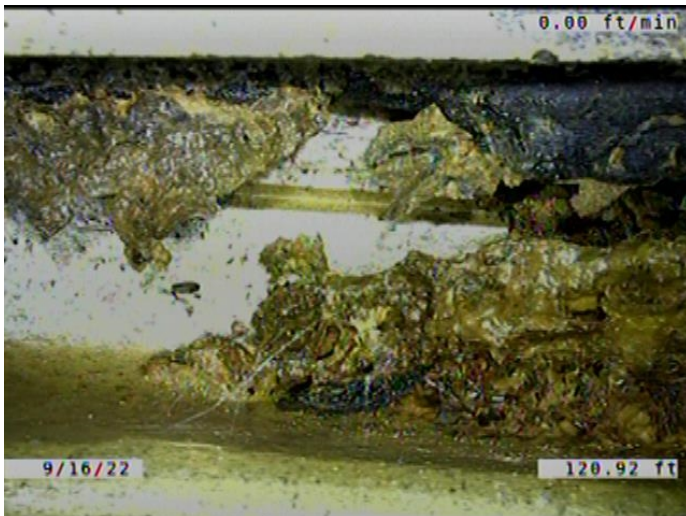
Code: **JAL**  
Description: **Joint Angular Large**

Distance (ft): **120.9**  
Structural Grade: **4**  
O&M Grade: **0**  
Clock Start/From:  
Clock To:  
1st Value:  
2nd Value:  
Value Percent:  
Continuous Index:  
Within 8" of Joint: **NO**  
Remarks:

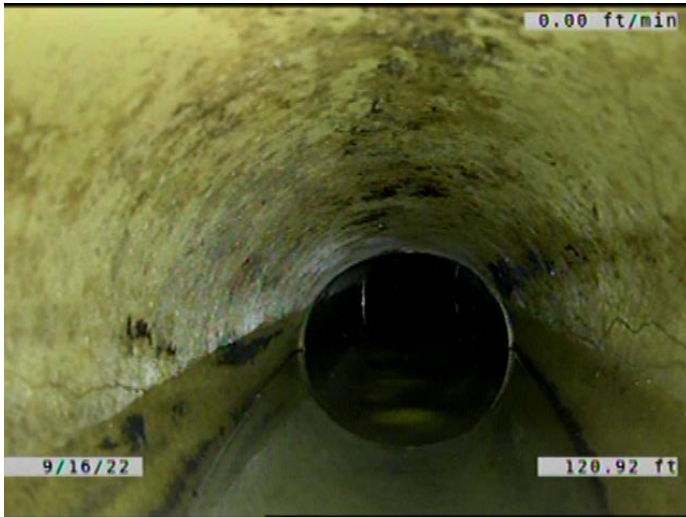
Code: **LD**  
Description: **Line Down**

Distance (ft): **120.9**  
Structural Grade: **0**  
O&M Grade: **2**  
Clock Start/From:  
Clock To:  
1st Value:  
2nd Value:  
Value Percent: **20.000**  
Continuous Index:  
Within 8" of Joint: **NO**  
Remarks:

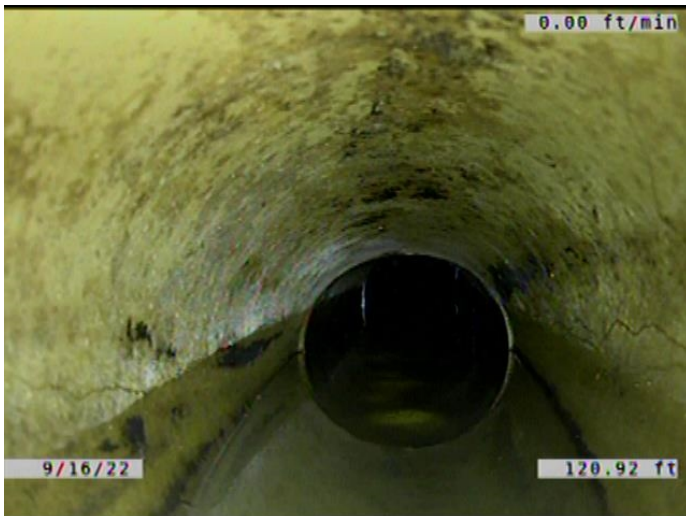
Code: **MWLS**  
Description: **Miscellaneous Water Level Sag**

Distance (ft): **120.9**  
Structural Grade: **3**  
O&M Grade: **0**  
Clock Start/From:  
Clock To:  
1st Value:  
2nd Value:  
Value Percent: **45.000**  
Continuous Index: **S03**  
Within 8" of Joint: **NO**  
Remarks:

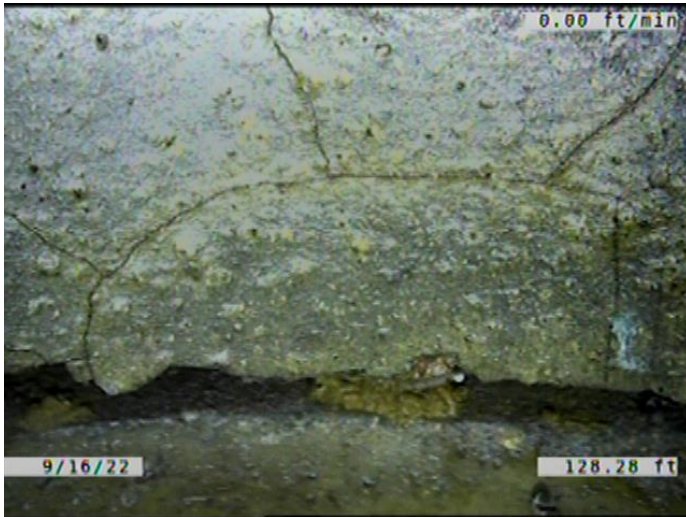
Code: **CM**  
 Description: **Crack Multiple**

Distance (ft): **128.3**  
 Structural Grade: **3**  
 O&M Grade: **0**  
 Clock Start/From: **11**  
 Clock To: **1**  
 1st Value:  
 2nd Value:  
 Value Percent:  
 Continuous Index:  
 Within 8" of Joint: **YES**  
 Remarks:

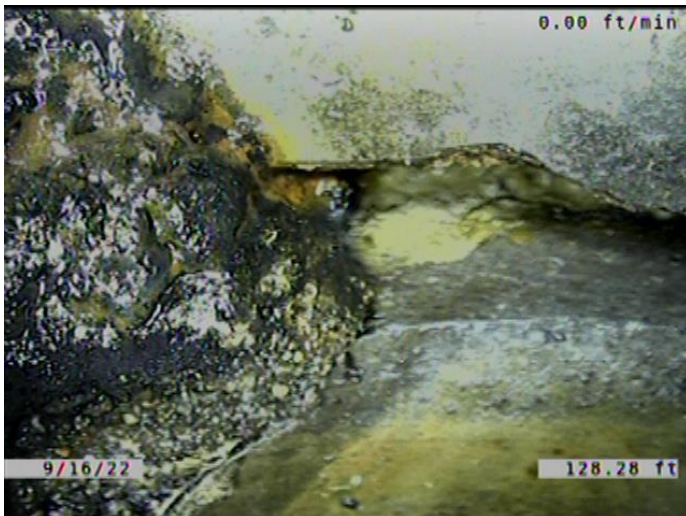
Code: **DAE**  
 Description: **Deposits Attached Encrustation**

Distance (ft): **128.3**  
 Structural Grade: **0**  
 O&M Grade: **2**  
 Clock Start/From: **9**  
 Clock To: **3**  
 1st Value:  
 2nd Value:  
 Value Percent: **5.000**  
 Continuous Index:  
 Within 8" of Joint: **YES**  
 Remarks:

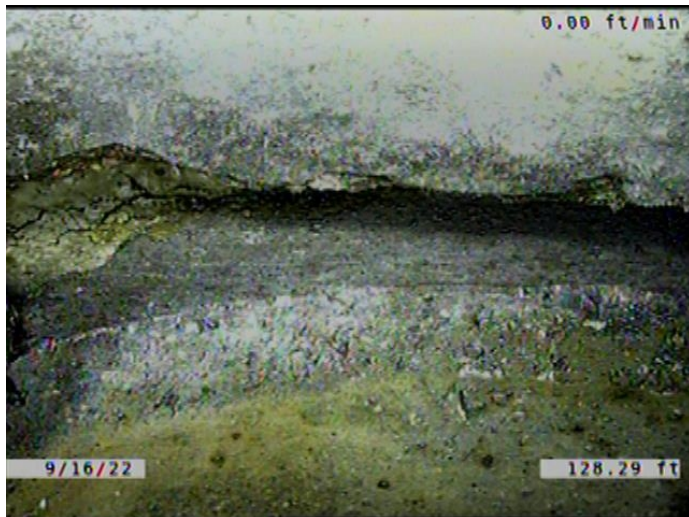
Code: **JOMD**  
Description: **Joint Offset Medium Defective**

Distance (ft): **128.3**  
Structural Grade: **3**  
O&M Grade: **0**  
Clock Start/From:  
Clock To:  
1st Value:  
2nd Value:  
Value Percent:  
Continuous Index:  
Within 8" of Joint: **NO**  
Remarks:

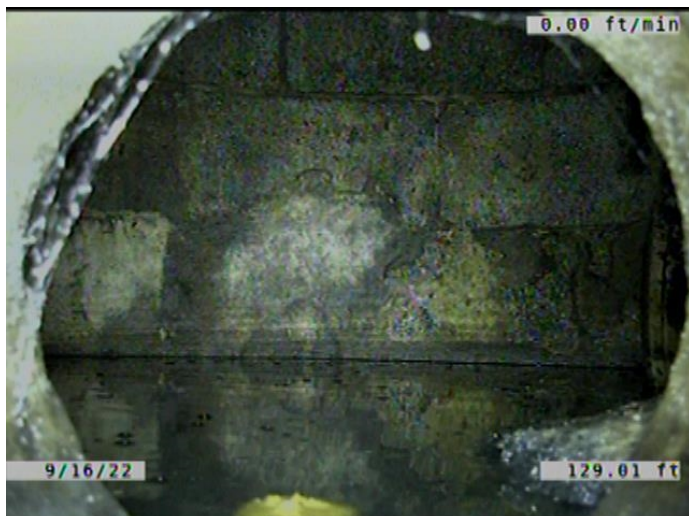
Code: **MWLS**  
Description: **Miscellaneous Water Level Sag**

Distance (ft): **129.0**  
Structural Grade: **3**  
O&M Grade: **0**  
Clock Start/From:  
Clock To:  
1st Value:  
2nd Value:  
Value Percent: **45.000**  
Continuous Index: **F03**  
Within 8" of Joint: **NO**  
Remarks:

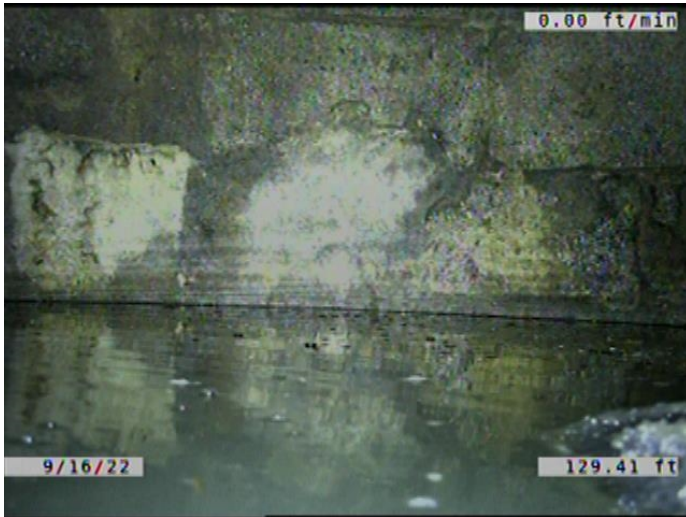
Code: **DSF**  
 Description: **Deposits Settled Fine**

Distance (ft): **129.4**  
 Structural Grade: **0**  
 O&M Grade: **2**  
 Clock Start/From: **5**  
 Clock To: **7**  
 1st Value:  
 2nd Value:  
 Value Percent: **5.000**  
 Continuous Index: **F01**  
 Within 8" of Joint: **YES**  
 Remarks:

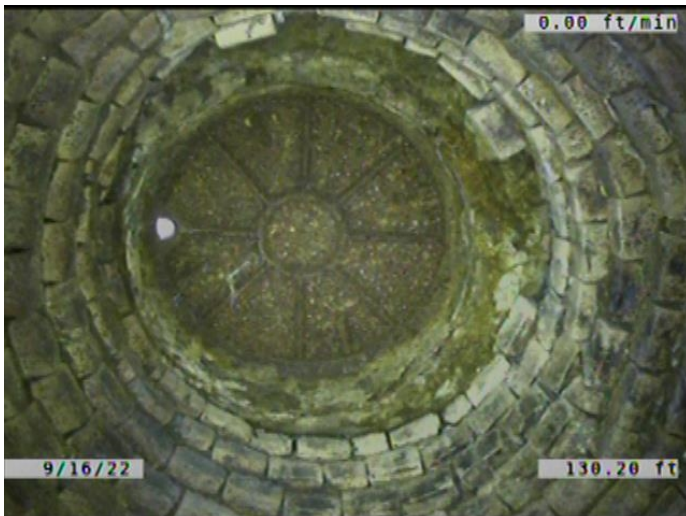
Code: **AMH**  
 Description: **Manhole**

Distance (ft): **130.2**  
 Structural Grade: **0**  
 O&M Grade: **0**  
 Clock Start/From:  
 Clock To:  
 1st Value:  
 2nd Value:  
 Value Percent:  
 Continuous Index:  
 Within 8" of Joint: **NO**  
 Remarks: **M-706-064**
