Profile/Photo Observation Report

Date:	04/11/2018	Weather:		Coding:	PACP 6.0
Pipe Length (ft):	175.2	Owner:	NA	Pre Clean:	No Pre-Cleaning
P.O.#:		Surveyor:	Jen Costello	PSR:	P-706-066-067
Customer:		Clean Date:	01/01/1900	Shape:	C

Street:	OFF E 8TH ST	Flow Control:	Not Controlled
City:	Hobart, IN	Year Renewed:	
Location:	Yard	Tape/Media #:	
Purpose:	Routine Assessment	Dia/Height:	8"
Use:	Sanitary	Material:	VCP
Drain Area:	NA	Lining:	
Category:	NA		
Comment:			
Location Details:		Direction of Survey:	Upstream
US MH:	M-706-066	DS MH:	M-706-067
		Total Length Surveyed (ft):	161.2

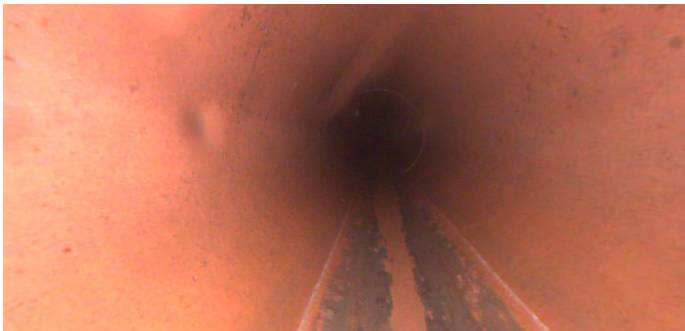
Code: **AMH**
Description: **Manhole**

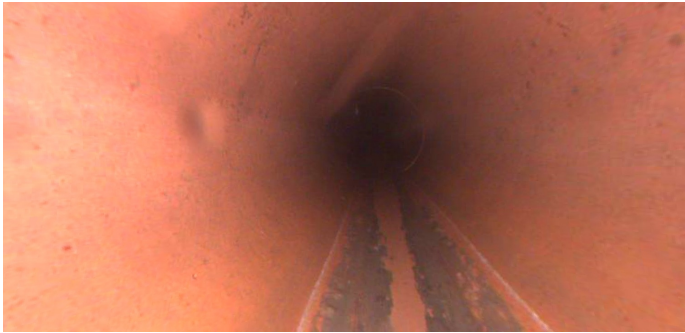
Code:	MWL
Description:	Water Level

Distance (ft):	.0
Structural Grade:	0
O&M Grade:	0
Clock Start/From:	
Clock To:	
1st Value:	
2nd Value:	
Value Percent:	5.000
Continuous Index:	
Within 8" of Joint:	NO
Remarks:

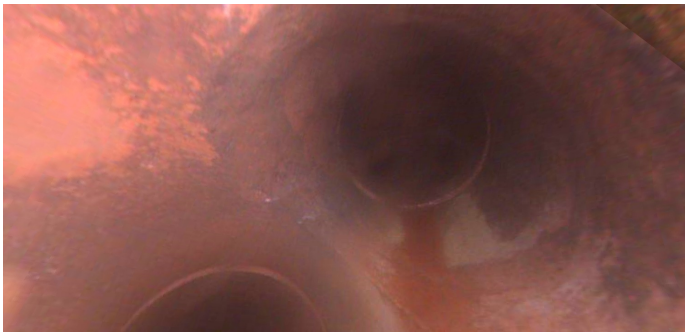
Code:	TF
Description:	Tap Factory

Distance (ft):	44.7
Structural Grade:	0
O&M Grade:	0
Clock Start/From:	2
Clock To:	
1st Value:	4.000
2nd Value:	
Value Percent:	
Continuous Index:	
Within 8" of Joint:	
Remarks:

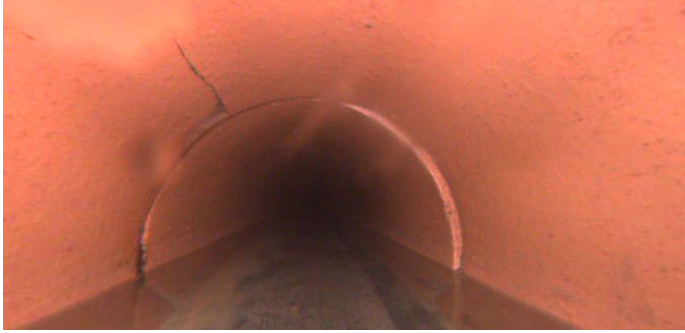
Code: **FL**
Description: **Fracture Longitudinal**

Distance (ft): **93.5**
Structural Grade: **3**
O&M Grade: **0**
Clock Start/From: **11**
Clock To:
1st Value:
2nd Value:
Value Percent:
Continuous Index:
Within 8" of Joint: **YES**
Remarks:

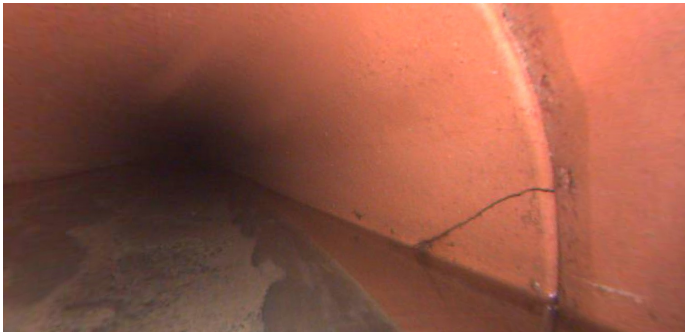
Code: **FS**
Description: **Fracture Spiral**

Distance (ft): **124.2**
Structural Grade: **3**
O&M Grade: **0**
Clock Start/From: **2**
Clock To: **3**
1st Value:
2nd Value:
Value Percent:
Continuous Index:
Within 8" of Joint: **YES**
Remarks:

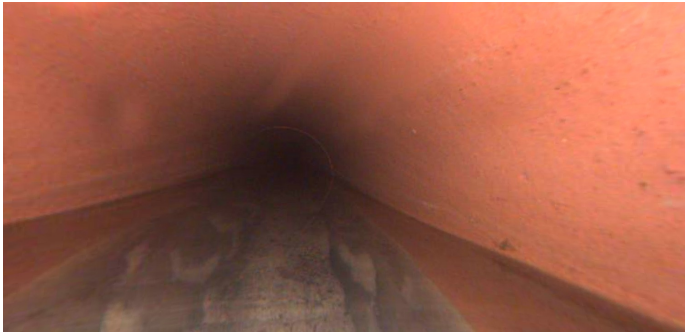
Code: **MWL**
Description: **Water Level**

Distance (ft): **127.5**
Structural Grade: **0**
O&M Grade: **0**
Clock Start/From:
Clock To:
1st Value:
2nd Value:
Value Percent: **40.000**
Continuous Index:
Within 8" of Joint: **NO**
Remarks:

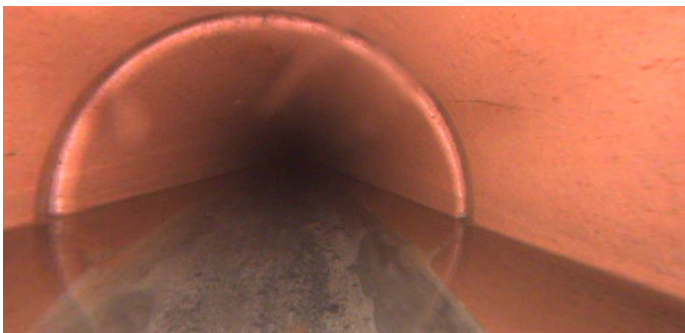
Code: **CL**
Description: **Crack Longitudinal**

Distance (ft): **133.9**
Structural Grade: **2**
O&M Grade: **0**
Clock Start/From: **2**
Clock To:
1st Value:
2nd Value:
Value Percent:
Continuous Index:
Within 8" of Joint: **YES**
Remarks:

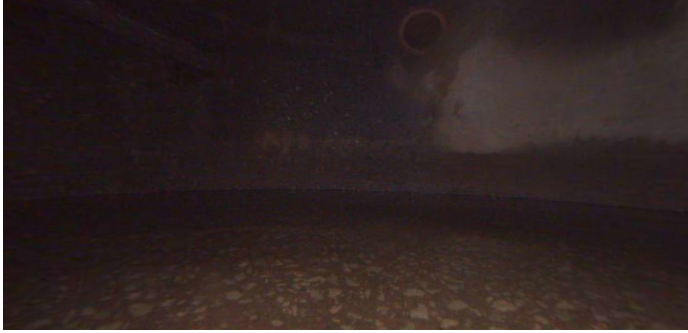
Code:	AMH
Description:	Manhole
Distance (ft):	161.2
Structural Grade:	0
O&M Grade:	0
Clock Start/From:	
Clock To:	
1st Value:	
2nd Value:	
Value Percent:	
Continuous Index:	
Within 8" of Joint:	NO
Remarks:	M-706-066
