Profile/Photo Observation Report

Street:	FOXCROFT STREET	Flow Control:	Not Controlled
City:	Hobart, IN	Year Renewed:	
Location:	Yard	Tape/Media #:	
Purpose:	Routine Assessment	Dia/Height:	8"
Use:	Sanitary	Material:	VCP
Drain Area:	NA	Lining:	
Category:	NA		
Comment:

Location Details:		Direction of Survey:	Upstream
US MH:	M-706-066	DS MH:	M-706-067
		Total Length Surveyed (ft):	161.2

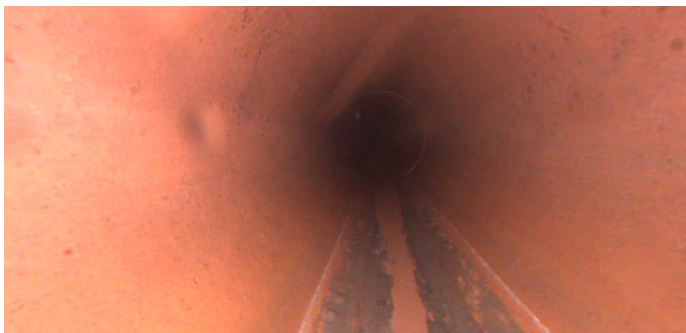
Code: **AMH**
Description: **Manhole**

Distance (ft): **.0**
Structural Grade: **0**
O&M Grade: **0**
Clock Start/From:
Clock To:
1st Value:
2nd Value:
Value Percent:
Continuous Index:
Within 8" of Joint: **NO**
Remarks: **M-706-067**

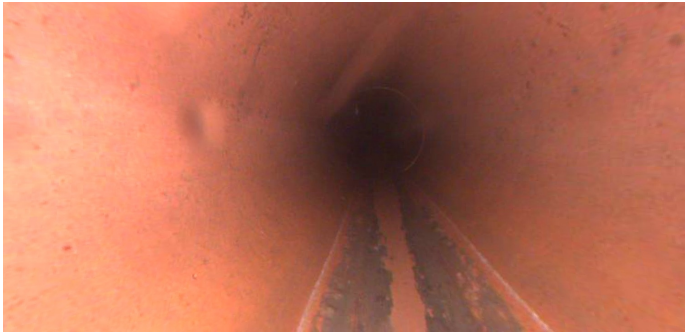
Code:	MWL
Description:	Water Level

Distance (ft):	.0
Structural Grade:	0
O&M Grade:	0
Clock Start/From:	
Clock To:	
1st Value:	
2nd Value:	
Value Percent:	5.000
Continuous Index:	
Within 8" of Joint:	NO
Remarks:

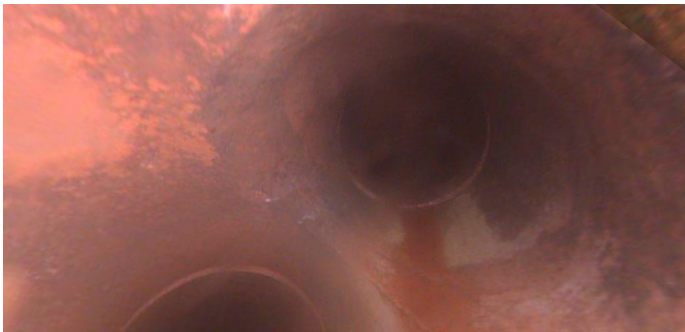
Code:	TF
Description:	Tap Factory

Distance (ft):	44.7
Structural Grade:	0
O&M Grade:	0
Clock Start/From:	2
Clock To:	
1st Value:	4.000
2nd Value:	
Value Percent:	
Continuous Index:	
Within 8" of Joint:	
Remarks:

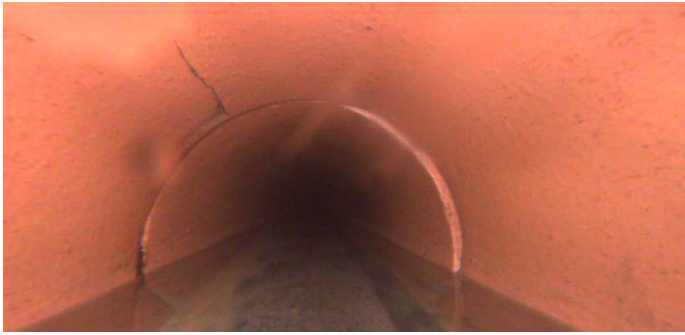
Code: **FL**
Description: **Fracture Longitudinal**

Distance (ft): **93.5**
Structural Grade: **3**
O&M Grade: **0**
Clock Start/From: **11**
Clock To:
1st Value:
2nd Value:
Value Percent:
Continuous Index:
Within 8" of Joint: **YES**
Remarks:

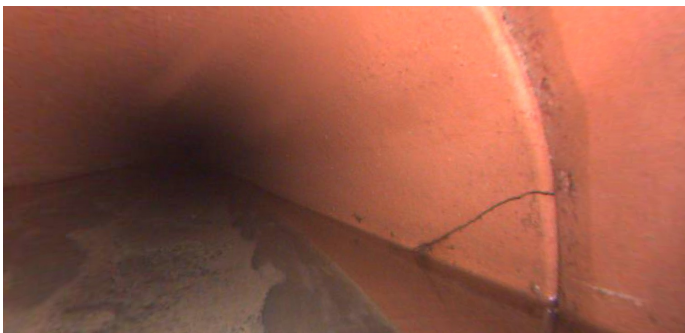
Code: **FS**
Description: **Fracture Spiral**

Distance (ft): **124.2**
Structural Grade: **3**
O&M Grade: **0**
Clock Start/From: **2**
Clock To: **3**
1st Value:
2nd Value:
Value Percent:
Continuous Index:
Within 8" of Joint: **YES**
Remarks:

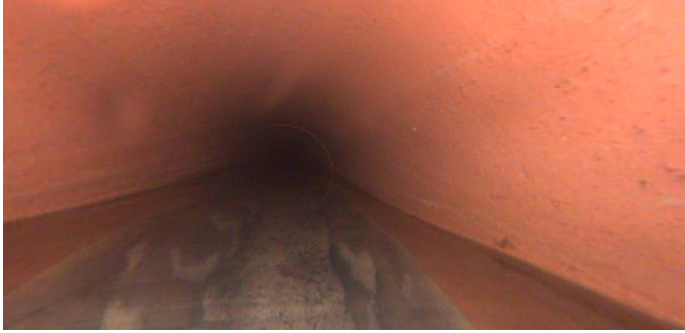
Code: **MWL**
Description: **Water Level**

Distance (ft): **127.5**
Structural Grade: **0**
O&M Grade: **0**
Clock Start/From:
Clock To:
1st Value:
2nd Value:
Value Percent: **40.000**
Continuous Index:
Within 8" of Joint: **NO**
Remarks:

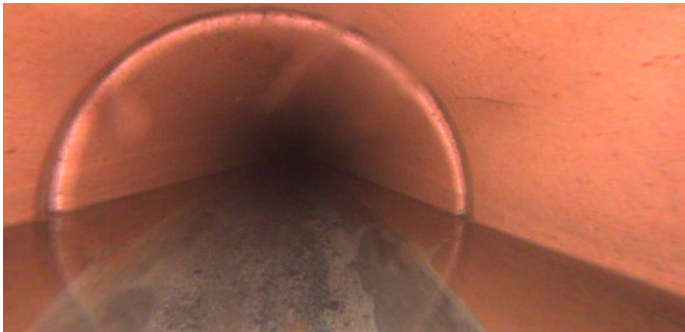
Code: **CL**
Description: **Crack Longitudinal**

Distance (ft): **133.9**
Structural Grade: **2**
O&M Grade: **0**
Clock Start/From: **2**
Clock To:
1st Value:
2nd Value:
Value Percent:
Continuous Index:
Within 8" of Joint: **YES**
Remarks:

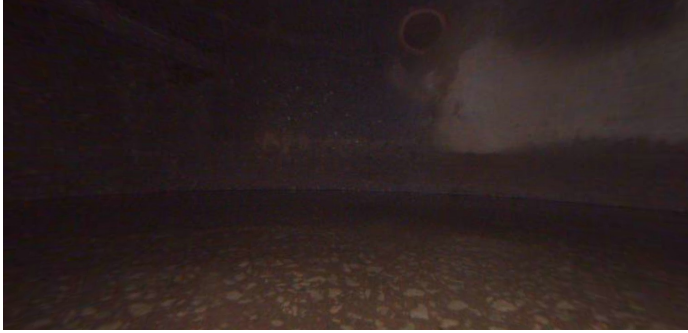
Code:	AMH
Description:	Manhole
Distance (ft):	161.2
Structural Grade:	0
O&M Grade:	0
Clock Start/From:	
Clock To:	
1st Value:	
2nd Value:	
Value Percent:	
Continuous Index:	
Within 8" of Joint:	NO
Remarks:	M-706-066
