Profile/Photo Observation Report

Street:	E 8TH ST	Flow Control:	Not Controlled
City:	Hobart, IN	Year Renewed:	
Location:	Yard	Tape/Media #:	
Purpose:	Routine Assessment	Dia/Height:	8"
Use:	Sanitary	Material:	VCP
Drain Area:	NA	Lining:	
Category:	NA		
Comment:			
Location Details:		Direction of Survey:	Downstream
US MH:	M-706-067	DS MH:	M-606-007
		Total Length Surveyed (ft):	9.1

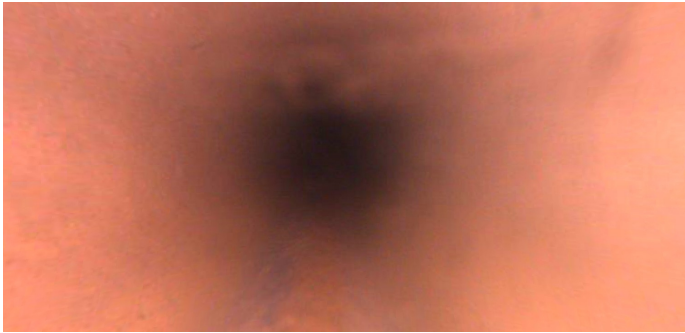
Code:	MWL
Description:	Water Level

Distance (ft):	.0
Structural Grade:	0
O&M Grade:	0
Clock Start/From:	
Clock To:	
1st Value:	
2nd Value:	
Value Percent:	5.000
Continuous Index:	
Within 8" of Joint:	NO
Remarks:

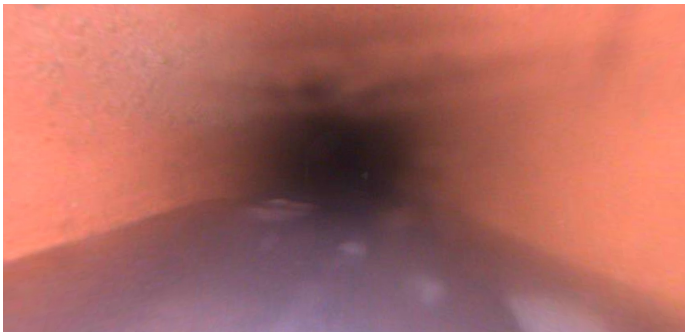
Code:	MWL
Description:	Water Level

Distance (ft):	8.6
Structural Grade:	0
O&M Grade:	0
Clock Start/From:	
Clock To:	
1st Value:	
2nd Value:	
Value Percent:	40.000
Continuous Index:	
Within 8" of Joint:	NO
Remarks:

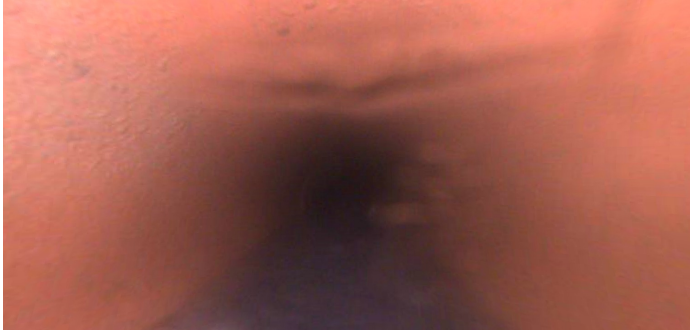
Code:	MSA
Description:	Abandoned Survey
Distance (ft):	9.1
Structural Grade:	0
O&M Grade:	0
Clock Start/From:	
Clock To:	
1st Value:	
2nd Value:	
Value Percent:	
Continuous Index:	
Within 8" of Joint:	NO
Remarks:	debris under water
