Profile/Photo Observation Report

Street:	FOXCROFT STREET	Flow Control:	Not Controlled
City:	Hobart, IN	Year Renewed:	
Location:	Yard	Tape/Media #:	
Purpose:	Routine Assessment	Dia/Height:	8"
Use:	Sanitary	Material:	VCP
Drain Area:	NA	Lining:	
Category:	NA		
Comment:

Location Details:		Direction of Survey:	Downstream
US MH:	M-706-067	DS MH:	M-606-007
		Total Length Surveyed (ft):	9.1

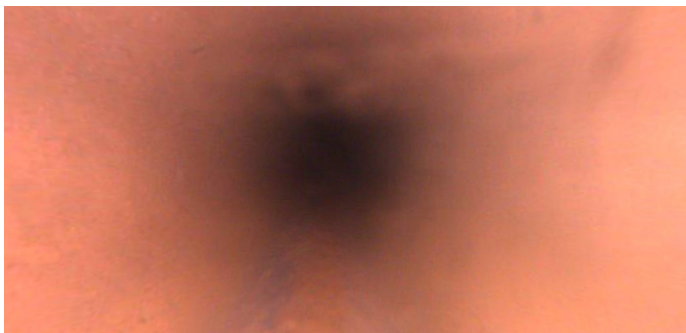
Code: **AMH**
Description: **Manhole**

Distance (ft): **.0**
Structural Grade: **0**
O&M Grade: **0**
Clock Start/From:
Clock To:
1st Value:
2nd Value:
Value Percent:
Continuous Index:
Within 8" of Joint: **NO**
Remarks: **M-706-067**

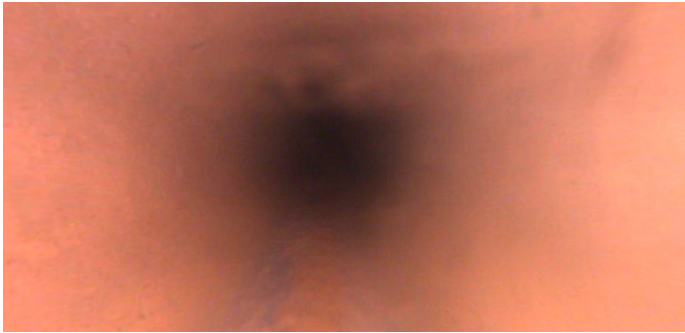
Code:	MWL
Description:	Water Level

Distance (ft):	.0
Structural Grade:	0
O&M Grade:	0
Clock Start/From:	
Clock To:	
1st Value:	
2nd Value:	
Value Percent:	5.000
Continuous Index:	
Within 8" of Joint:	NO
Remarks:

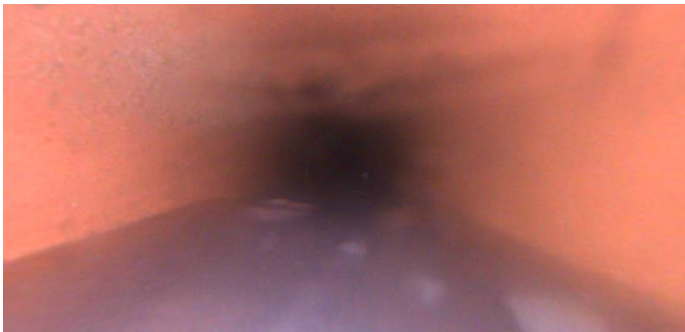
Code:	MWL
Description:	Water Level

Distance (ft):	8.6
Structural Grade:	0
O&M Grade:	0
Clock Start/From:	
Clock To:	
1st Value:	
2nd Value:	
Value Percent:	40.000
Continuous Index:	
Within 8" of Joint:	NO
Remarks:

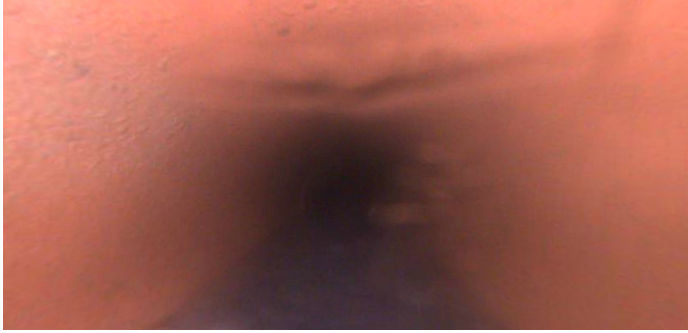
Code:	MSA
Description:	Abandoned Survey
Distance (ft):	9.1
Structural Grade:	0
O&M Grade:	0
Clock Start/From:	
Clock To:	
1st Value:	
2nd Value:	
Value Percent:	
Continuous Index:	
Within 8" of Joint:	NO
Remarks:	debris under water
