## Profile/Photo Observation Report

Street:	<b>E 14TH ST</b>	Flow Control:	<b>Not Controlled</b>
City:	<b>Hobart, IN</b>	Year Renewed:	
Location:	<b>Light Highway</b>	Tape/Media #:	
Purpose:	<b>Maintenance Related</b>	Dia/Height:	<b>8"</b>
Use:	<b>Sanitary</b>	Material:	<b>VCP</b>
Drain Area:	<b>NA</b>	Lining:	<b>Cured in Place</b>
Category:	<b>NA</b>		
Comment:	<b>Flow direction wrong.</b>

Location Details:		Direction of Survey:	<b>Upstream</b>
US MH:	<b>M-707-001</b>	DS MH:	<b>M-807-008</b>
		Total Length Surveyed (ft):	<b>247.7</b>

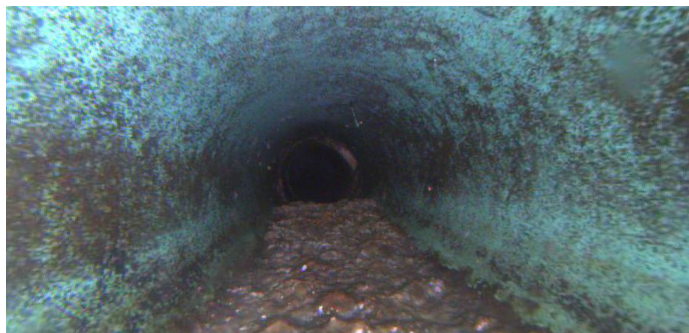
Code: **AMH**  
Description: **Manhole**

Distance (ft): **.0**  
Structural Grade: **0**  
O&M Grade: **0**  
Clock Start/From:  
Clock To:  
1st Value:  
2nd Value:  
Value Percent:  
Continuous Index:  
Within 8" of Joint: **NO**  
Remarks: **M-807-008**

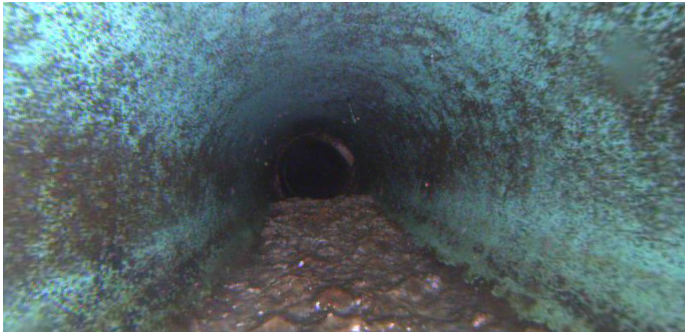
Code:	<b>MWL</b>
Description:	<b>Water Level</b>

Distance (ft):	<b>.0</b>
Structural Grade:	<b>0</b>
O&M Grade:	<b>0</b>
Clock Start/From:	
Clock To:	
1st Value:	
2nd Value:	
Value Percent:	<b>5.000</b>
Continuous Index:	
Within 8" of Joint:	<b>NO</b>
Remarks:

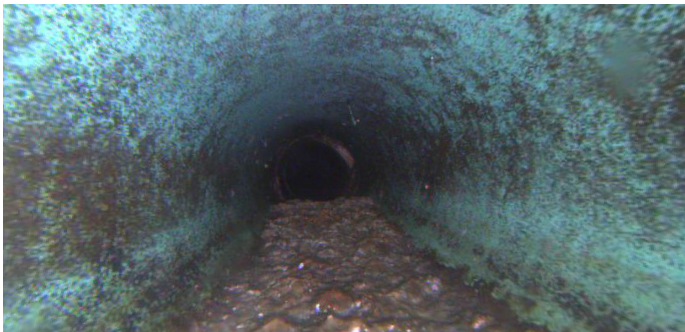
Code:	<b>DSF</b>
Description:	<b>Deposits Settled Fine</b>

Distance (ft):	<b>.0</b>
Structural Grade:	<b>0</b>
O&M Grade:	<b>3</b>
Clock Start/From:	<b>4</b>
Clock To:	<b>8</b>
1st Value:	
2nd Value:	
Value Percent:	<b>20.000</b>
Continuous Index:	
Within 8" of Joint:	<b>NO</b>
Remarks:

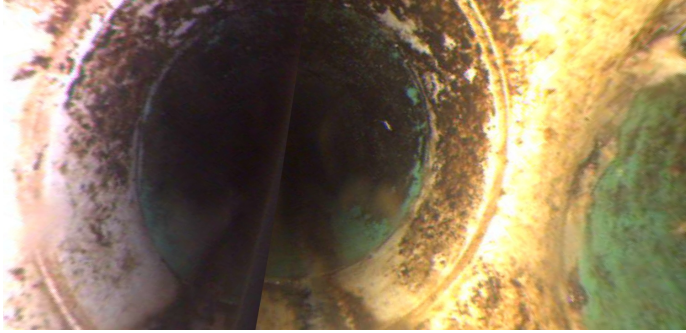
Code: **TF**  
Description: **Tap Factory**

Distance (ft): **3.9**  
Structural Grade: **0**  
O&M Grade: **0**  
Clock Start/From: **2**  
Clock To:  
1st Value: **4.000**  
2nd Value:  
Value Percent:  
Continuous Index:  
Within 8" of Joint:  
Remarks:

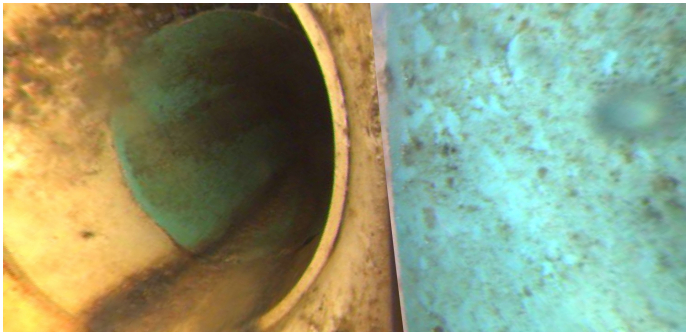
Code: **TF**  
Description: **Tap Factory**

Distance (ft): **22.6**  
Structural Grade: **0**  
O&M Grade: **0**  
Clock Start/From: **10**  
Clock To:  
1st Value: **4.000**  
2nd Value:  
Value Percent:  
Continuous Index:  
Within 8" of Joint:  
Remarks:

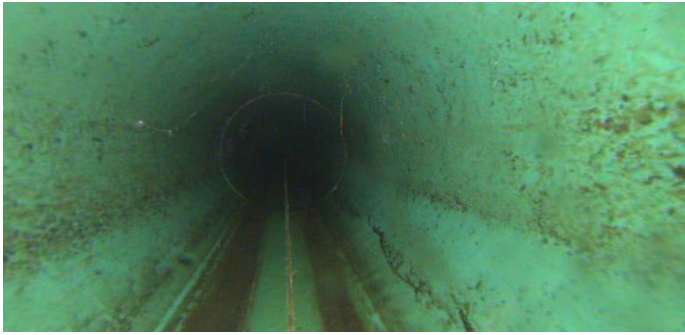
Code: **MGO**  
Description: **General Observation**

Distance (ft): **65.4**  
Structural Grade: **0**  
O&M Grade: **0**  
Clock Start/From:  
Clock To:  
1st Value:  
2nd Value:  
Value Percent:  
Continuous Index:  
Within 8" of Joint: **NO**  
Remarks: **REAR CAMERA**

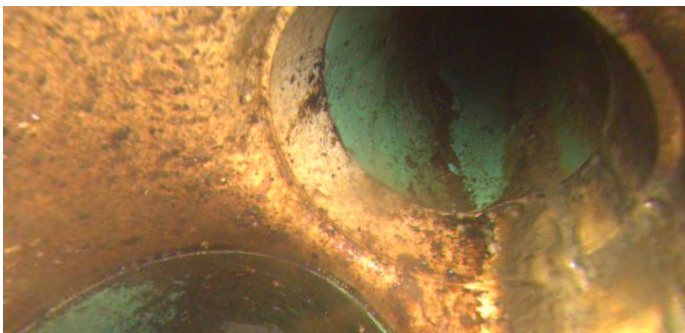
Code: **TF**  
Description: **Tap Factory**

Distance (ft): **168.3**  
Structural Grade: **0**  
O&M Grade: **0**  
Clock Start/From: **11**  
Clock To:  
1st Value: **4.000**  
2nd Value:  
Value Percent:  
Continuous Index:  
Within 8" of Joint:  
Remarks:

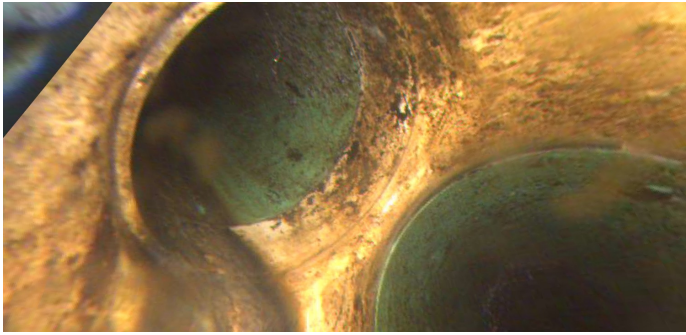
Code: **TF**  
Description: **Tap Factory**

Distance (ft): **194.9**  
Structural Grade: **0**  
O&M Grade: **0**  
Clock Start/From: **2**  
Clock To:  
1st Value: **4.000**  
2nd Value:  
Value Percent:  
Continuous Index:  
Within 8" of Joint:  
Remarks:

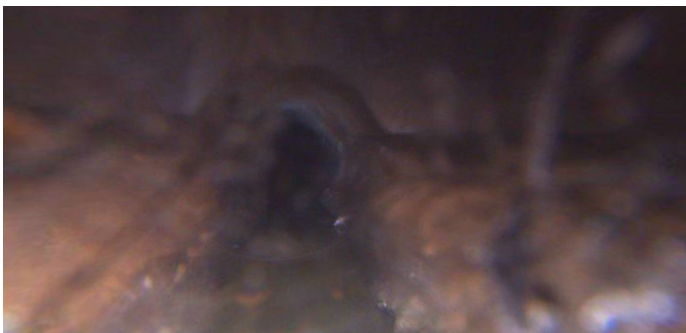
Code: **AMH**  
Description: **Manhole**

Distance (ft): **247.7**  
Structural Grade: **0**  
O&M Grade: **0**  
Clock Start/From:  
Clock To:  
1st Value:  
2nd Value:  
Value Percent:  
Continuous Index:  
Within 8" of Joint: **NO**  
Remarks: **M-707-001**
