Profile/Photo Observation Report

Date:	03/30/2018	Weather:		Coding:	PACP 6.0
Pipe Length (ft):	251.6	Owner:	NA	Pre Clean:	Not Known
P.O.#:		Surveyor:	Jen Costello	PSR:	P-807-008-001
Customer:		Clean Date:	01/01/1900	Shape:	C

Street:	14th	Flow Control:	Not Controlled
City:	Hobart, IN	Year Renewed:	
Location:	Light Highway	Tape/Media #:	
Purpose:	Maintenance Related	Dia/Height:	8"
Use:	Sanitary	Material:	VCP
Drain Area:	NA	Lining:	Cured in Place
Category:	NA		
Comment:	Flow direction wrong.

Location Details:		Direction of Survey:	Upstream
US MH:	M-707-001	DS MH:	M-807-008
		Total Length Surveyed (ft):	247.7

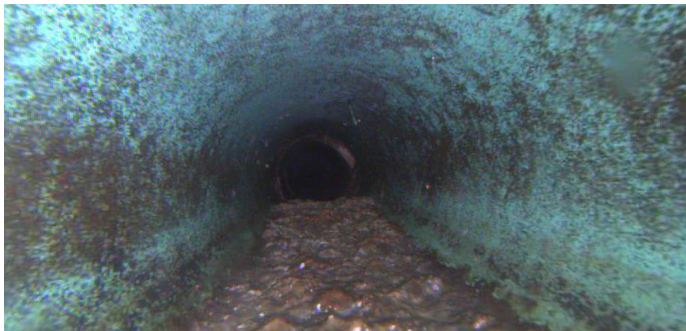
Code: **AMH**
Description: **Manhole**

Distance (ft): **.0**
Structural Grade: **0**
O&M Grade: **0**
Clock Start/From:
Clock To:
1st Value:
2nd Value:
Value Percent:
Continuous Index:
Within 8" of Joint: **NO**
Remarks: **M-807-008**

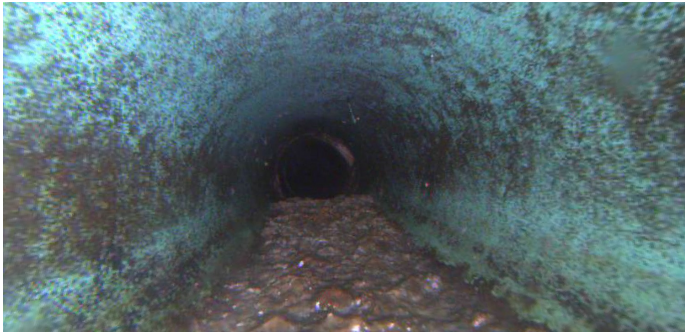
Code:	MWL
Description:	Water Level

Distance (ft):	.0
Structural Grade:	0
O&M Grade:	0
Clock Start/From:	
Clock To:	
1st Value:	
2nd Value:	
Value Percent:	5.000
Continuous Index:	
Within 8" of Joint:	NO
Remarks:

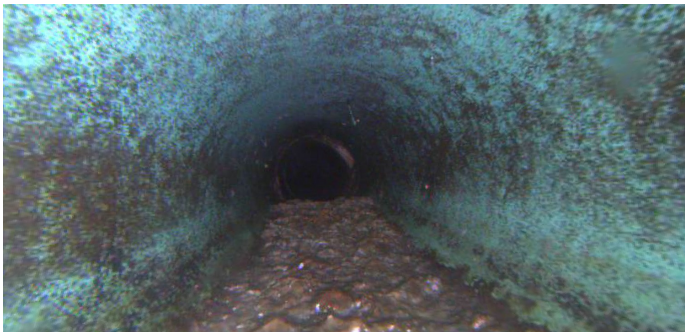
Code:	DSF
Description:	Deposits Settled Fine

Distance (ft):	.0
Structural Grade:	0
O&M Grade:	3
Clock Start/From:	4
Clock To:	8
1st Value:	
2nd Value:	
Value Percent:	20.000
Continuous Index:	
Within 8" of Joint:	NO
Remarks:

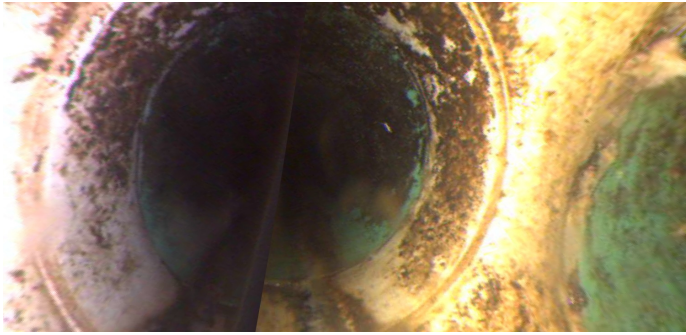
Code: **TF**
Description: **Tap Factory**

Distance (ft): **3.9**
Structural Grade: **0**
O&M Grade: **0**
Clock Start/From: **2**
Clock To:
1st Value: **4.000**
2nd Value:
Value Percent:
Continuous Index:
Within 8" of Joint:
Remarks:

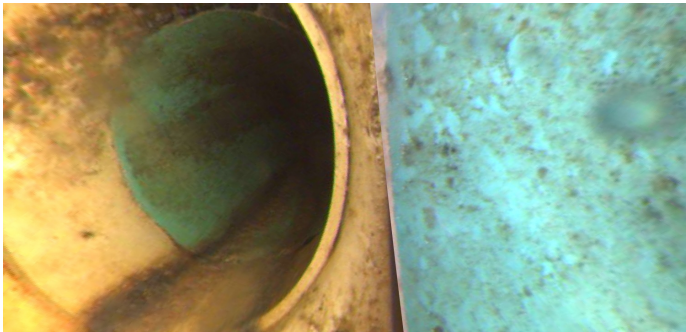
Code: **TF**
Description: **Tap Factory**

Distance (ft): **22.6**
Structural Grade: **0**
O&M Grade: **0**
Clock Start/From: **10**
Clock To:
1st Value: **4.000**
2nd Value:
Value Percent:
Continuous Index:
Within 8" of Joint:
Remarks:

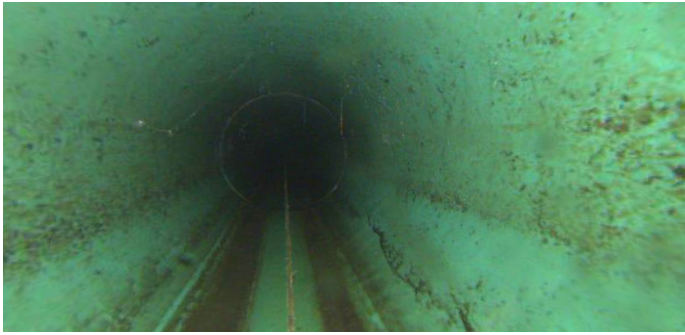
Code: **MGO**
Description: **General Observation**

Distance (ft): **65.4**
Structural Grade: **0**
O&M Grade: **0**
Clock Start/From:
Clock To:
1st Value:
2nd Value:
Value Percent:
Continuous Index:
Within 8" of Joint: **NO**
Remarks: **REAR CAMERA**

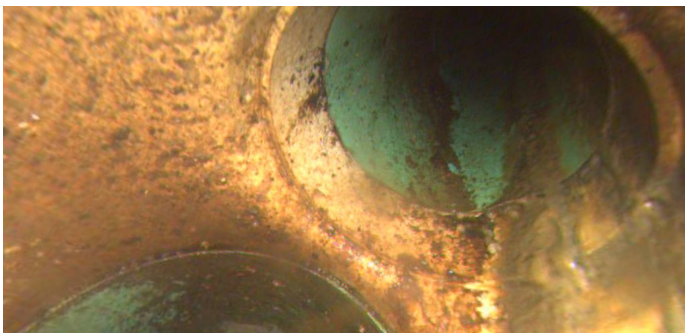
Code: **TF**
Description: **Tap Factory**

Distance (ft): **168.3**
Structural Grade: **0**
O&M Grade: **0**
Clock Start/From: **11**
Clock To:
1st Value: **4.000**
2nd Value:
Value Percent:
Continuous Index:
Within 8" of Joint:
Remarks:

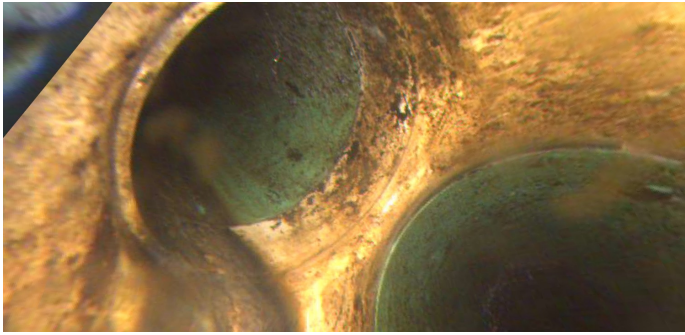
Code: **TF**
Description: **Tap Factory**

Distance (ft): **194.9**
Structural Grade: **0**
O&M Grade: **0**
Clock Start/From: **2**
Clock To:
1st Value: **4.000**
2nd Value:
Value Percent:
Continuous Index:
Within 8" of Joint:
Remarks:

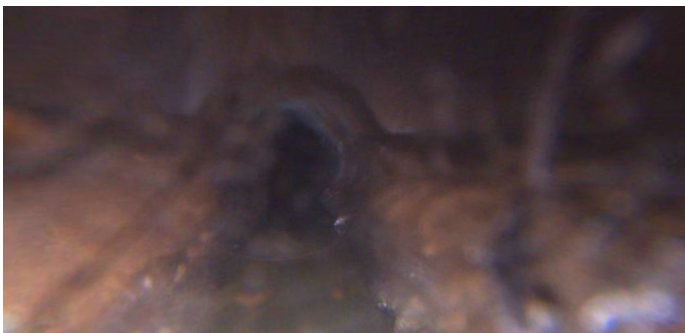
Code: **AMH**
Description: **Manhole**

Distance (ft): **247.7**
Structural Grade: **0**
O&M Grade: **0**
Clock Start/From:
Clock To:
1st Value:
2nd Value:
Value Percent:
Continuous Index:
Within 8" of Joint: **NO**
Remarks: **M-707-001**
