## Profile/Photo Observation Report

Street:	<b>E 14TH ST &amp; GARFIELD ST</b>	Flow Control:	<b>Not Controlled</b>
City:	<b>Hobart, IN</b>	Year Renewed:	
Location:	<b>Light Highway</b>	Tape/Media #:	
Purpose:	<b>Maintenance Related</b>	Dia/Height:	<b>8"</b>
Use:	<b>Sanitary</b>	Material:	<b>PVC</b>
Drain Area:	<b>NA</b>	Lining:	<b>Cured in Place</b>
Category:	<b>NA</b>		
Comment:

Location Details:		Direction of Survey:	<b>Downstream</b>
US MH:	<b>M-707-002</b>	DS MH:	<b>M-707-001</b>
		Total Length Surveyed (ft):	<b>270.7</b>

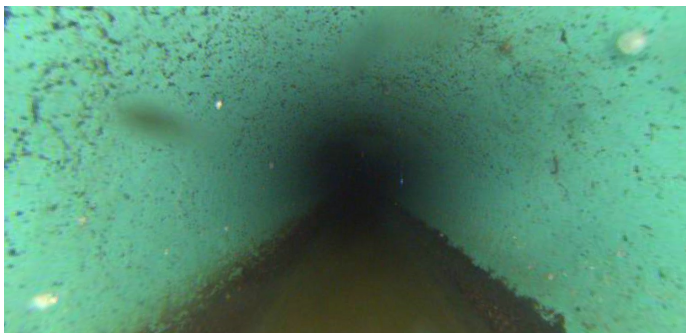
Code: **AMH**  
Description: **Manhole**

Distance (ft): **.0**  
Structural Grade: **0**  
O&M Grade: **0**  
Clock Start/From:  
Clock To:  
1st Value:  
2nd Value:  
Value Percent:  
Continuous Index:  
Within 8" of Joint: **NO**  
Remarks: **M-707-002**

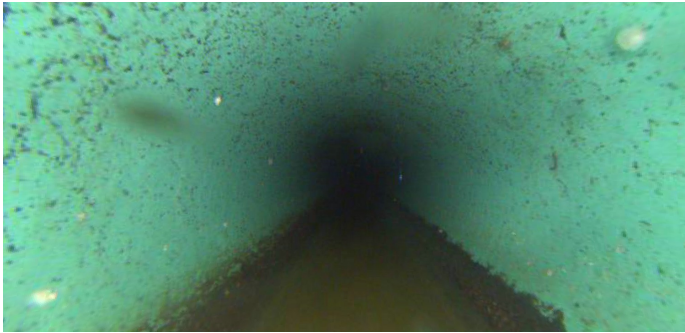
Code:	<b>MWL</b>
Description:	<b>Water Level</b>

Distance (ft):	<b>.0</b>
Structural Grade:	<b>0</b>
O&M Grade:	<b>0</b>
Clock Start/From:	
Clock To:	
1st Value:	
2nd Value:	
Value Percent:	<b>5.000</b>
Continuous Index:	
Within 8" of Joint:	<b>NO</b>
Remarks:

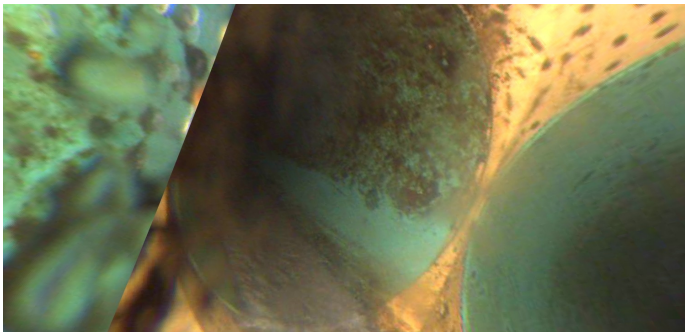
Code:	<b>TF</b>
Description:	<b>Tap Factory</b>

Distance (ft):	<b>53.8</b>
Structural Grade:	<b>0</b>
O&M Grade:	<b>0</b>
Clock Start/From:	<b>2</b>
Clock To:	
1st Value:	<b>4.000</b>
2nd Value:	
Value Percent:	
Continuous Index:	
Within 8" of Joint:	
Remarks:

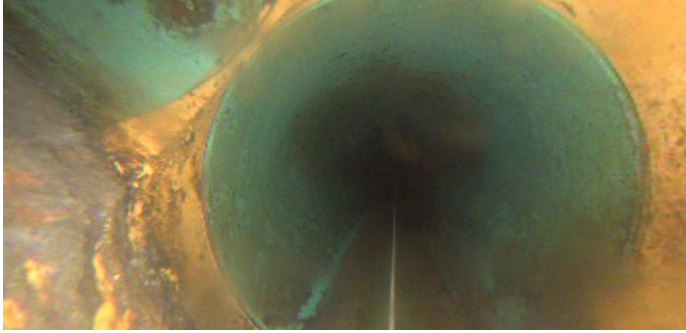
Code: **MGO**  
Description: **General Observation**

Distance (ft): **53.8**  
Structural Grade: **0**  
O&M Grade: **0**  
Clock Start/From:  
Clock To:  
1st Value:  
2nd Value:  
Value Percent:  
Continuous Index:  
Within 8" of Joint: **NO**  
Remarks: **rear camera**

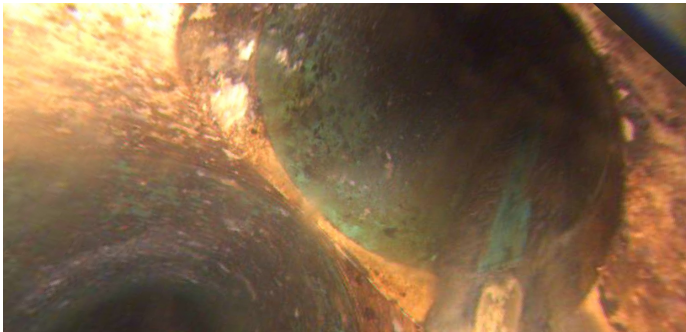
Code: **TF**  
Description: **Tap Factory**

Distance (ft): **156.1**  
Structural Grade: **0**  
O&M Grade: **0**  
Clock Start/From: **11**  
Clock To:  
1st Value: **4.000**  
2nd Value:  
Value Percent:  
Continuous Index:  
Within 8" of Joint:  
Remarks:

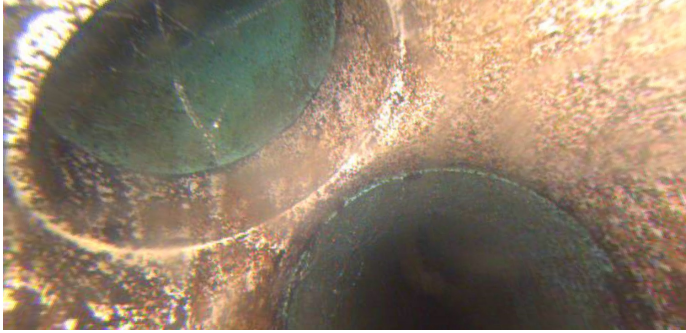
Code: **TF**  
Description: **Tap Factory**

Distance (ft): **190.4**  
Structural Grade: **0**  
O&M Grade: **0**  
Clock Start/From: **1**  
Clock To:  
1st Value: **4.000**  
2nd Value:  
Value Percent:  
Continuous Index:  
Within 8" of Joint:  
Remarks:

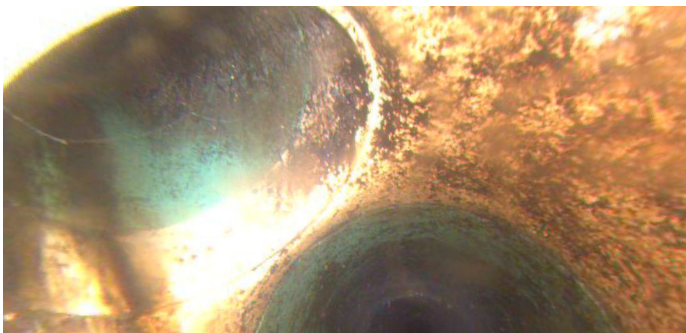
Code: **TFA**  
Description: **Tap Factory Active**

Distance (ft): **246.9**  
Structural Grade: **0**  
O&M Grade: **0**  
Clock Start/From: **1**  
Clock To:  
1st Value: **4.000**  
2nd Value:  
Value Percent:  
Continuous Index:  
Within 8" of Joint:  
Remarks:

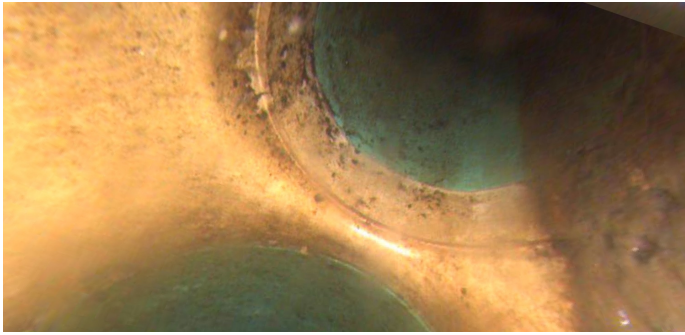
Code: **TF**  
Description: **Tap Factory**

Distance (ft): **265.6**  
Structural Grade: **0**  
O&M Grade: **0**  
Clock Start/From: **11**  
Clock To:  
1st Value: **4.000**  
2nd Value:  
Value Percent:  
Continuous Index:  
Within 8" of Joint:  
Remarks:

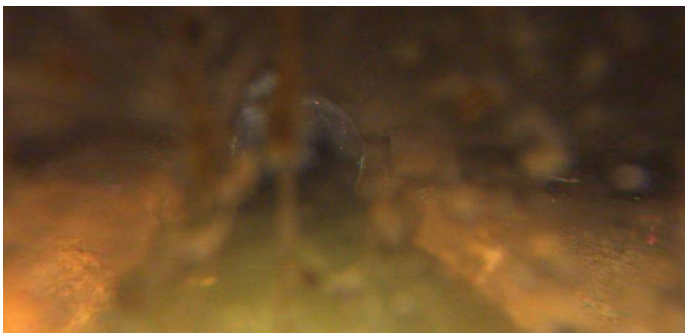
Code: **AMH**  
Description: **Manhole**

Distance (ft): **270.7**  
Structural Grade: **0**  
O&M Grade: **0**  
Clock Start/From:  
Clock To:  
1st Value:  
2nd Value:  
Value Percent:  
Continuous Index:  
Within 8" of Joint: **NO**  
Remarks: **M-707-001**
