Profile/Photo Observation Report

Date:	03/30/2018	Weather:		Coding:	PACP 6.0
Pipe Length (ft):	251.4	Owner:	NA	Pre Clean:	Not Known
P.O.#:		Surveyor:	Jen Costello	PSR:	P-707-001-002
Customer:		Clean Date:	01/01/1900	Shape:	C

Street:	14th	Flow Control:	Not Controlled
City:	Hobart, IN	Year Renewed:	
Location:	Light Highway	Tape/Media #:	
Purpose:	Maintenance Related	Dia/Height:	8"
Use:	Sanitary	Material:	PVC
Drain Area:	NA	Lining:	Cured in Place
Category:	NA		
Comment:

Location Details:		Direction of Survey:	Downstream
US MH:	M-707-002	DS MH:	M-707-001
		Total Length Surveyed (ft):	270.7

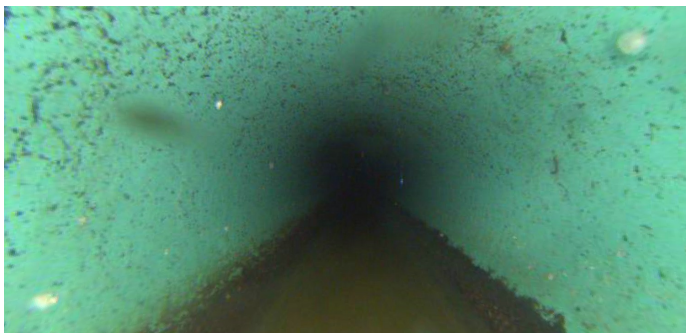
Code: **AMH**
Description: **Manhole**

Distance (ft): **.0**
Structural Grade: **0**
O&M Grade: **0**
Clock Start/From:
Clock To:
1st Value:
2nd Value:
Value Percent:
Continuous Index:
Within 8" of Joint: **NO**
Remarks: **M-707-002**

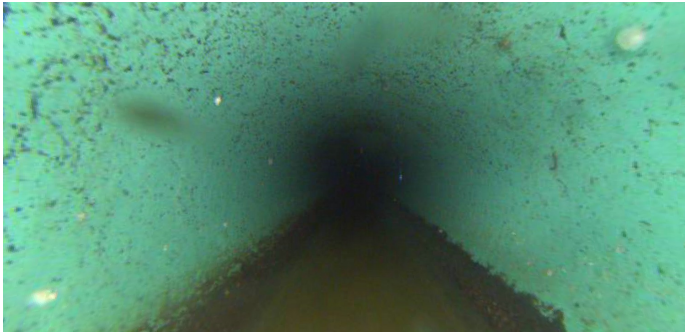
Code:	MWL
Description:	Water Level

Distance (ft):	.0
Structural Grade:	0
O&M Grade:	0
Clock Start/From:	
Clock To:	
1st Value:	
2nd Value:	
Value Percent:	5.000
Continuous Index:	
Within 8" of Joint:	NO
Remarks:

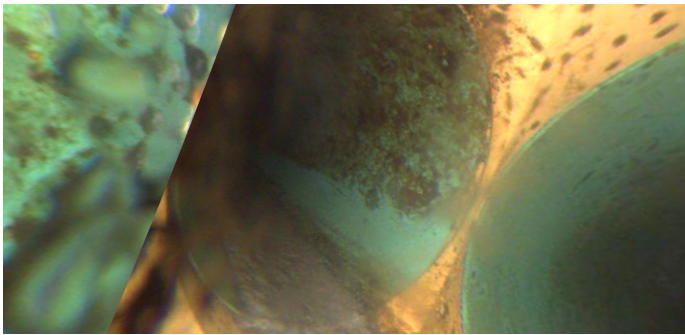
Code:	TF
Description:	Tap Factory

Distance (ft):	53.8
Structural Grade:	0
O&M Grade:	0
Clock Start/From:	2
Clock To:	
1st Value:	4.000
2nd Value:	
Value Percent:	
Continuous Index:	
Within 8" of Joint:	
Remarks:

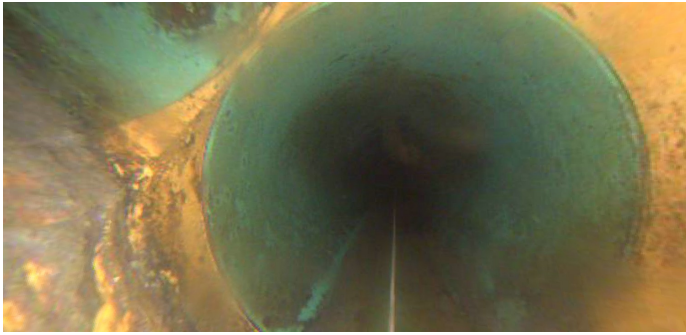
Code: **MGO**
Description: **General Observation**

Distance (ft): **53.8**
Structural Grade: **0**
O&M Grade: **0**
Clock Start/From:
Clock To:
1st Value:
2nd Value:
Value Percent:
Continuous Index:
Within 8" of Joint: **NO**
Remarks: **rear camera**

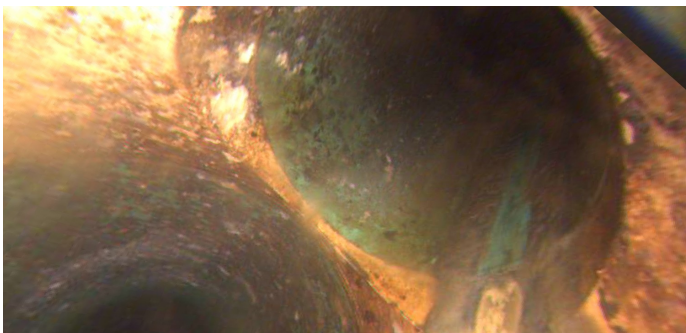
Code: **TF**
Description: **Tap Factory**

Distance (ft): **156.1**
Structural Grade: **0**
O&M Grade: **0**
Clock Start/From: **11**
Clock To:
1st Value: **4.000**
2nd Value:
Value Percent:
Continuous Index:
Within 8" of Joint:
Remarks:

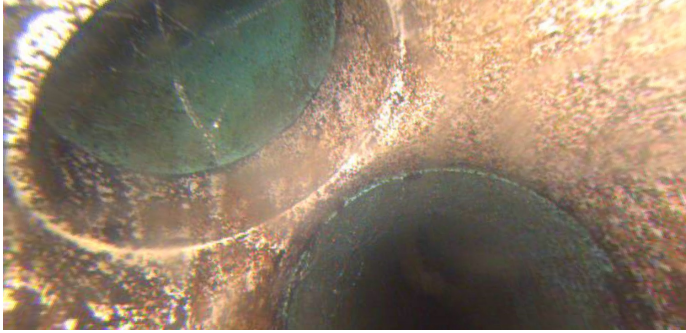
Code: **TF**
Description: **Tap Factory**

Distance (ft): **190.4**
Structural Grade: **0**
O&M Grade: **0**
Clock Start/From: **1**
Clock To:
1st Value: **4.000**
2nd Value:
Value Percent:
Continuous Index:
Within 8" of Joint:
Remarks:

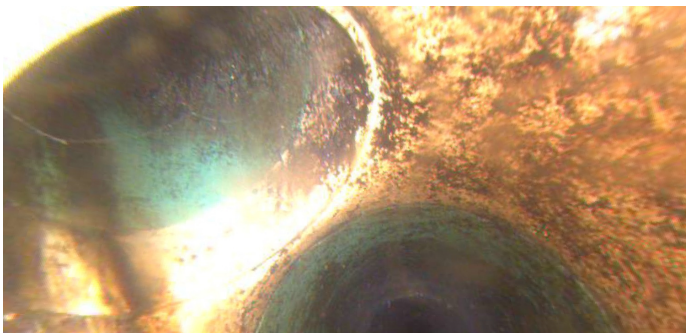
Code: **TFA**
Description: **Tap Factory Active**

Distance (ft): **246.9**
Structural Grade: **0**
O&M Grade: **0**
Clock Start/From: **1**
Clock To:
1st Value: **4.000**
2nd Value:
Value Percent:
Continuous Index:
Within 8" of Joint:
Remarks:

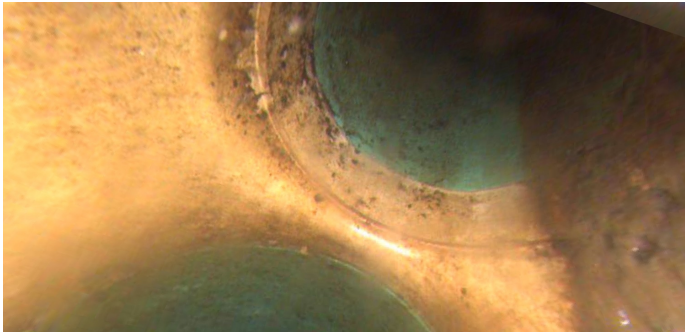
Code: **TF**
Description: **Tap Factory**

Distance (ft): **265.6**
Structural Grade: **0**
O&M Grade: **0**
Clock Start/From: **11**
Clock To:
1st Value: **4.000**
2nd Value:
Value Percent:
Continuous Index:
Within 8" of Joint:
Remarks:

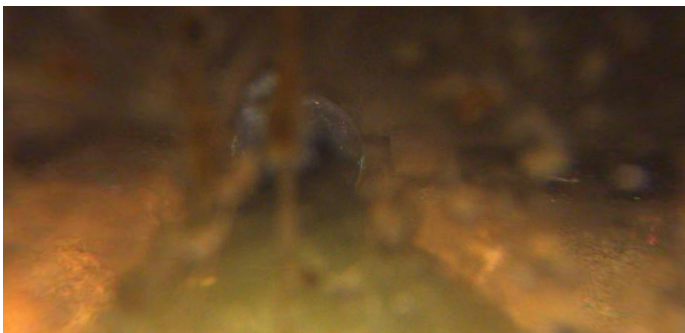
Code: **AMH**
Description: **Manhole**

Distance (ft): **270.7**
Structural Grade: **0**
O&M Grade: **0**
Clock Start/From:
Clock To:
1st Value:
2nd Value:
Value Percent:
Continuous Index:
Within 8" of Joint: **NO**
Remarks: **M-707-001**
