Profile/Photo Observation Report

Street:	E 14TH ST	Flow Control:	Not Controlled
City:	Hobart, IN	Year Renewed:	
Location:	Light Highway	Tape/Media #:	
Purpose:	Maintenance Related	Dia/Height:	10"
Use:	Sanitary	Material:	PVC
Drain Area:	NA	Lining:	Cured in Place
Category:	NA		
Comment:	Flow direction wrong.

Location Details:		Direction of Survey:	Downstream
US MH:	M-707-002	DS MH:	M-707-003
		Total Length Surveyed (ft):	201.0

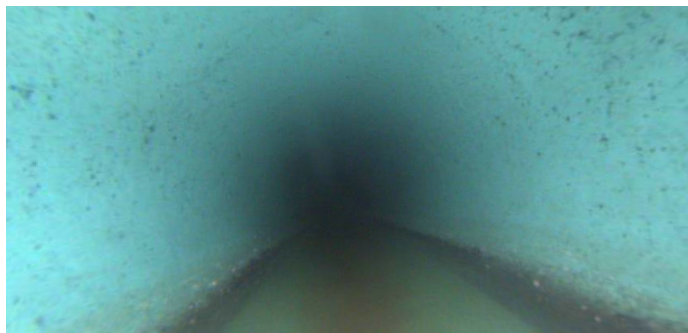
Code: **AMH**
 Description: **Manhole**

Distance (ft): **.0**
 Structural Grade: **0**
 O&M Grade: **0**
 Clock Start/From:
 Clock To:
 1st Value:
 2nd Value:
 Value Percent:
 Continuous Index:
 Within 8" of Joint: **NO**
 Remarks: **M-707-002**

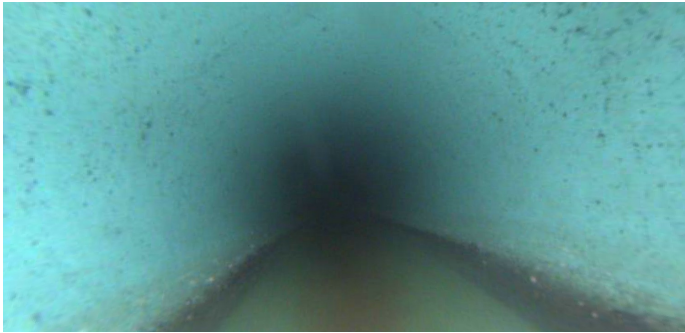
Code:	MWL
Description:	Water Level

Distance (ft):	.0
Structural Grade:	0
O&M Grade:	0
Clock Start/From:	
Clock To:	
1st Value:	
2nd Value:	
Value Percent:	10.000
Continuous Index:	
Within 8" of Joint:	NO
Remarks:

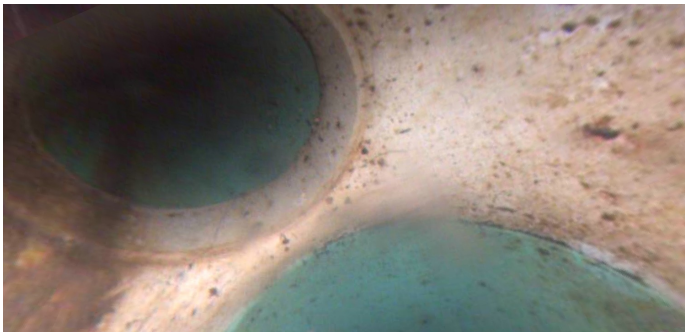
Code:	TF
Description:	Tap Factory

Distance (ft):	11.6
Structural Grade:	0
O&M Grade:	0
Clock Start/From:	11
Clock To:	
1st Value:	4.000
2nd Value:	
Value Percent:	
Continuous Index:	
Within 8" of Joint:	
Remarks:

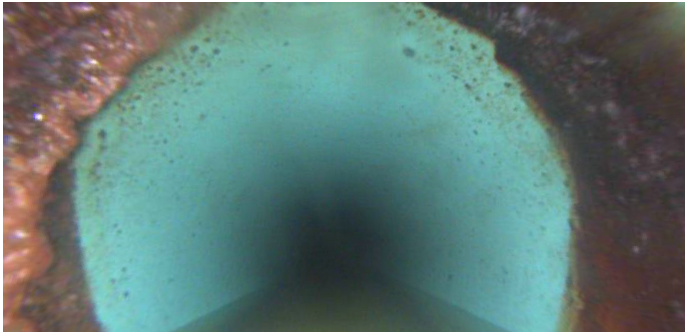
Code: **DAE**
Description: **Deposits Attached Encrustation**

Distance (ft): **89.3**
Structural Grade: **0**
O&M Grade: **2**
Clock Start/From: **8**
Clock To: **4**
1st Value:
2nd Value:
Value Percent: **5.000**
Continuous Index:
Within 8" of Joint: **YES**
Remarks:

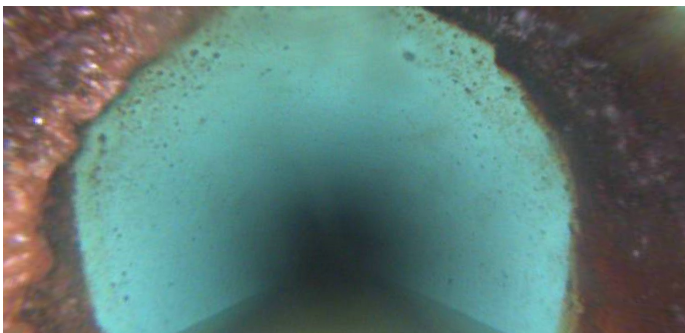
Code: **IW**
Description: **Infil Weeper**

Distance (ft): **89.3**
Structural Grade: **0**
O&M Grade: **2**
Clock Start/From: **8**
Clock To: **4**
1st Value:
2nd Value:
Value Percent:
Continuous Index:
Within 8" of Joint: **YES**
Remarks:

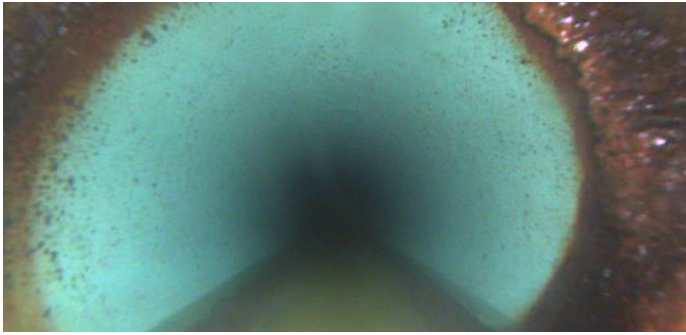
Code: **IW**
Description: **Infil Weeper**

Distance (ft): **113.2**
Structural Grade: **0**
O&M Grade: **2**
Clock Start/From: **8**
Clock To: **4**
1st Value:
2nd Value:
Value Percent:
Continuous Index:
Within 8" of Joint: **YES**
Remarks:

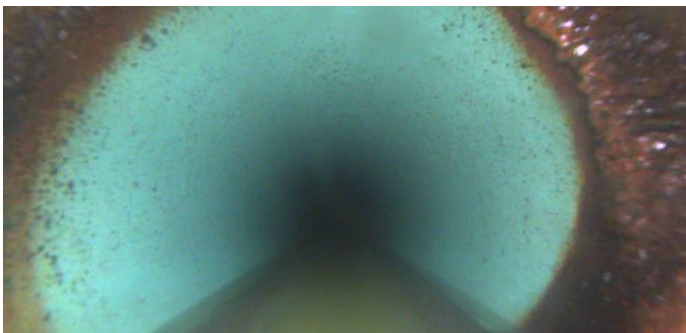
Code: **DAE**
Description: **Deposits Attached Encrustation**

Distance (ft): **113.2**
Structural Grade: **0**
O&M Grade: **2**
Clock Start/From: **8**
Clock To: **4**
1st Value:
2nd Value:
Value Percent: **5.000**
Continuous Index:
Within 8" of Joint: **YES**
Remarks:

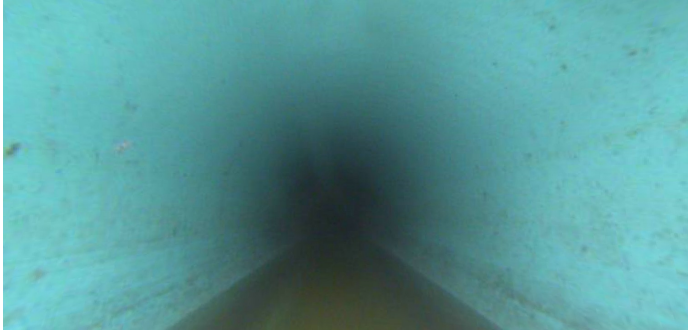
Code:	MSA
Description:	Abandoned Survey
Distance (ft):	201.0
Structural Grade:	0
O&M Grade:	0
Clock Start/From:	
Clock To:	
1st Value:	
2nd Value:	
Value Percent:	
Continuous Index:	
Within 8" of Joint:	NO
Remarks:	UNKNOWN
