Profile/Photo Observation Report

Street:	14th	Flow Control:	Not Controlled
City:	Hobart, IN	Year Renewed:	
Location:	Light Highway	Tape/Media #:	
Purpose:	Maintenance Related	Dia/Height:	10"
Use:	Sanitary	Material:	PVC
Drain Area:	NA	Lining:	Cured in Place
Category:	NA		
Comment:	Flow direction wrong.

Location Details:		Direction of Survey:	Downstream
US MH:	M-707-002	DS MH:	M-707-003
		Total Length Surveyed (ft):	201.0

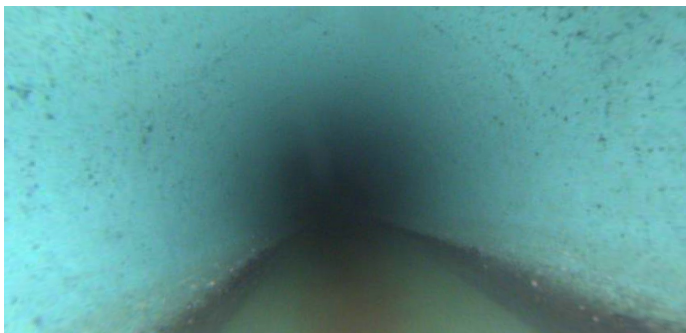
Code: **AMH**
Description: **Manhole**

Distance (ft): **.0**
Structural Grade: **0**
O&M Grade: **0**
Clock Start/From:
Clock To:
1st Value:
2nd Value:
Value Percent:
Continuous Index:
Within 8" of Joint: **NO**
Remarks: **M-707-002**

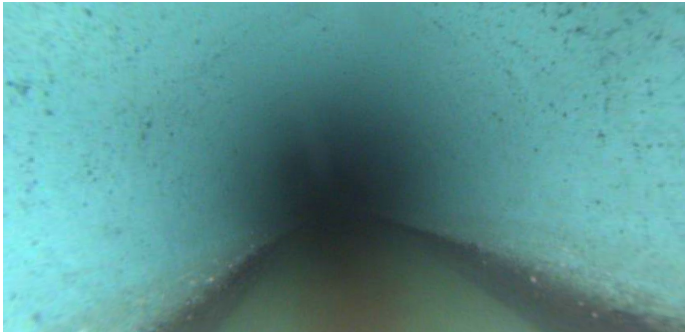
Code:	MWL
Description:	Water Level

Distance (ft):	.0
Structural Grade:	0
O&M Grade:	0
Clock Start/From:	
Clock To:	
1st Value:	
2nd Value:	
Value Percent:	10.000
Continuous Index:	
Within 8" of Joint:	NO
Remarks:

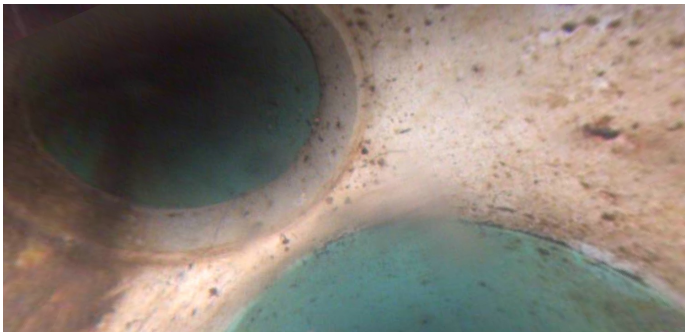
Code:	TF
Description:	Tap Factory

Distance (ft):	11.6
Structural Grade:	0
O&M Grade:	0
Clock Start/From:	11
Clock To:	
1st Value:	4.000
2nd Value:	
Value Percent:	
Continuous Index:	
Within 8" of Joint:	
Remarks:

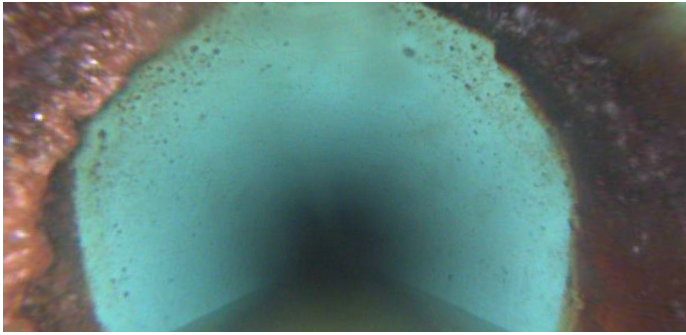
Code: **DAE**
Description: **Deposits Attached Encrustation**

Distance (ft): **89.3**
Structural Grade: **0**
O&M Grade: **2**
Clock Start/From: **8**
Clock To: **4**
1st Value:
2nd Value:
Value Percent: **5.000**
Continuous Index:
Within 8" of Joint: **YES**
Remarks:

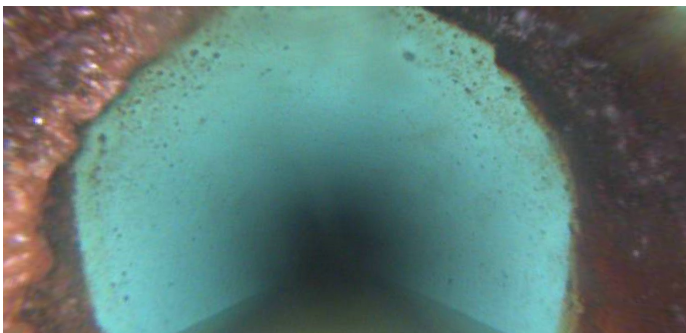
Code: **IW**
Description: **Infil Weeper**

Distance (ft): **89.3**
Structural Grade: **0**
O&M Grade: **2**
Clock Start/From: **8**
Clock To: **4**
1st Value:
2nd Value:
Value Percent:
Continuous Index:
Within 8" of Joint: **YES**
Remarks:

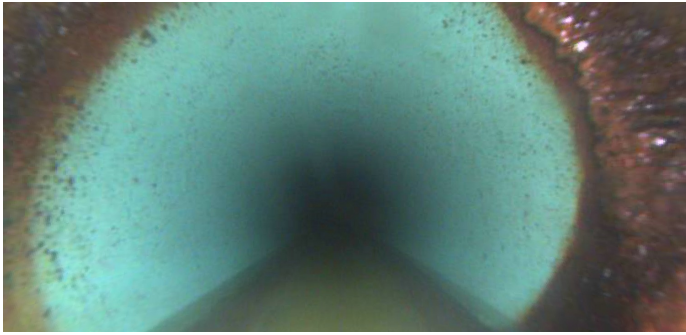
Code: **IW**
Description: **Infil Weeper**

Distance (ft): **113.2**
Structural Grade: **0**
O&M Grade: **2**
Clock Start/From: **8**
Clock To: **4**
1st Value:
2nd Value:
Value Percent:
Continuous Index:
Within 8" of Joint: **YES**
Remarks:

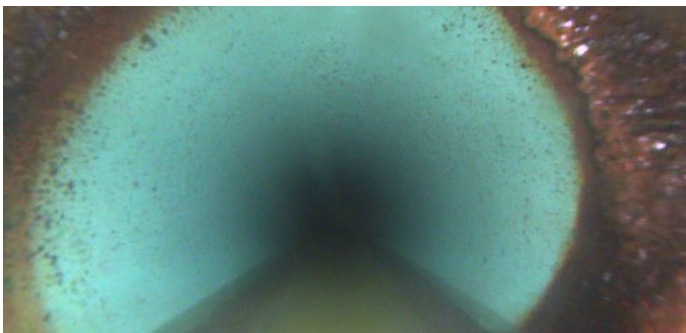
Code: **DAE**
Description: **Deposits Attached Encrustation**

Distance (ft): **113.2**
Structural Grade: **0**
O&M Grade: **2**
Clock Start/From: **8**
Clock To: **4**
1st Value:
2nd Value:
Value Percent: **5.000**
Continuous Index:
Within 8" of Joint: **YES**
Remarks:

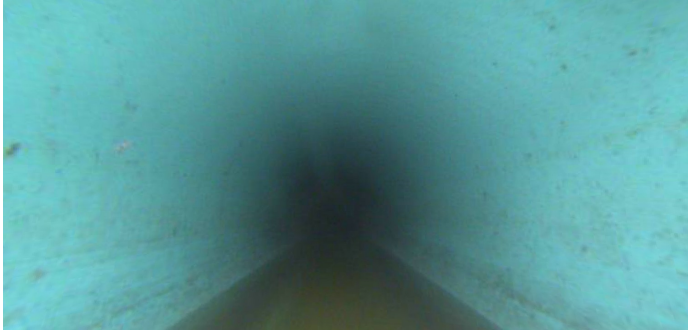
Code:	MSA
Description:	Abandoned Survey
Distance (ft):	201.0
Structural Grade:	0
O&M Grade:	0
Clock Start/From:	
Clock To:	
1st Value:	
2nd Value:	
Value Percent:	
Continuous Index:	
Within 8" of Joint:	NO
Remarks:	UNKNOWN
