Profile/Photo Observation Report

Date:	03/30/2018	Weather:		Coding:	PACP 6.0
Pipe Length (ft):	345.8	Owner:	NA	Pre Clean:	Not Known
P.O.#:		Surveyor:	Jen Costello	PSR:	P-707-003-002
Customer:		Clean Date:	01/01/1900	Shape:	C

Street:	14th	Flow Control:	Not Controlled
City:	Hobart, IN	Year Renewed:	
Location:	Light Highway	Tape/Media #:	
Purpose:	Maintenance Related	Dia/Height:	10"
Use:	Sanitary	Material:	PVC
Drain Area:	NA	Lining:	Cured in Place
Category:	NA		
Comment:	Flow direction wrong. Reverse setup.		
Location Details:		Direction of Survey:	Upstream
US MH:	M-707-002	DS MH:	M-707-003
		Total Length Surveyed (ft):	306.1

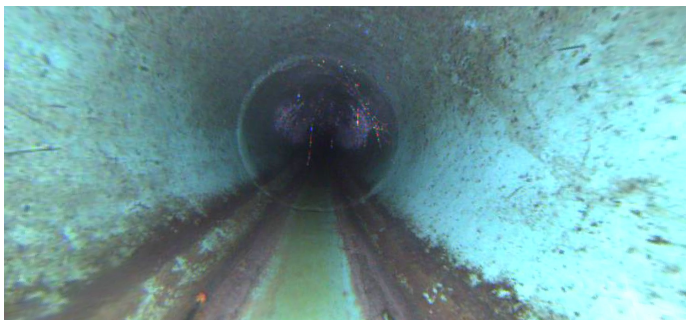
Code: **AMH**
Description: **Manhole**

Distance (ft): **.0**
Structural Grade: **0**
O&M Grade: **0**
Clock Start/From:
Clock To:
1st Value:
2nd Value:
Value Percent:
Continuous Index:
Within 8" of Joint: **NO**
Remarks: **M-707-003**

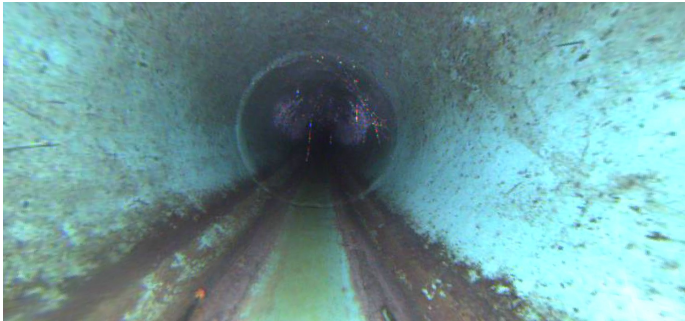
Code:	MWL
Description:	Water Level

Distance (ft):	.0
Structural Grade:	0
O&M Grade:	0
Clock Start/From:	
Clock To:	
1st Value:	
2nd Value:	
Value Percent:	5.000
Continuous Index:	
Within 8" of Joint:	NO
Remarks:

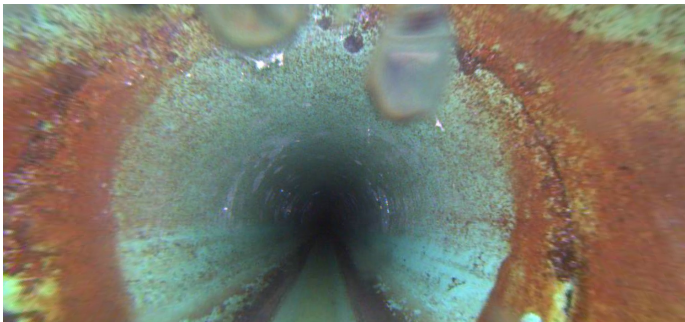
Code:	IS
Description:	Infil Stain

Distance (ft):	51.3
Structural Grade:	0
O&M Grade:	0
Clock Start/From:	8
Clock To:	4
1st Value:	
2nd Value:	
Value Percent:	
Continuous Index:	
Within 8" of Joint:	YES
Remarks:

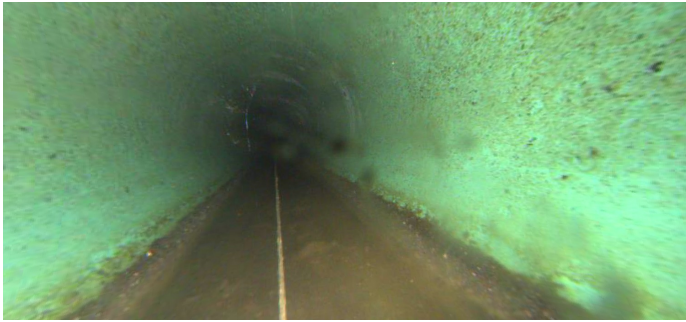
Code: **MGO**
Description: **General Observation**

Distance (ft): **75.7**
Structural Grade: **0**
O&M Grade: **0**
Clock Start/From:
Clock To:
1st Value:
2nd Value:
Value Percent:
Continuous Index:
Within 8" of Joint: **NO**
Remarks: **REAR CAMERA**

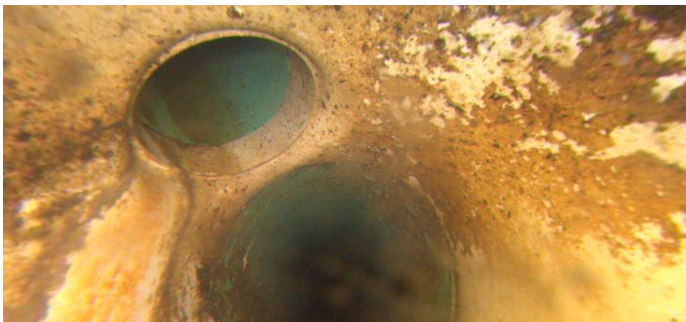
Code: **TF**
Description: **Tap Factory**

Distance (ft): **126.1**
Structural Grade: **0**
O&M Grade: **0**
Clock Start/From: **1**
Clock To:
1st Value: **4.000**
2nd Value:
Value Percent:
Continuous Index:
Within 8" of Joint:
Remarks:

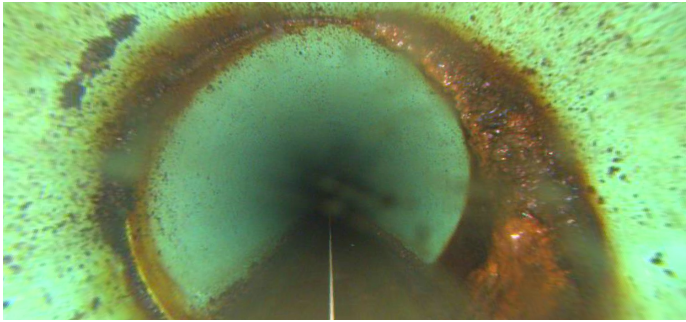
Code: **DAE**
Description: **Deposits Attached Encrustation**

Distance (ft): **223.8**
Structural Grade: **0**
O&M Grade: **2**
Clock Start/From: **8**
Clock To: **4**
1st Value:
2nd Value:
Value Percent: **5.000**
Continuous Index:
Within 8" of Joint: **YES**
Remarks:

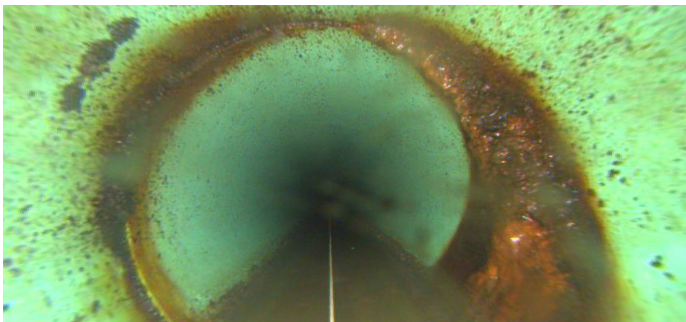
Code: **IW**
Description: **Infil Weeper**

Distance (ft): **223.8**
Structural Grade: **0**
O&M Grade: **2**
Clock Start/From: **8**
Clock To: **4**
1st Value:
2nd Value:
Value Percent:
Continuous Index:
Within 8" of Joint: **YES**
Remarks:

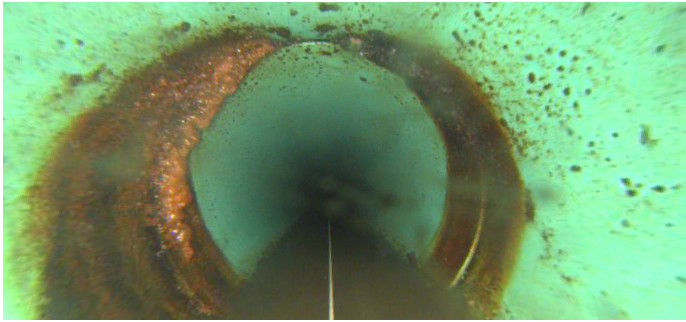
Code: **IW**
Description: **Infil Weeper**

Distance (ft): **248.9**
Structural Grade: **0**
O&M Grade: **2**
Clock Start/From: **8**
Clock To: **4**
1st Value:
2nd Value:
Value Percent:
Continuous Index:
Within 8" of Joint: **YES**
Remarks:

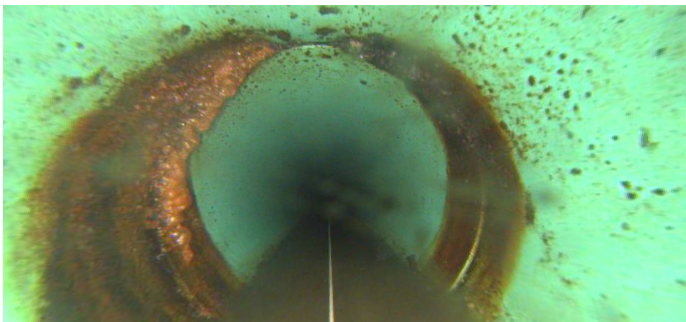
Code: **DAE**
Description: **Deposits Attached Encrustation**

Distance (ft): **248.9**
Structural Grade: **0**
O&M Grade: **2**
Clock Start/From: **8**
Clock To: **4**
1st Value:
2nd Value:
Value Percent: **10.000**
Continuous Index:
Within 8" of Joint: **YES**
Remarks:

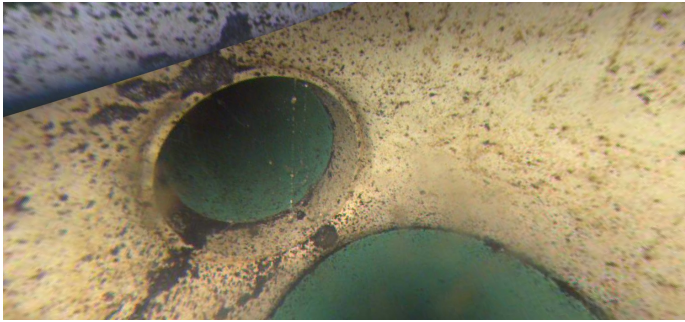
Code: **TF**
Description: **Tap Factory**

Distance (ft): **261.6**
Structural Grade: **0**
O&M Grade: **0**
Clock Start/From: **1**
Clock To:
1st Value: **4.000**
2nd Value:
Value Percent:
Continuous Index:
Within 8" of Joint:
Remarks:

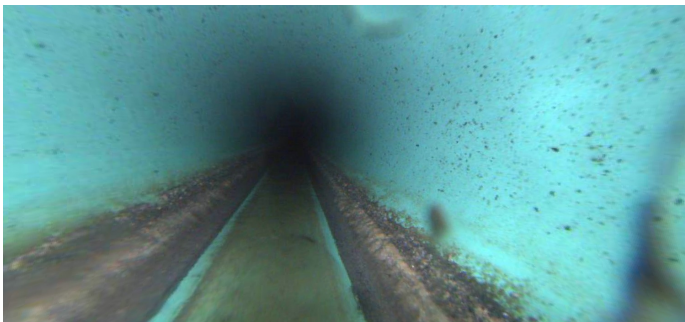
Code: **MSA**
Description: **Abandoned Survey**

Distance (ft): **306.1**
Structural Grade: **0**
O&M Grade: **0**
Clock Start/From:
Clock To:
1st Value:
2nd Value:
Value Percent:
Continuous Index:
Within 8" of Joint: **NO**
Remarks: **UNKNOWN**
