Profile/Photo Observation Report

Date:	03/30/2018	Weather:		Coding:	PACP 6.0
Pipe Length (ft):	286.5	Owner:	NA	Pre Clean:	Not Known
P.O.#:		Surveyor:	Jen Costello	PSR:	P-707-002-004
Customer:		Clean Date:	01/01/1900	Shape:	C

Street:	14th	Flow Control:	Not Controlled
City:	Hobart, IN	Year Renewed:	
Location:	Light Highway	Tape/Media #:	
Purpose:	Maintenance Related	Dia/Height:	10"
Use:	Sanitary	Material:	PVC
Drain Area:	NA	Lining:	Cured in Place
Category:	NA		
Comment:	Flow direction wrong.		
Location Details:		Direction of Survey:	Upstream
US MH:	M-707-004	DS MH:	M-707-002
		Total Length Surveyed (ft):	284.4

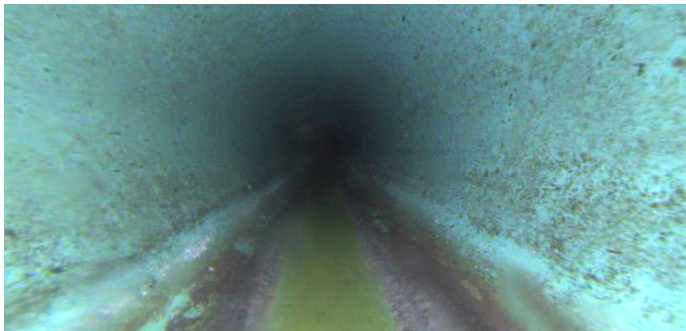
Code: **AMH**
Description: **Manhole**

Distance (ft): **.0**
Structural Grade: **0**
O&M Grade: **0**
Clock Start/From:
Clock To:
1st Value:
2nd Value:
Value Percent:
Continuous Index:
Within 8" of Joint: **NO**
Remarks: **M-707-002**

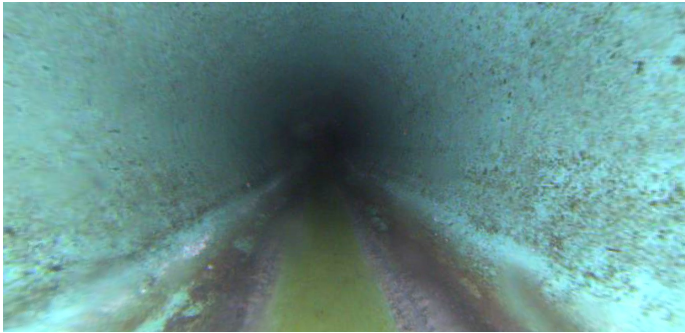
Code:	MWL
Description:	Water Level

Distance (ft):	.0
Structural Grade:	0
O&M Grade:	0
Clock Start/From:	
Clock To:	
1st Value:	
2nd Value:	
Value Percent:	5.000
Continuous Index:	
Within 8" of Joint:	NO
Remarks:

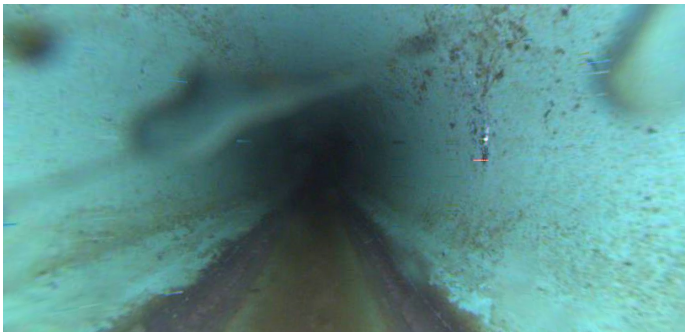
Code:	MGO
Description:	General Observation

Distance (ft):	32.8
Structural Grade:	0
O&M Grade:	0
Clock Start/From:	
Clock To:	
1st Value:	
2nd Value:	
Value Percent:	
Continuous Index:	
Within 8" of Joint:	NO
Remarks:	rear camera

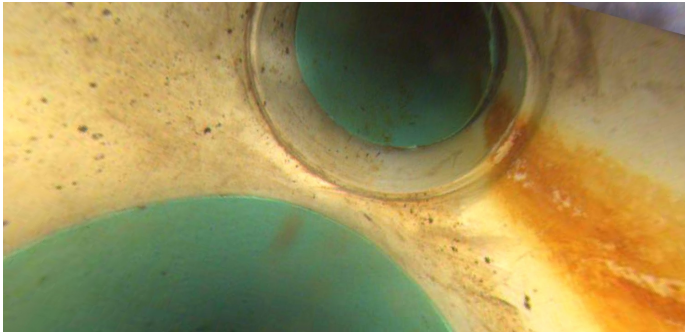
Code: **TF**
Description: **Tap Factory**

Distance (ft): **79.3**
Structural Grade: **0**
O&M Grade: **0**
Clock Start/From: **11**
Clock To:
1st Value: **4.000**
2nd Value:
Value Percent:
Continuous Index:
Within 8" of Joint:
Remarks:

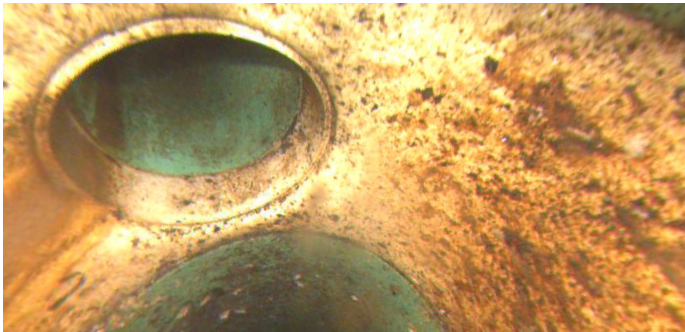
Code: **TF**
Description: **Tap Factory**

Distance (ft): **160.3**
Structural Grade: **0**
O&M Grade: **0**
Clock Start/From: **1**
Clock To:
1st Value: **4.000**
2nd Value:
Value Percent:
Continuous Index:
Within 8" of Joint:
Remarks:

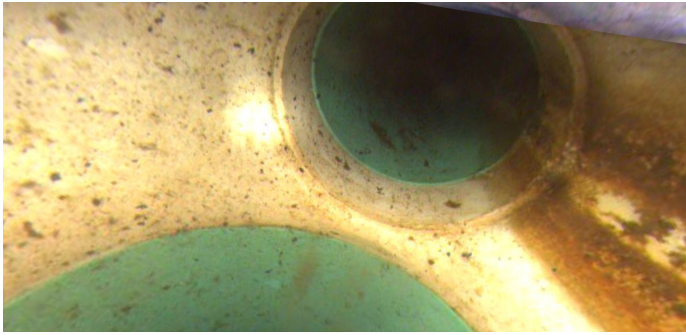
Code: **TF**
Description: **Tap Factory**

Distance (ft): **180.3**
Structural Grade: **0**
O&M Grade: **0**
Clock Start/From: **11**
Clock To:
1st Value: **4.000**
2nd Value:
Value Percent:
Continuous Index:
Within 8" of Joint:
Remarks:

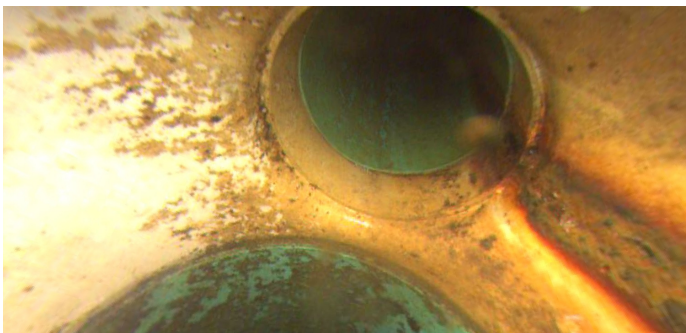
Code: **TFA**
Description: **Tap Factory Active**

Distance (ft): **222.0**
Structural Grade: **0**
O&M Grade: **0**
Clock Start/From: **1**
Clock To:
1st Value: **4.000**
2nd Value:
Value Percent:
Continuous Index:
Within 8" of Joint:
Remarks:

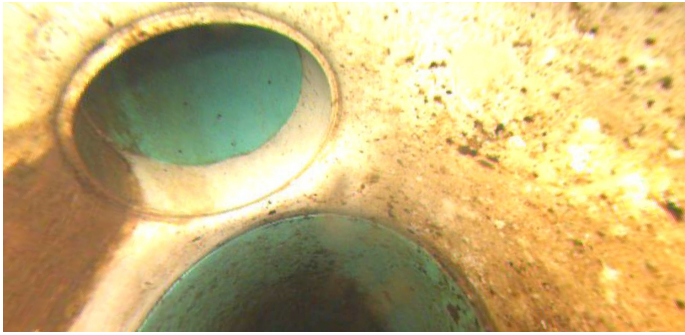
Code: **TF**
Description: **Tap Factory**

Distance (ft): **253.7**
Structural Grade: **0**
O&M Grade: **0**
Clock Start/From: **1**
Clock To:
1st Value: **4.000**
2nd Value:
Value Percent:
Continuous Index:
Within 8" of Joint:
Remarks:

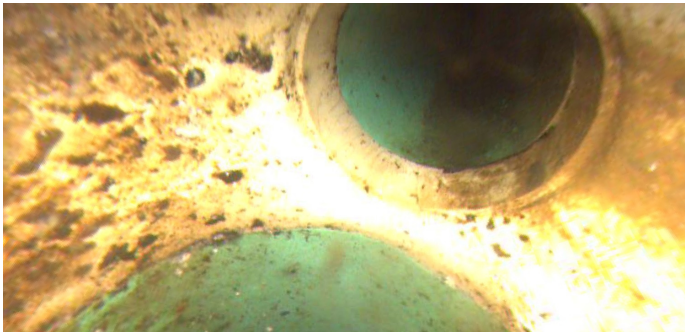
Code: **TF**
Description: **Tap Factory**

Distance (ft): **264.7**
Structural Grade: **0**
O&M Grade: **0**
Clock Start/From: **11**
Clock To:
1st Value: **4.000**
2nd Value:
Value Percent:
Continuous Index:
Within 8" of Joint:
Remarks:

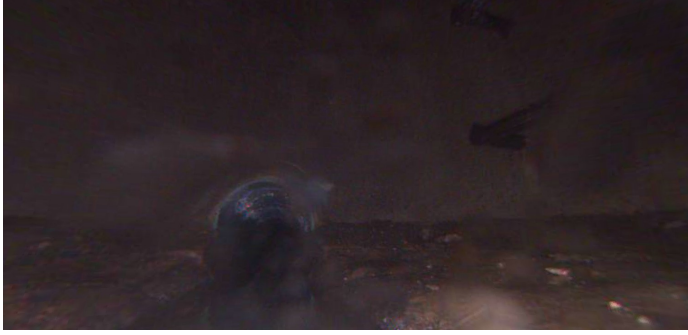
Code:	AMH
Description:	Manhole
Distance (ft):	284.4
Structural Grade:	0
O&M Grade:	0
Clock Start/From:	
Clock To:	
1st Value:	
2nd Value:	
Value Percent:	
Continuous Index:	
Within 8" of Joint:	NO
Remarks:	M-707-004
