Profile/Photo Observation Report

Street:	GARFIELD ST	Flow Control:	Not Controlled
City:	Hobart, IN	Year Renewed:	
Location:	Light Highway	Tape/Media #:	
Purpose:	Maintenance Related	Dia/Height:	10"
Use:	Sanitary	Material:	PVC
Drain Area:	NA	Lining:	Cured in Place
Category:	NA		
Comment:	ran through MH, flow incorrect.		
Location Details:		Direction of Survey:	Downstream
US MH:	M-707-005	DS MH:	M-707-004
		Total Length Surveyed (ft):	446.0

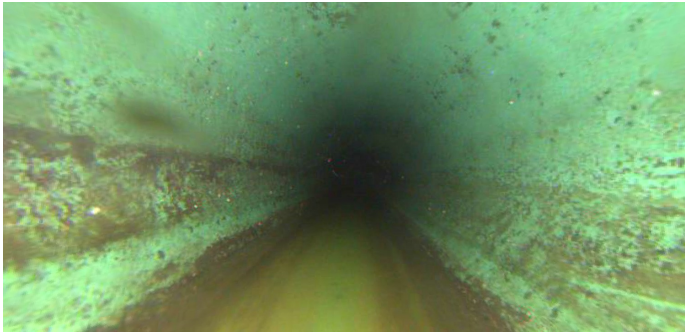
Code:	MWL
Description:	Water Level

Distance (ft):	.0
Structural Grade:	0
O&M Grade:	0
Clock Start/From:	
Clock To:	
1st Value:	
2nd Value:	
Value Percent:	5.000
Continuous Index:	
Within 8" of Joint:	NO
Remarks:

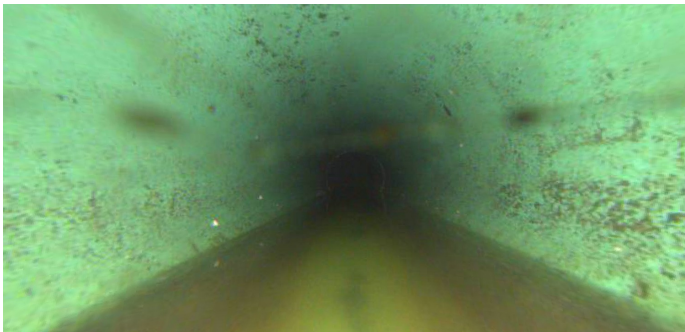
Code:	MWL
Description:	Water Level

Distance (ft):	20.5
Structural Grade:	0
O&M Grade:	0
Clock Start/From:	
Clock To:	
1st Value:	
2nd Value:	
Value Percent:	20.000
Continuous Index:	
Within 8" of Joint:	NO
Remarks:

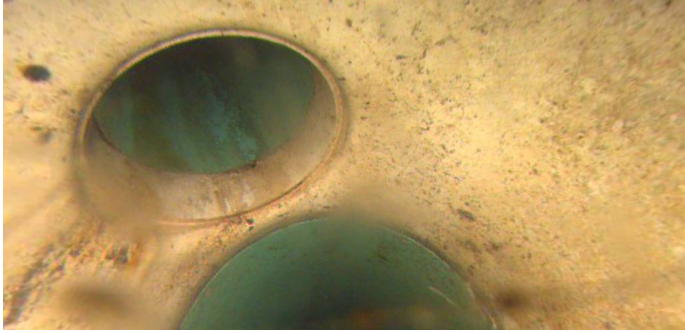
Code: **TF**
Description: **Tap Factory**

Distance (ft): **49.5**
Structural Grade: **0**
O&M Grade: **0**
Clock Start/From: **11**
Clock To:
1st Value: **4.000**
2nd Value:
Value Percent:
Continuous Index:
Within 8" of Joint:
Remarks:

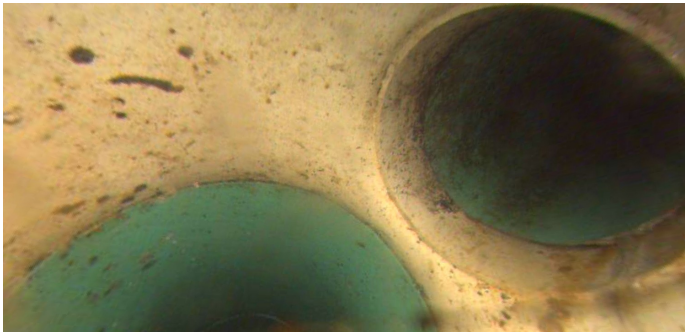
Code: **TF**
Description: **Tap Factory**

Distance (ft): **61.6**
Structural Grade: **0**
O&M Grade: **0**
Clock Start/From: **2**
Clock To:
1st Value: **4.000**
2nd Value:
Value Percent:
Continuous Index:
Within 8" of Joint:
Remarks:

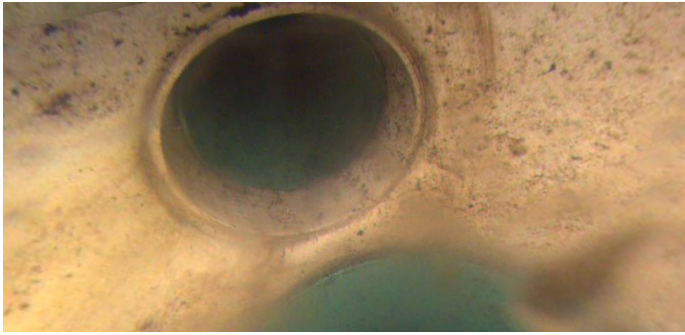
Code: **TF**
Description: **Tap Factory**

Distance (ft): **78.3**
Structural Grade: **0**
O&M Grade: **0**
Clock Start/From: **12**
Clock To:
1st Value: **4.000**
2nd Value:
Value Percent:
Continuous Index:
Within 8" of Joint:
Remarks:

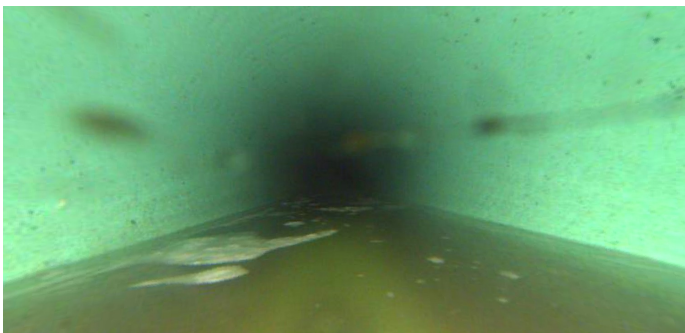
Code: **MWL**
Description: **Water Level**

Distance (ft): **95.8**
Structural Grade: **0**
O&M Grade: **0**
Clock Start/From:
Clock To:
1st Value:
2nd Value:
Value Percent: **40.000**
Continuous Index:
Within 8" of Joint: **NO**
Remarks:

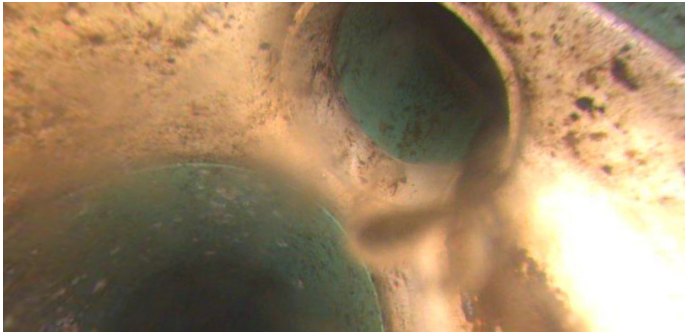
Code: **TF**
Description: **Tap Factory**

Distance (ft): **114.0**
Structural Grade: **0**
O&M Grade: **0**
Clock Start/From: **10**
Clock To:
1st Value: **4.000**
2nd Value:
Value Percent:
Continuous Index:
Within 8" of Joint:
Remarks:

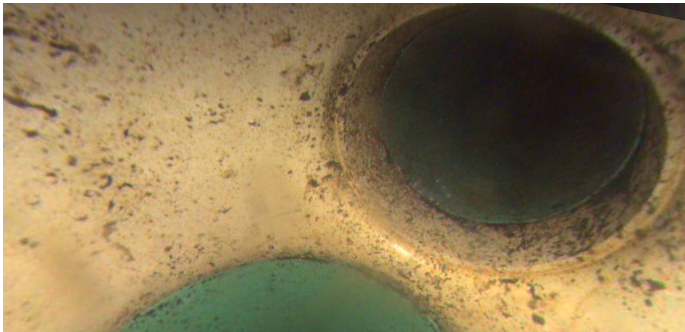
Code: **TF**
Description: **Tap Factory**

Distance (ft): **159.3**
Structural Grade: **0**
O&M Grade: **0**
Clock Start/From: **1**
Clock To:
1st Value: **4.000**
2nd Value:
Value Percent:
Continuous Index:
Within 8" of Joint:
Remarks:

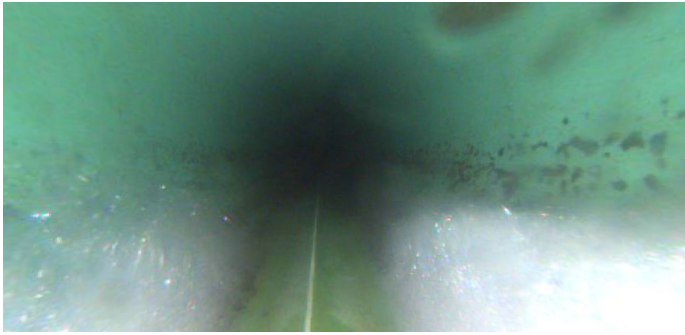
Code: **MGO**
Description: **General Observation**

Distance (ft): **175.6**
Structural Grade: **0**
O&M Grade: **0**
Clock Start/From:
Clock To:
1st Value:
2nd Value:
Value Percent:
Continuous Index:
Within 8" of Joint: **NO**
Remarks: **rear camera**

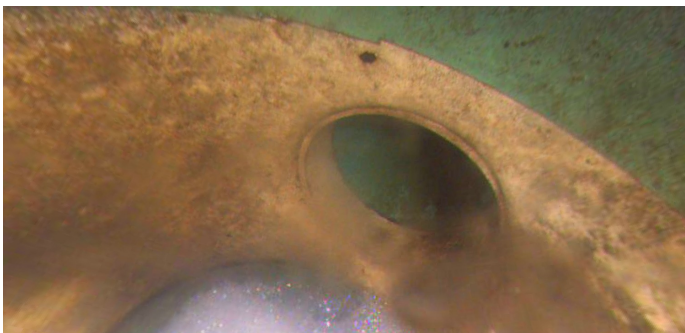
Code: **TF**
Description: **Tap Factory**

Distance (ft): **178.7**
Structural Grade: **0**
O&M Grade: **0**
Clock Start/From: **11**
Clock To:
1st Value: **4.000**
2nd Value:
Value Percent:
Continuous Index:
Within 8" of Joint:
Remarks:

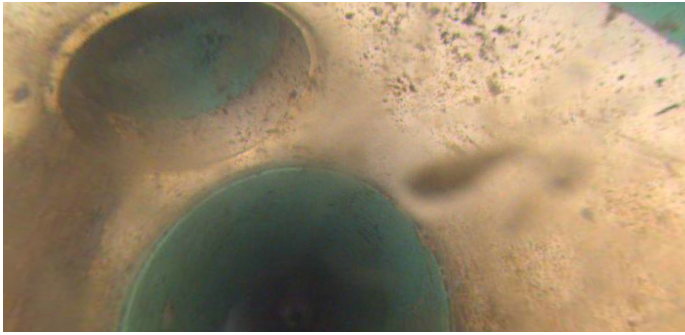
Code: **TF**
Description: **Tap Factory**

Distance (ft): **186.5**
Structural Grade: **0**
O&M Grade: **0**
Clock Start/From: **1**
Clock To:
1st Value: **4.000**
2nd Value:
Value Percent:
Continuous Index:
Within 8" of Joint:
Remarks:

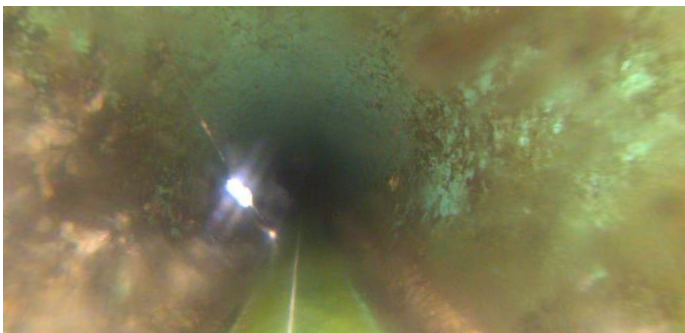
Code: **DAGS**
Description: **Deposits Attached Grease**

Distance (ft): **237.2**
Structural Grade: **0**
O&M Grade: **2**
Clock Start/From: **2**
Clock To: **4**
1st Value:
2nd Value:
Value Percent: **5.000**
Continuous Index:
Within 8" of Joint: **NO**
Remarks:

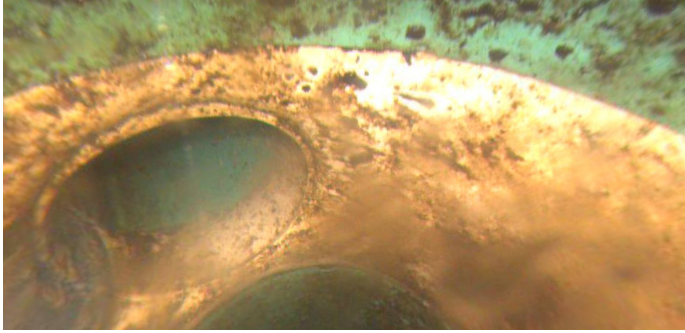
Code: **TF**
Description: **Tap Factory**

Distance (ft): **238.0**
Structural Grade: **0**
O&M Grade: **0**
Clock Start/From: **1**
Clock To:
1st Value: **4.000**
2nd Value:
Value Percent:
Continuous Index:
Within 8" of Joint:
Remarks:

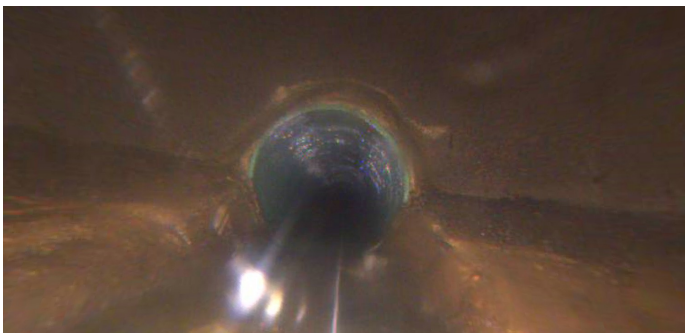
Code: **AMH**
Description: **Manhole**

Distance (ft): **271.6**
Structural Grade: **0**
O&M Grade: **0**
Clock Start/From:
Clock To:
1st Value:
2nd Value:
Value Percent:
Continuous Index:
Within 8" of Joint: **NO**
Remarks: **M-707-004**
