Profile/Photo Observation Report

Date:	04/09/2018	Weather:		Coding:	PACP 6.0
Pipe Length (ft):	270.8	Owner:	NA	Pre Clean:	Not Known
P.O.#:		Surveyor:	Jen Costello	PSR:	P-707-004-005
Customer:		Clean Date:	01/01/1900	Shape:	C

Street:	Capitol	Flow Control:	Not Controlled
City:	Hobart, IN	Year Renewed:	
Location:	Light Highway	Tape/Media #:	
Purpose:	Maintenance Related	Dia/Height:	10"
Use:	Sanitary	Material:	PVC
Drain Area:	NA	Lining:	Cured in Place
Category:	NA		
Comment:	ran through MH, flow incorrect.		
Location Details:		Direction of Survey:	Downstream
US MH:	M-707-005	DS MH:	M-707-004
		Total Length Surveyed (ft):	446.0

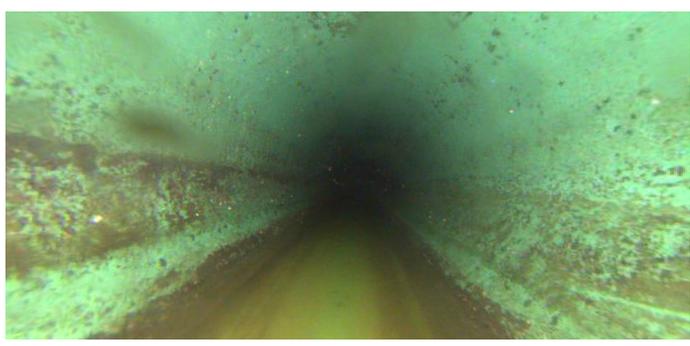
Code: **AMH**
 Description: **Manhole**
 Distance (ft): **.0**
 Structural Grade: **0**
 O&M Grade: **0**
 Clock Start/From:
 Clock To:
 1st Value:
 2nd Value:
 Value Percent:
 Continuous Index:
 Within 8" of Joint: **NO**
 Remarks: **M-707-005**

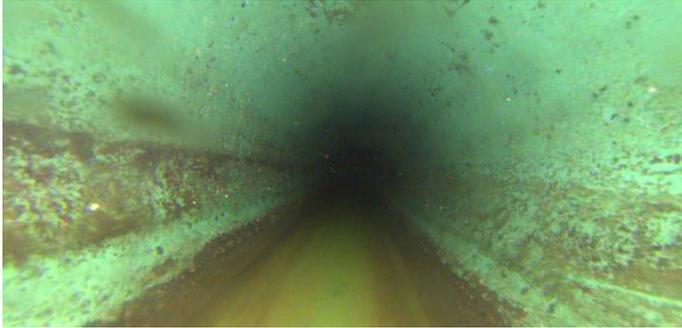
Code: **MWL**
Description: **Water Level**

Distance (ft): **.0**
Structural Grade: **0**
O&M Grade: **0**
Clock Start/From:
Clock To:
1st Value:
2nd Value:
Value Percent: **5.000**
Continuous Index:
Within 8" of Joint: **NO**
Remarks:

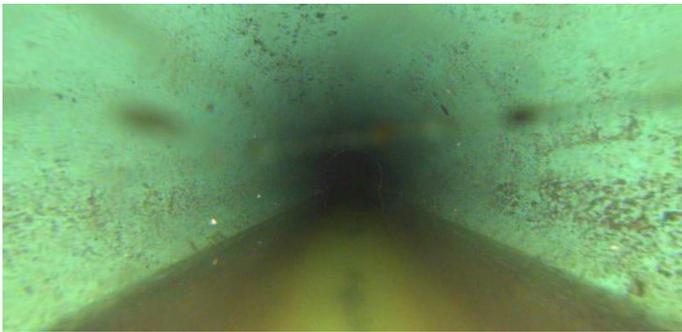
Code: **MWL**
Description: **Water Level**

Distance (ft): **20.5**
Structural Grade: **0**
O&M Grade: **0**
Clock Start/From:
Clock To:
1st Value:
2nd Value:
Value Percent: **20.000**
Continuous Index:
Within 8" of Joint: **NO**
Remarks:

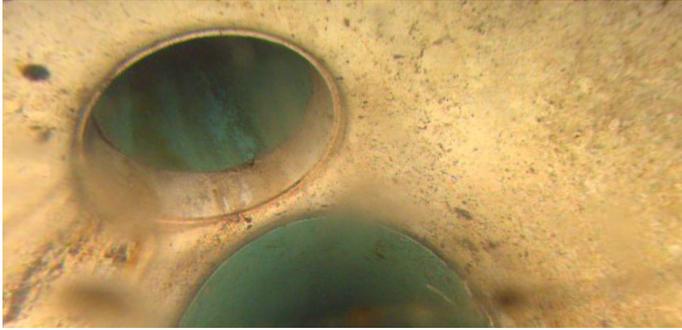
Code: **TF**
Description: **Tap Factory**

Distance (ft): **49.5**
Structural Grade: **0**
O&M Grade: **0**
Clock Start/From: **11**
Clock To:
1st Value: **4.000**
2nd Value:
Value Percent:
Continuous Index:
Within 8" of Joint:
Remarks:

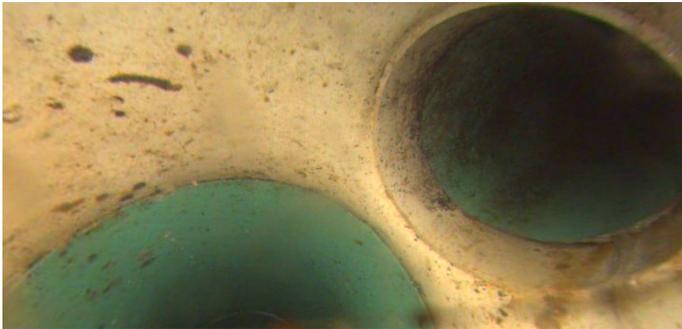
Code: **TF**
Description: **Tap Factory**

Distance (ft): **61.6**
Structural Grade: **0**
O&M Grade: **0**
Clock Start/From: **2**
Clock To:
1st Value: **4.000**
2nd Value:
Value Percent:
Continuous Index:
Within 8" of Joint:
Remarks:

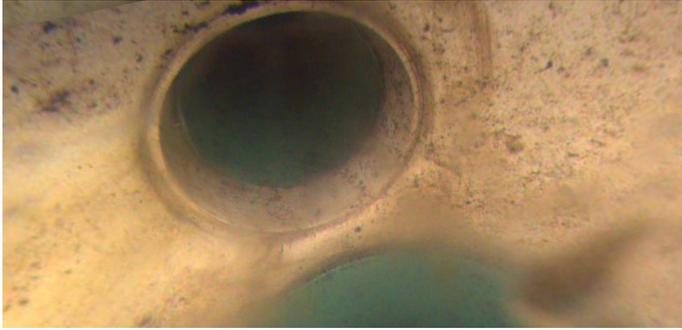
Code: **TF**
Description: **Tap Factory**

Distance (ft): **78.3**
Structural Grade: **0**
O&M Grade: **0**
Clock Start/From: **12**
Clock To:
1st Value: **4.000**
2nd Value:
Value Percent:
Continuous Index:
Within 8" of Joint:
Remarks:

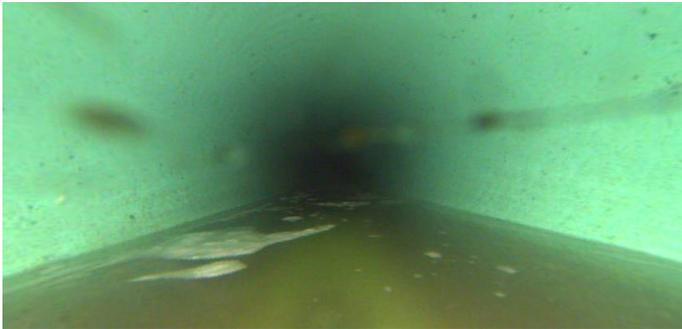
Code: **MWL**
Description: **Water Level**

Distance (ft): **95.8**
Structural Grade: **0**
O&M Grade: **0**
Clock Start/From:
Clock To:
1st Value:
2nd Value:
Value Percent: **40.000**
Continuous Index:
Within 8" of Joint: **NO**
Remarks:

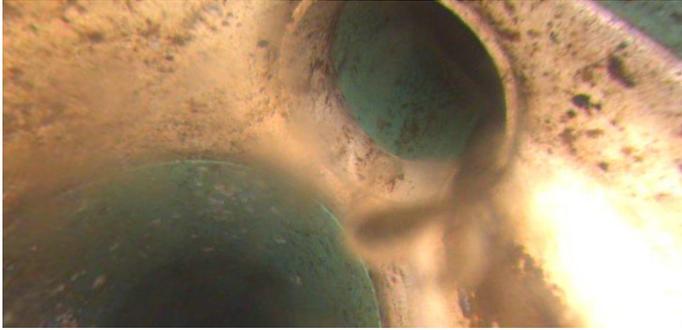
Code: **TF**
Description: **Tap Factory**

Distance (ft): **114.0**
Structural Grade: **0**
O&M Grade: **0**
Clock Start/From: **10**
Clock To:
1st Value: **4.000**
2nd Value:
Value Percent:
Continuous Index:
Within 8" of Joint:
Remarks:

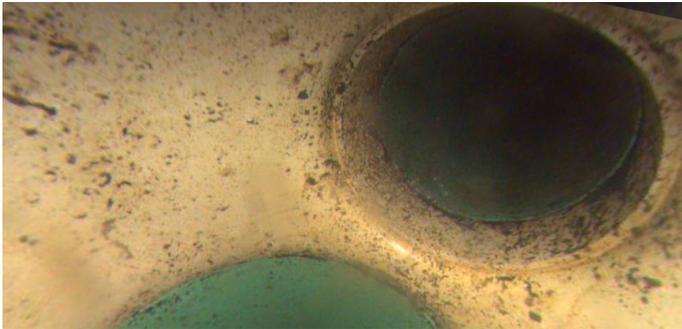
Code: **TF**
Description: **Tap Factory**

Distance (ft): **159.3**
Structural Grade: **0**
O&M Grade: **0**
Clock Start/From: **1**
Clock To:
1st Value: **4.000**
2nd Value:
Value Percent:
Continuous Index:
Within 8" of Joint:
Remarks:

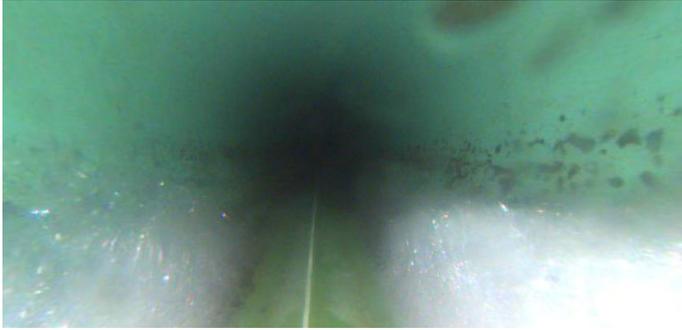
Code: **MGO**
Description: **General Observation**

Distance (ft): **175.6**
Structural Grade: **0**
O&M Grade: **0**
Clock Start/From:
Clock To:
1st Value:
2nd Value:
Value Percent:
Continuous Index:
Within 8" of Joint: **NO**
Remarks: **rear camera**

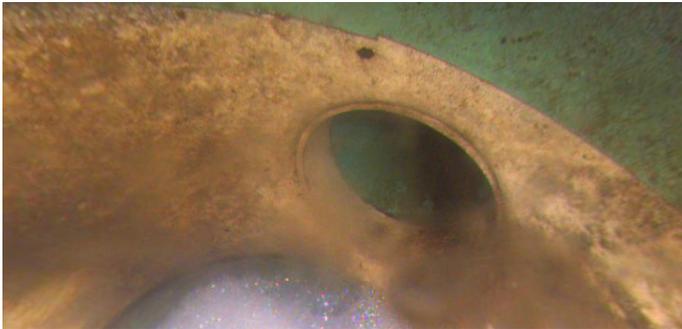
Code: **TF**
Description: **Tap Factory**

Distance (ft): **178.7**
Structural Grade: **0**
O&M Grade: **0**
Clock Start/From: **11**
Clock To:
1st Value: **4.000**
2nd Value:
Value Percent:
Continuous Index:
Within 8" of Joint:
Remarks:

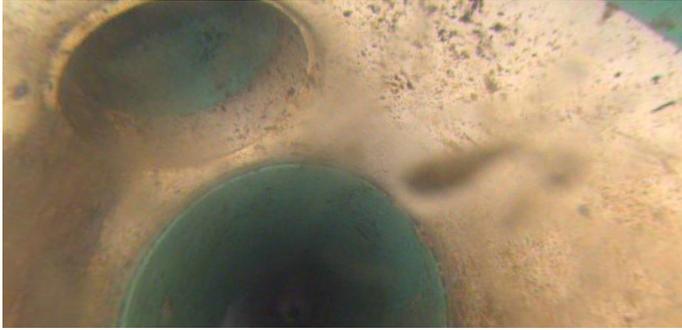
Code: **TF**
Description: **Tap Factory**

Distance (ft): **186.5**
Structural Grade: **0**
O&M Grade: **0**
Clock Start/From: **1**
Clock To:
1st Value: **4.000**
2nd Value:
Value Percent:
Continuous Index:
Within 8" of Joint:
Remarks:

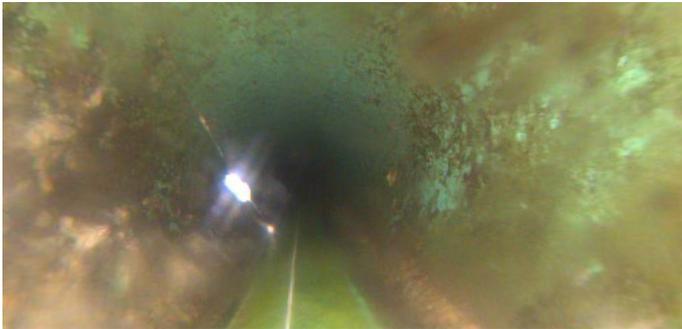
Code: **DAGS**
Description: **Deposits Attached Grease**

Distance (ft): **237.2**
Structural Grade: **0**
O&M Grade: **2**
Clock Start/From: **2**
Clock To: **4**
1st Value:
2nd Value:
Value Percent: **5.000**
Continuous Index:
Within 8" of Joint: **NO**
Remarks:

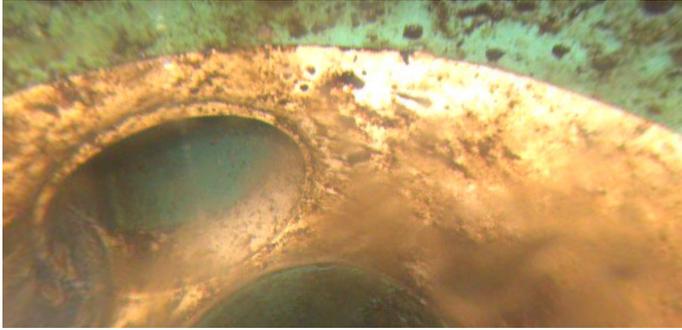
Code: **TF**
Description: **Tap Factory**

Distance (ft): **238.0**
Structural Grade: **0**
O&M Grade: **0**
Clock Start/From: **1**
Clock To:
1st Value: **4.000**
2nd Value:
Value Percent:
Continuous Index:
Within 8" of Joint:
Remarks:

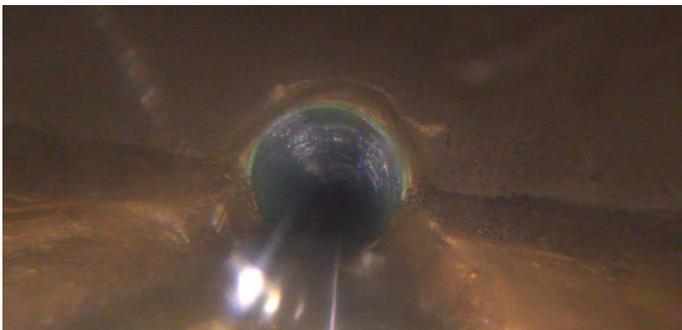
Code: **AMH**
Description: **Manhole**

Distance (ft): **271.6**
Structural Grade: **0**
O&M Grade: **0**
Clock Start/From:
Clock To:
1st Value:
2nd Value:
Value Percent:
Continuous Index:
Within 8" of Joint: **NO**
Remarks: **M-707-004**
