Profile/Photo Observation Report

Street:	E 13TH ST & GARFIELD ST	Flow Control:	Not Controlled
City:	Hobart, IN	Year Renewed:	
Location:	Light Highway	Tape/Media #:	
Purpose:	Maintenance Related	Dia/Height:	10"
Use:	Sanitary	Material:	PVC
Drain Area:	NA	Lining:	Cured in Place
Category:	NA		
Comment:	flow incorrect.

Location Details:		Direction of Survey:	Downstream
US MH:	M-707-006	DS MH:	M-707-005
		Total Length Surveyed (ft):	261.6

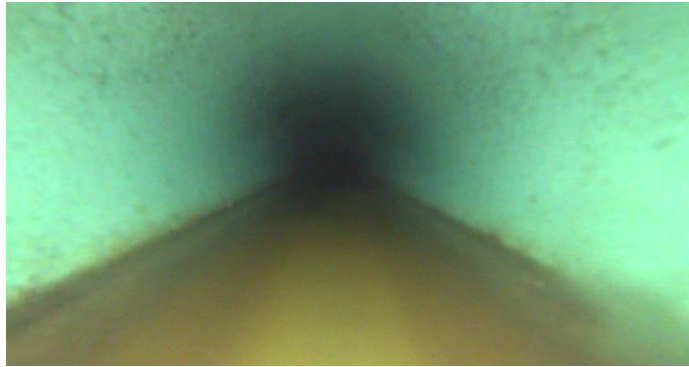
Code: **MWL**
Description: **Water Level**

Distance (ft): **.0**
Structural Grade: **0**
O&M Grade: **0**
Clock Start/From:
Clock To:
1st Value:
2nd Value:
Value Percent: **10.000**
Continuous Index:
Within 8" of Joint: **NO**
Remarks:

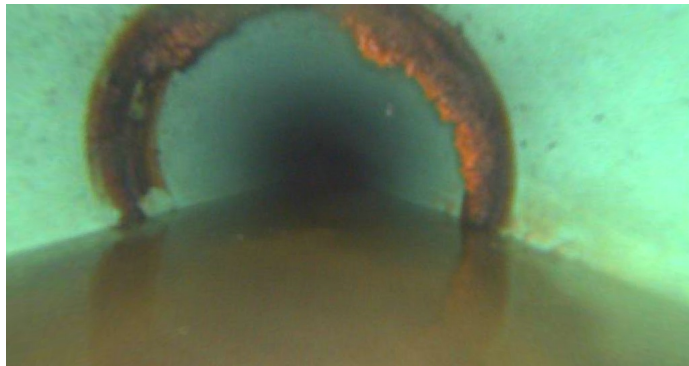
Code: **DAZ**
Description: **Deposits Attached Other**

Distance (ft): **47.8**
Structural Grade: **0**
O&M Grade: **2**
Clock Start/From: **7**
Clock To: **5**
1st Value:
2nd Value:
Value Percent: **5.000**
Continuous Index:
Within 8" of Joint: **NO**
Remarks:

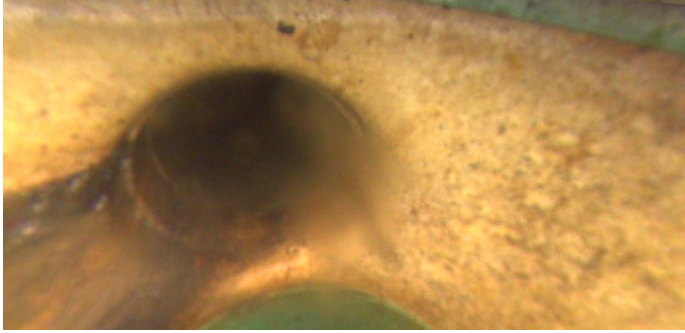
Code: **TFA**
Description: **Tap Factory Active**

Distance (ft): **105.0**
Structural Grade: **0**
O&M Grade: **0**
Clock Start/From: **12**
Clock To:
1st Value: **4.000**
2nd Value:
Value Percent:
Continuous Index:
Within 8" of Joint:
Remarks:

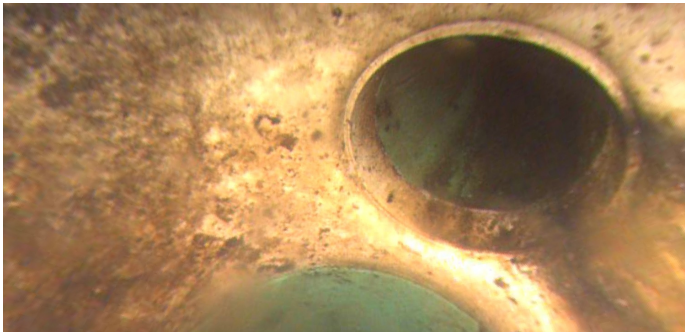
Code: **TF**
Description: **Tap Factory**

Distance (ft): **197.4**
Structural Grade: **0**
O&M Grade: **0**
Clock Start/From: **11**
Clock To:
1st Value: **4.000**
2nd Value:
Value Percent:
Continuous Index:
Within 8" of Joint:
Remarks:

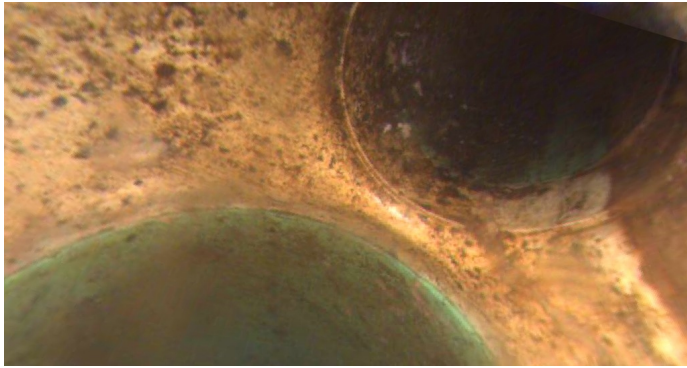
Code: **TF**
Description: **Tap Factory**

Distance (ft): **257.2**
Structural Grade: **0**
O&M Grade: **0**
Clock Start/From: **10**
Clock To:
1st Value: **4.000**
2nd Value:
Value Percent:
Continuous Index:
Within 8" of Joint:
Remarks: **Photo taken from rear camera.**

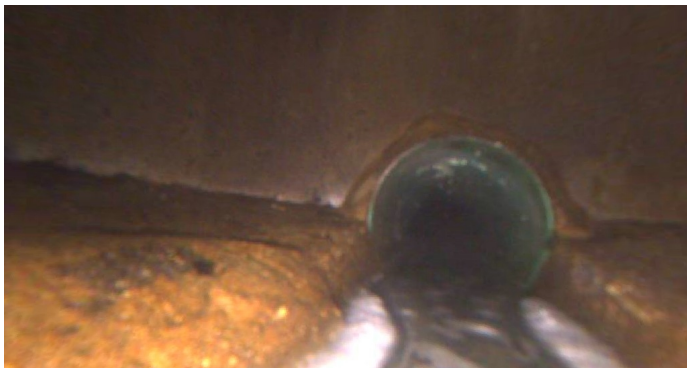
Code: **AMH**
Description: **Manhole**

Distance (ft): **261.6**
Structural Grade: **0**
O&M Grade: **0**
Clock Start/From:
Clock To:
1st Value:
2nd Value:
Value Percent:
Continuous Index:
Within 8" of Joint: **NO**
Remarks: **M-707-005**
