Profile/Photo Observation Report

Date:	04/09/2018	Weather:		Coding:	PACP 6.0
Pipe Length (ft):	267.3	Owner:	NA	Pre Clean:	Not Known
P.O.#:		Surveyor:	Mark Ruby	PSR:	P-707-005-006
Customer:		Clean Date:	01/01/1900	Shape:	C

Location Details:		Direction of Survey:	Downstream
US MH:	M-707-006	DS MH:	M-707-005
		Total Length Surveyed (ft):	261.6

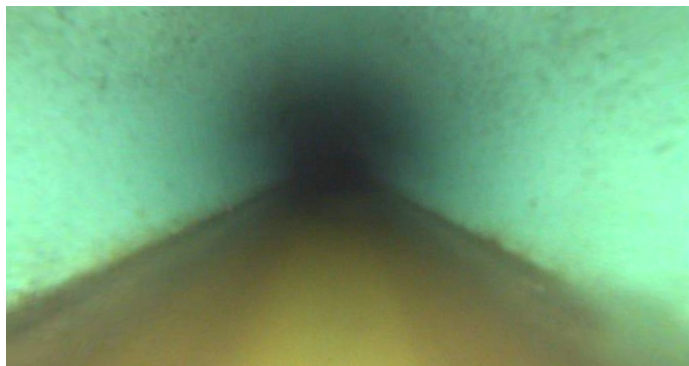
Code: **AMH**
Description: **Manhole**

Distance (ft): **.0**
Structural Grade: **0**
O&M Grade: **0**
Clock Start/From:
Clock To:
1st Value:
2nd Value:
Value Percent:
Continuous Index:
Within 8" of Joint: **NO**
Remarks: **M-707-006**

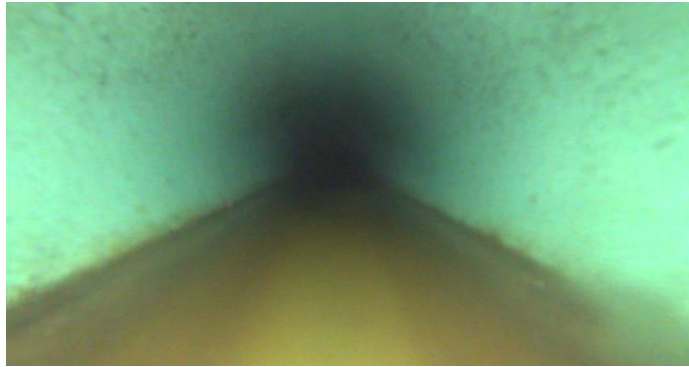
Code: **MWL**
Description: **Water Level**

Distance (ft): **.0**
Structural Grade: **0**
O&M Grade: **0**
Clock Start/From:
Clock To:
1st Value:
2nd Value:
Value Percent: **10.000**
Continuous Index:
Within 8" of Joint: **NO**
Remarks:

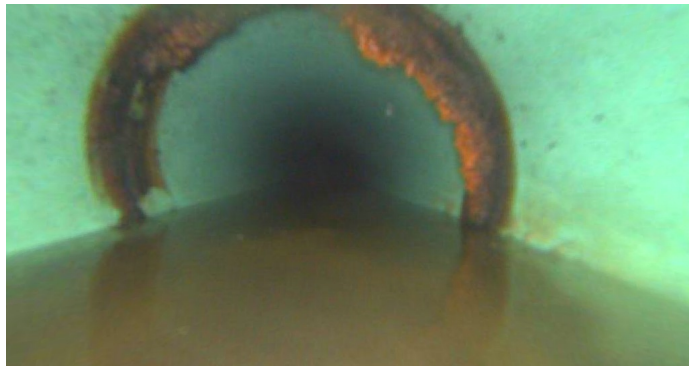
Code: **DAZ**
Description: **Deposits Attached Other**

Distance (ft): **47.8**
Structural Grade: **0**
O&M Grade: **2**
Clock Start/From: **7**
Clock To: **5**
1st Value:
2nd Value:
Value Percent: **5.000**
Continuous Index:
Within 8" of Joint: **NO**
Remarks:

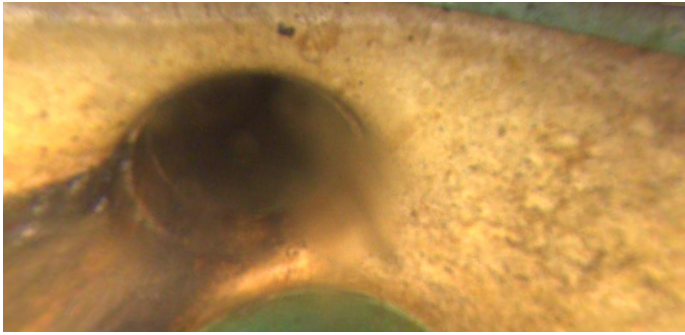
Code: **TFA**
Description: **Tap Factory Active**

Distance (ft): **105.0**
Structural Grade: **0**
O&M Grade: **0**
Clock Start/From: **12**
Clock To:
1st Value: **4.000**
2nd Value:
Value Percent:
Continuous Index:
Within 8" of Joint:
Remarks:

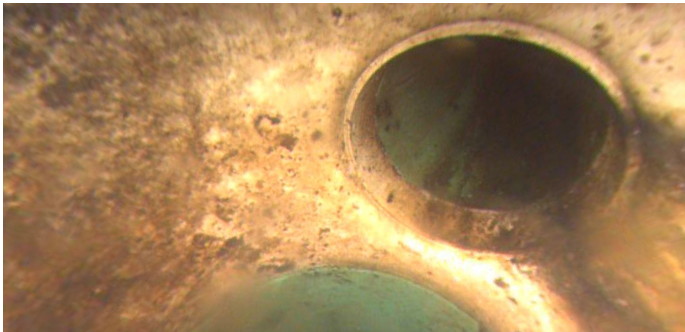
Code: **TF**
Description: **Tap Factory**

Distance (ft): **197.4**
Structural Grade: **0**
O&M Grade: **0**
Clock Start/From: **11**
Clock To:
1st Value: **4.000**
2nd Value:
Value Percent:
Continuous Index:
Within 8" of Joint:
Remarks:

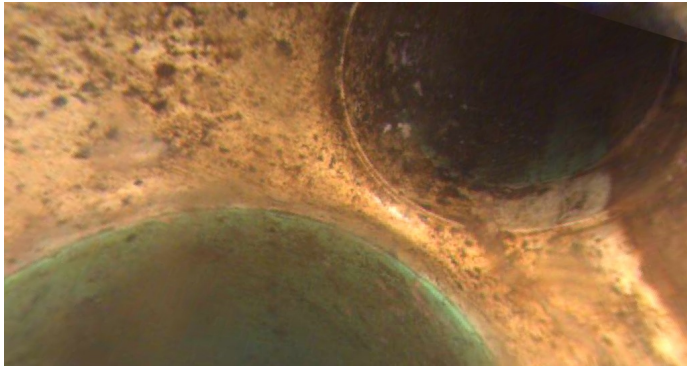
Code: **TF**
Description: **Tap Factory**

Distance (ft): **257.2**
Structural Grade: **0**
O&M Grade: **0**
Clock Start/From: **10**
Clock To:
1st Value: **4.000**
2nd Value:
Value Percent:
Continuous Index:
Within 8" of Joint:
Remarks: **Photo taken from rear camera.**

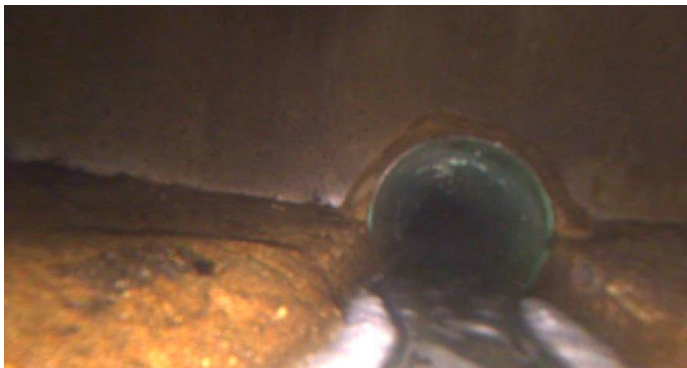
Code: **AMH**
Description: **Manhole**

Distance (ft): **261.6**
Structural Grade: **0**
O&M Grade: **0**
Clock Start/From:
Clock To:
1st Value:
2nd Value:
Value Percent:
Continuous Index:
Within 8" of Joint: **NO**
Remarks: **M-707-005**
