Profile/Photo Observation Report

| Street: | E 13TH ST | Flow Control: | Not Controlled |
| City: | Hobart, IN | Year Renewed: | |

| US MH: | M-707-007 | DS MH: | M-807-007 |

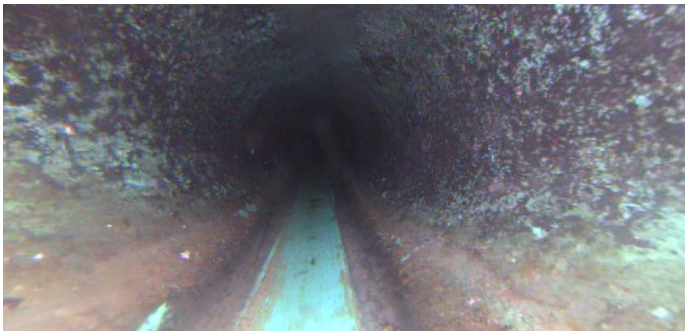
Code: **AMH**
Description: **Manhole**

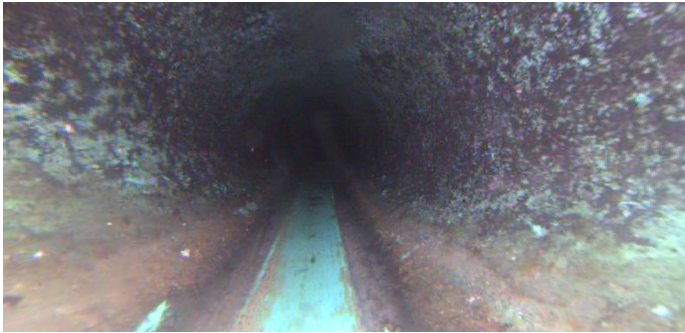
| Code: | MWL |
| Description: | Water Level |

| Distance (ft): | .0 |
| Value Percent: | 5.000 |

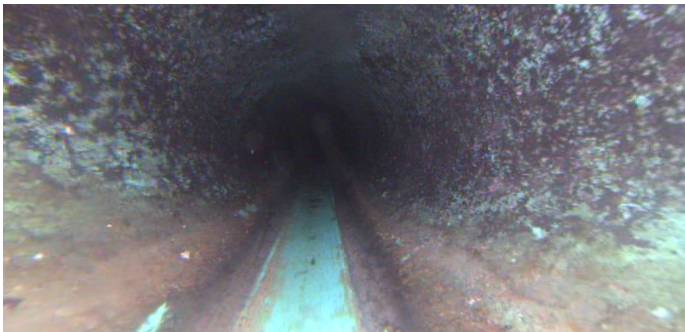
| Code: | DAGS |
| Description: | Deposits Attached Grease |

| Distance (ft): | .0 |
| O&M Grade: | 2 |
| Clock Start/From: | 7 |
| Clock To: | 5 |
| Value Percent: | 5.000 |
| Continuous Index: | S01 |

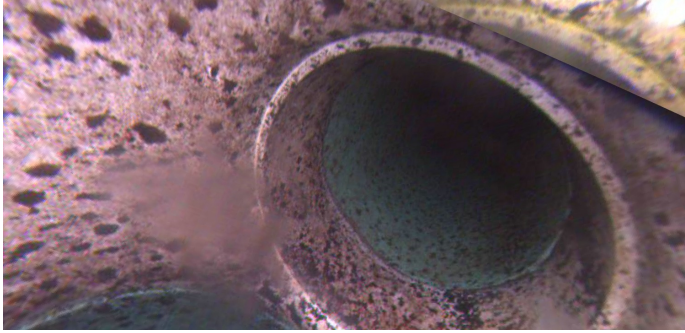
Code: **TF**
Description: **Tap Factory**

Distance (ft): **15.1**
Structural Grade: **0**
O&M Grade: **0**
Clock Start/From: **1**
Clock To:
1st Value: **4.000**
2nd Value:
Value Percent:
Continuous Index:
Within 8" of Joint:
Remarks:

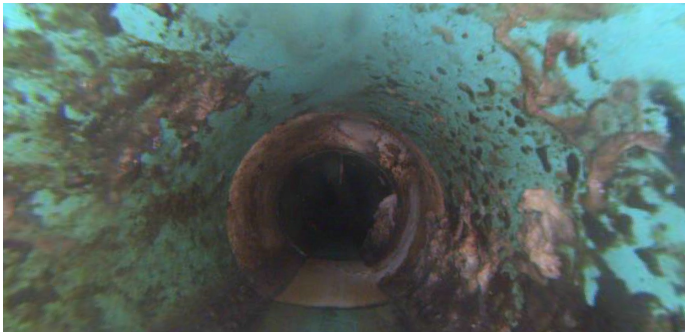
Code: **DAGS**
Description: **Deposits Attached Grease**

Distance (ft): **140.0**
Structural Grade: **0**
O&M Grade: **2**
Clock Start/From: **8**
Clock To: **4**
1st Value:
2nd Value:
Value Percent: **5.000**
Continuous Index:
Within 8" of Joint: **NO**
Remarks:

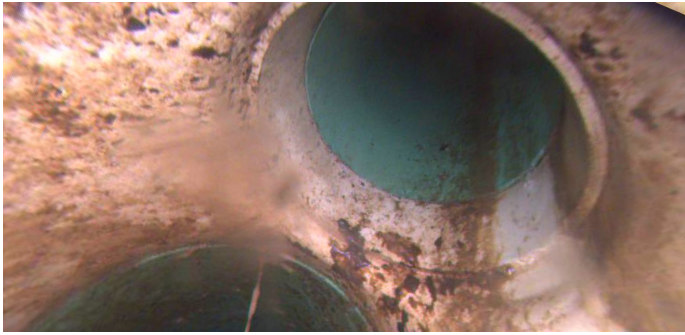
Code: **TF**
Description: **Tap Factory**

Distance (ft): **141.0**
Structural Grade: **0**
O&M Grade: **0**
Clock Start/From: **2**
Clock To:
1st Value: **4.000**
2nd Value:
Value Percent:
Continuous Index:
Within 8" of Joint:
Remarks:

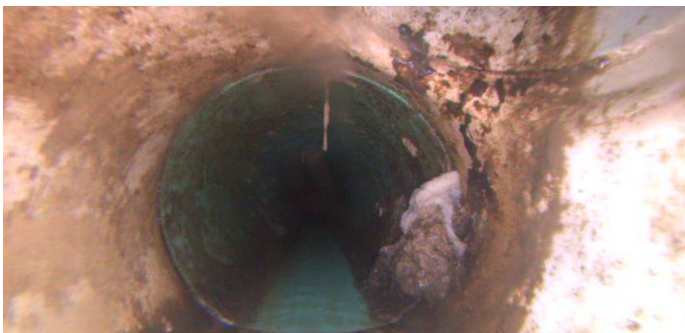
Code: **DAGS**
Description: **Deposits Attached Grease**

Distance (ft): **141.0**
Structural Grade: **0**
O&M Grade: **2**
Clock Start/From: **3**
Clock To: **4**
1st Value:
2nd Value:
Value Percent: **5.000**
Continuous Index:
Within 8" of Joint: **YES**
Remarks:

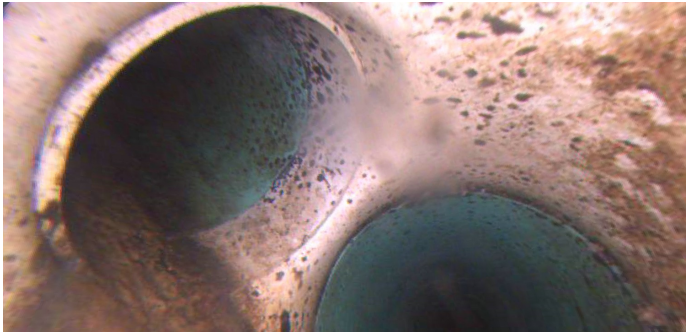
Code: **TF**
Description: **Tap Factory**

Distance (ft): **254.2**
Structural Grade: **0**
O&M Grade: **0**
Clock Start/From: **10**
Clock To:
1st Value: **4.000**
2nd Value:
Value Percent:
Continuous Index:
Within 8" of Joint:
Remarks:

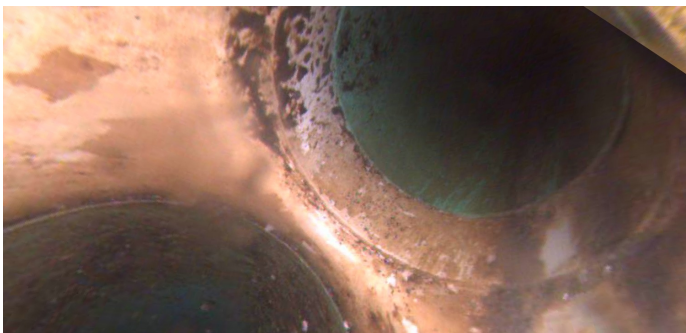
Code: **TF**
Description: **Tap Factory**

Distance (ft): **272.4**
Structural Grade: **0**
O&M Grade: **0**
Clock Start/From: **1**
Clock To:
1st Value: **4.000**
2nd Value:
Value Percent:
Continuous Index:
Within 8" of Joint:
Remarks:

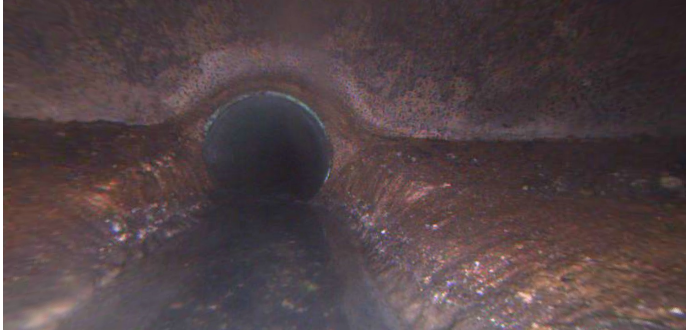
Code: **AMH**
Description: **Manhole**

Distance (ft): **339.5**
Structural Grade: **0**
O&M Grade: **0**
Clock Start/From:
Clock To:
1st Value:
2nd Value:
Value Percent:
Continuous Index:
Within 8" of Joint: **NO**
Remarks: **M-707-007**

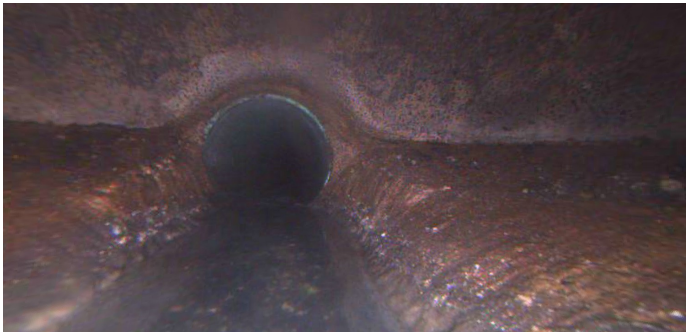
Code: **DAGS**
Description: **Deposits Attached Grease**

Distance (ft): **339.5**
Structural Grade: **0**
O&M Grade: **2**
Clock Start/From: **7**
Clock To: **5**
1st Value:
2nd Value:
Value Percent: **5.000**
Continuous Index: **F01**
Within 8" of Joint: **NO**
Remarks:
