Profile/Photo Observation Report

Street:	Capitol	Flow Control:	Not Controlled
City:	Hobart, IN	Year Renewed:	
Location:	Light Highway	Tape/Media #:	
Purpose:	Maintenance Related	Dia/Height:	12"
Use:	Sanitary	Material:	PVC
Drain Area:	NA	Lining:	Cured in Place
Category:	NA		
Comment:	flow incorrect.

Location Details:		Direction of Survey:	Downstream
US MH:	M-707-008	DS MH:	M-707-006
		Total Length Surveyed (ft):	230.9

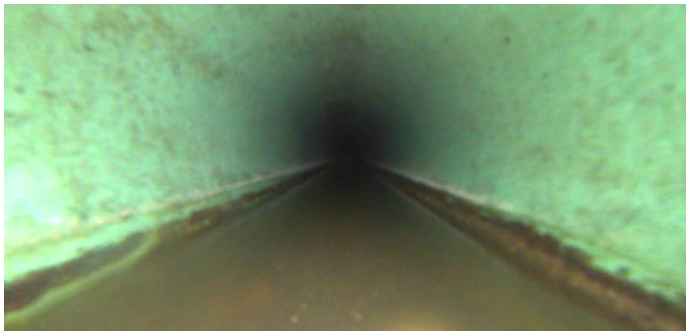
Code: **AMH**
Description: **Manhole**

Distance (ft): **.0**
Structural Grade: **0**
O&M Grade: **0**
Clock Start/From:
Clock To:
1st Value:
2nd Value:
Value Percent:
Continuous Index:
Within 8" of Joint: **NO**
Remarks: **M-707-008**

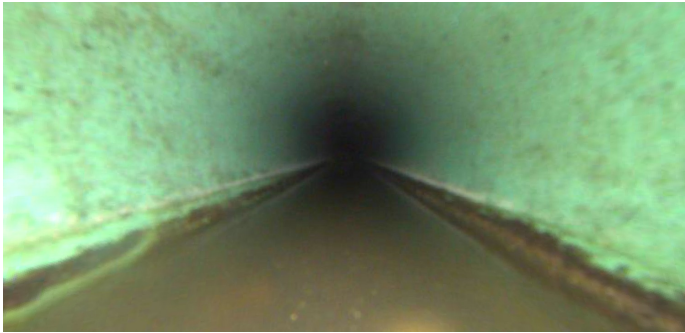
Code:	MWL
Description:	Water Level

Distance (ft):	.0
Structural Grade:	0
O&M Grade:	0
Clock Start/From:	
Clock To:	
1st Value:	
2nd Value:	
Value Percent:	30.000
Continuous Index:	
Within 8" of Joint:	NO
Remarks:

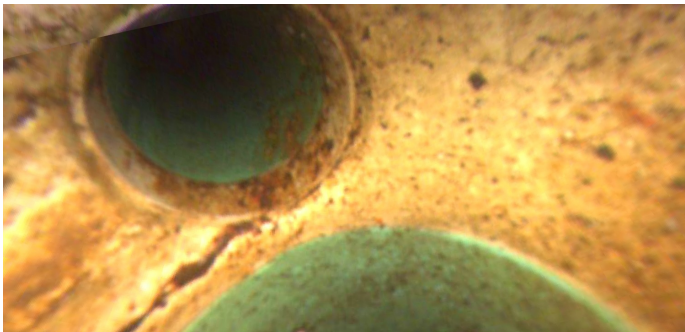
Code:	TF
Description:	Tap Factory

Distance (ft):	62.5
Structural Grade:	0
O&M Grade:	0
Clock Start/From:	11
Clock To:	
1st Value:	4.000
2nd Value:	
Value Percent:	
Continuous Index:	
Within 8" of Joint:	
Remarks:

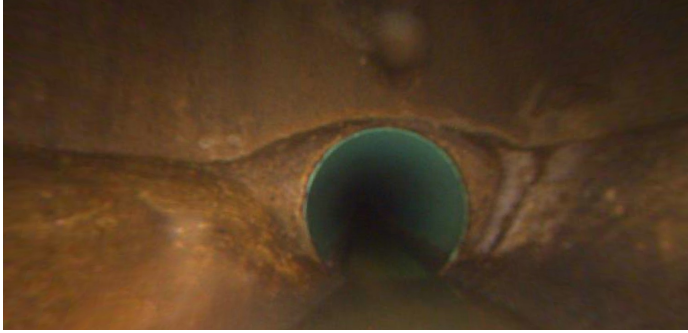
Code:	AMH
Description:	Manhole
Distance (ft):	230.9
Structural Grade:	0
O&M Grade:	0
Clock Start/From:	
Clock To:	
1st Value:	
2nd Value:	
Value Percent:	
Continuous Index:	
Within 8" of Joint:	NO
Remarks:	M-707-006
