Profile/Photo Observation Report

Street:	GARFIELD ST	Flow Control:	Not Controlled
City:	Hobart, IN	Year Renewed:	
Location:	Light Highway	Tape/Media #:	
Purpose:	Maintenance Related	Dia/Height:	12"
Use:	Sanitary	Material:	PVC
Drain Area:	NA	Lining:	Cured in Place
Category:	NA		
Comment:	battery at 189'.-flow incorrect		
Location Details:		Direction of Survey:	Upstream
US MH:	M-707-009	DS MH:	M-707-008
		Total Length Surveyed (ft):	190.7

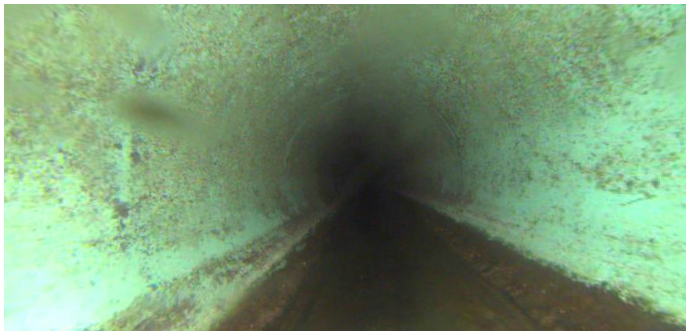
Code: **AMH**
Description: **Manhole**

Distance (ft): **.0**
Structural Grade: **0**
O&M Grade: **0**
Clock Start/From:
Clock To:
1st Value:
2nd Value:
Value Percent:
Continuous Index:
Within 8" of Joint: **NO**
Remarks: **M-707-008**

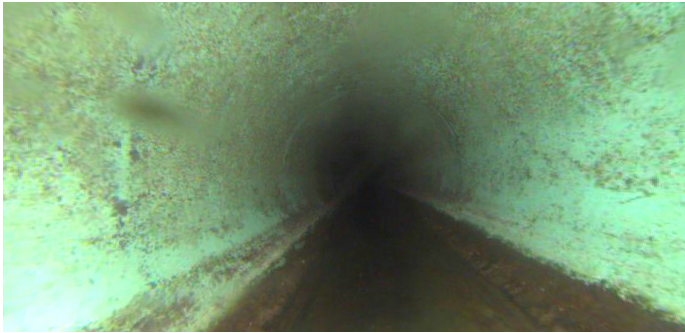
Code:	MWL
Description:	Water Level

Distance (ft):	.0
Structural Grade:	0
O&M Grade:	0
Clock Start/From:	
Clock To:	
1st Value:	
2nd Value:	
Value Percent:	5.000
Continuous Index:	
Within 8" of Joint:	NO
Remarks:

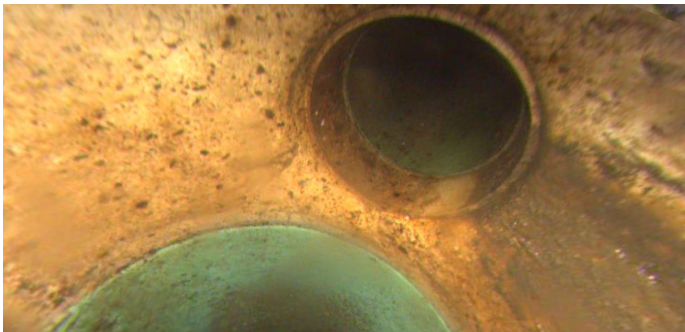
Code:	TF
Description:	Tap Factory

Distance (ft):	38.2
Structural Grade:	0
O&M Grade:	0
Clock Start/From:	1
Clock To:	
1st Value:	4.000
2nd Value:	
Value Percent:	
Continuous Index:	
Within 8" of Joint:	
Remarks:

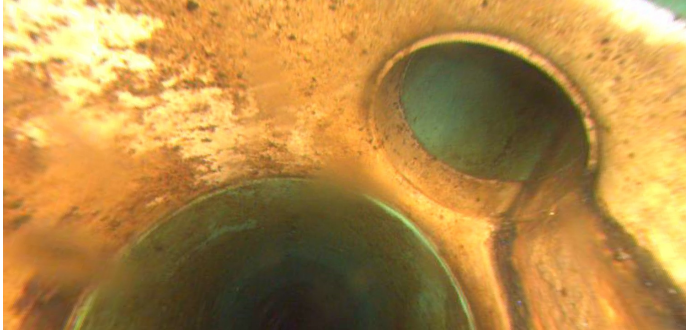
Code: **TF**
Description: **Tap Factory**

Distance (ft): **100.3**
Structural Grade: **0**
O&M Grade: **0**
Clock Start/From: **1**
Clock To:
1st Value: **4.000**
2nd Value:
Value Percent:
Continuous Index:
Within 8" of Joint:
Remarks:

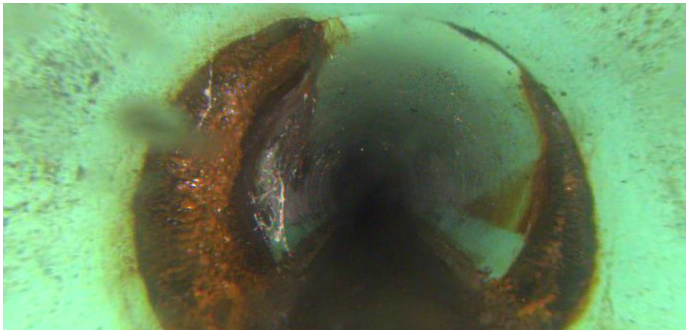
Code: **DAE**
Description: **Deposits Attached Encrustation**

Distance (ft): **105.0**
Structural Grade: **0**
O&M Grade: **2**
Clock Start/From: **8**
Clock To: **4**
1st Value:
2nd Value:
Value Percent: **10.000**
Continuous Index:
Within 8" of Joint: **YES**
Remarks:

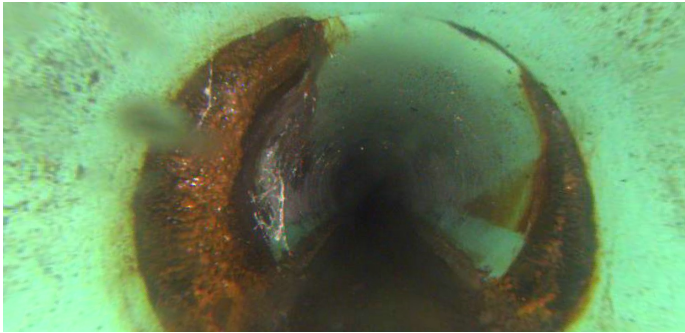
Code: **IW**
Description: **Infil Weeper**

Distance (ft): **105.0**
Structural Grade: **0**
O&M Grade: **2**
Clock Start/From: **8**
Clock To: **4**
1st Value:
2nd Value:
Value Percent:
Continuous Index:
Within 8" of Joint: **YES**
Remarks:

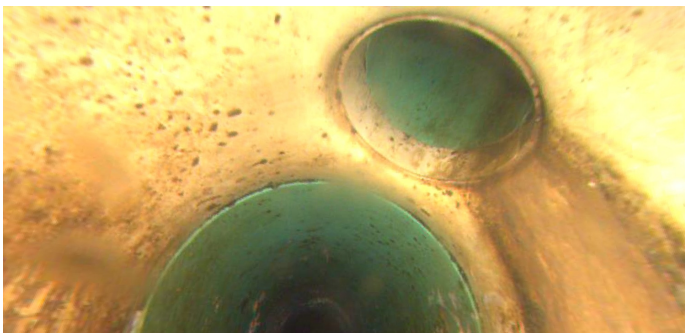
Code: **TF**
Description: **Tap Factory**

Distance (ft): **155.5**
Structural Grade: **0**
O&M Grade: **0**
Clock Start/From: **1**
Clock To:
1st Value: **4.000**
2nd Value:
Value Percent:
Continuous Index:
Within 8" of Joint:
Remarks:

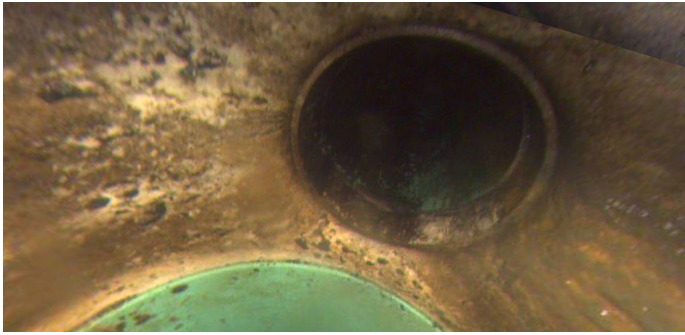
Code: **TF**
Description: **Tap Factory**

Distance (ft): **178.6**
Structural Grade: **0**
O&M Grade: **0**
Clock Start/From: **1**
Clock To:
1st Value: **4.000**
2nd Value:
Value Percent:
Continuous Index:
Within 8" of Joint:
Remarks:

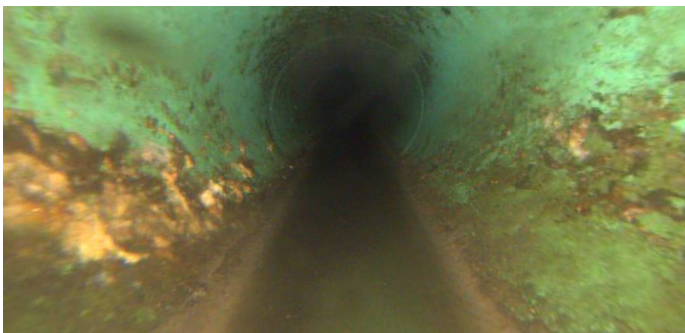
Code: **DAGS**
Description: **Deposits Attached Grease**

Distance (ft): **179.3**
Structural Grade: **0**
O&M Grade: **2**
Clock Start/From: **8**
Clock To: **4**
1st Value:
2nd Value:
Value Percent: **5.000**
Continuous Index:
Within 8" of Joint: **NO**
Remarks:

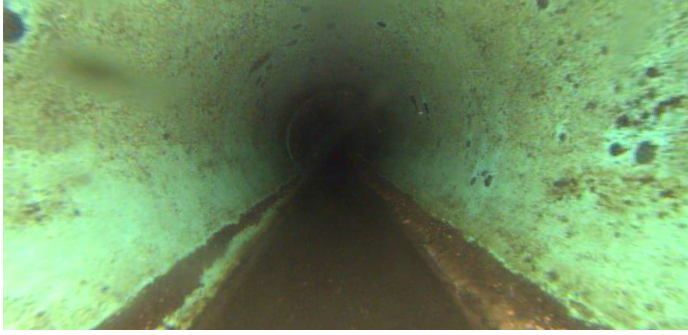
Code:	MSA
Description:	Abandoned Survey
Distance (ft):	190.7
Structural Grade:	0
O&M Grade:	0
Clock Start/From:	
Clock To:	
1st Value:	
2nd Value:	
Value Percent:	
Continuous Index:	
Within 8" of Joint:	NO
Remarks:	UNKNOWN
