Profile/Photo Observation Report

Street:	GARFIELD ST	Flow Control:	Not Controlled
City:	Hobart, IN	Year Renewed:	
Location:	Light Highway	Tape/Media #:	
Purpose:	Maintenance Related	Dia/Height:	12"
Use:	Sanitary	Material:	PVC
Drain Area:	NA	Lining:	Cured in Place
Category:	NA		
Comment:	user set max-flow incorrect.

Location Details:		Direction of Survey:	Downstream
US MH:	M-707-009	DS MH:	M-707-008
		Total Length Surveyed (ft):	161.6

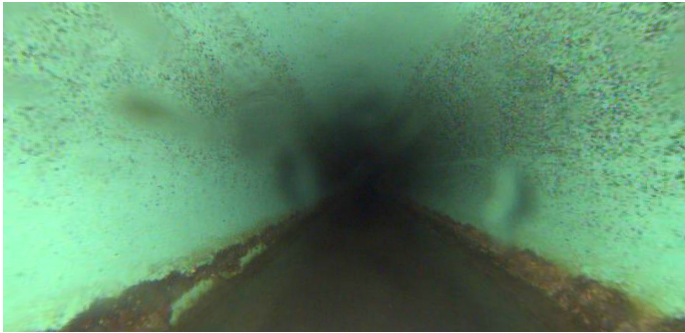
Code:	MWL
Description:	Water Level

Distance (ft):	.0
Structural Grade:	0
O&M Grade:	0
Clock Start/From:	
Clock To:	
1st Value:	
2nd Value:	
Value Percent:	10.000
Continuous Index:	
Within 8" of Joint:	NO
Remarks:

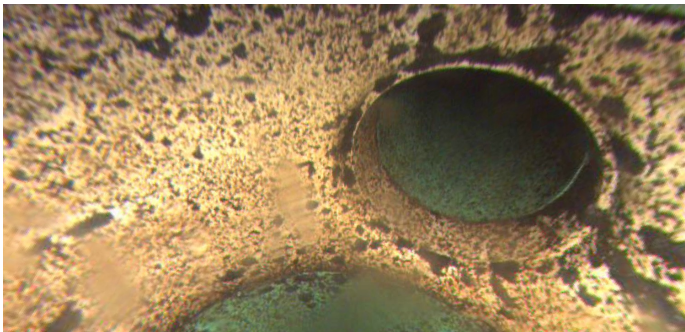
Code:	TF
Description:	Tap Factory

Distance (ft):	28.5
Structural Grade:	0
O&M Grade:	0
Clock Start/From:	1
Clock To:	
1st Value:	4.000
2nd Value:	
Value Percent:	
Continuous Index:	
Within 8" of Joint:	
Remarks:

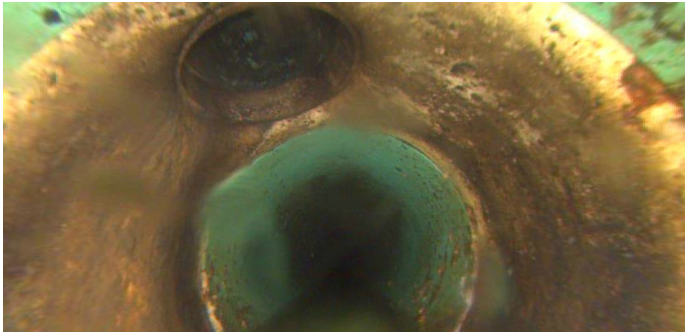
Code: **TF**
Description: **Tap Factory**

Distance (ft): **64.2**
Structural Grade: **0**
O&M Grade: **0**
Clock Start/From: **11**
Clock To:
1st Value: **4.000**
2nd Value:
Value Percent:
Continuous Index:
Within 8" of Joint:
Remarks:

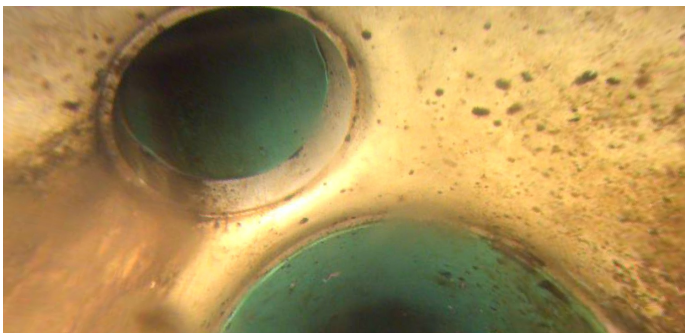
Code: **TF**
Description: **Tap Factory**

Distance (ft): **87.5**
Structural Grade: **0**
O&M Grade: **0**
Clock Start/From: **11**
Clock To:
1st Value: **4.000**
2nd Value:
Value Percent:
Continuous Index:
Within 8" of Joint:
Remarks:

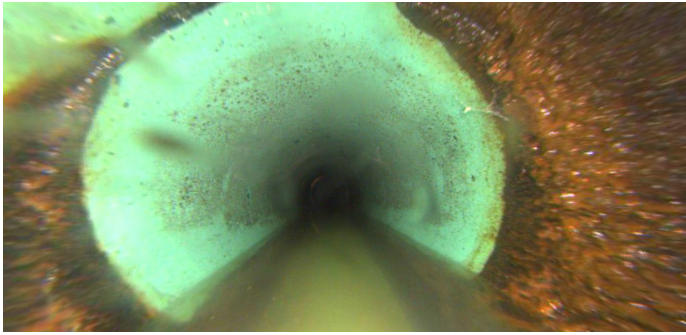
Code: **DAE**
Description: **Deposits Attached Encrustation**

Distance (ft): **137.8**
Structural Grade: **0**
O&M Grade: **2**
Clock Start/From: **8**
Clock To: **4**
1st Value:
2nd Value:
Value Percent: **5.000**
Continuous Index:
Within 8" of Joint: **YES**
Remarks:

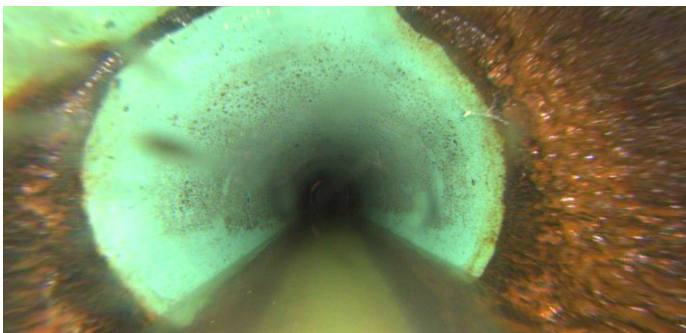
Code: **IW**
Description: **Infil Weeper**

Distance (ft): **137.8**
Structural Grade: **0**
O&M Grade: **2**
Clock Start/From: **8**
Clock To: **4**
1st Value:
2nd Value:
Value Percent:
Continuous Index:
Within 8" of Joint: **YES**
Remarks:

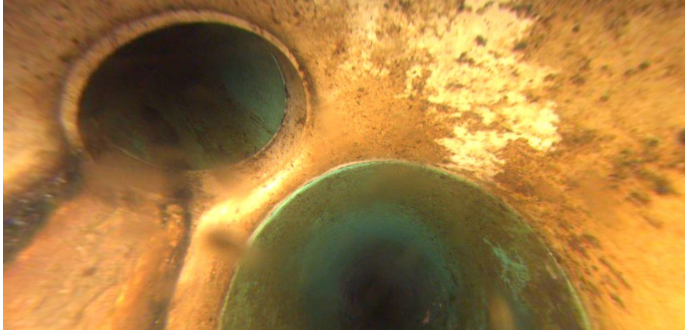
Code: **TF**
Description: **Tap Factory**

Distance (ft): **142.8**
Structural Grade: **0**
O&M Grade: **0**
Clock Start/From: **11**
Clock To:
1st Value: **4.000**
2nd Value:
Value Percent:
Continuous Index:
Within 8" of Joint:
Remarks:

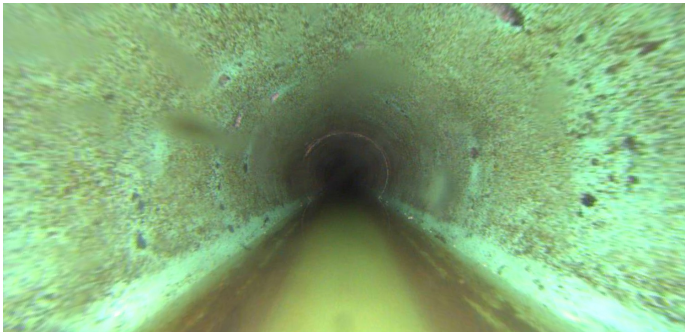
Code: **MSA**
Description: **Abandoned Survey**

Distance (ft): **161.6**
Structural Grade: **0**
O&M Grade: **0**
Clock Start/From:
Clock To:
1st Value:
2nd Value:
Value Percent:
Continuous Index:
Within 8" of Joint: **NO**
Remarks: **UNKNOWN**
