Profile/Photo Observation Report

Date:	04/11/2018	Weather:		Coding:	PACP 6.0
Pipe Length (ft):	245.4	Owner:	NA	Pre Clean:	Not Known
P.O.#:		Surveyor:	Jen Costello	PSR:	P-707-008-009
Customer:		Clean Date:	01/01/1900	Shape:	C

Location Details:		Direction of Survey:	Downstream
US MH:	M-707-009	DS MH:	M-707-008
		Total Length Surveyed (ft):	161.6

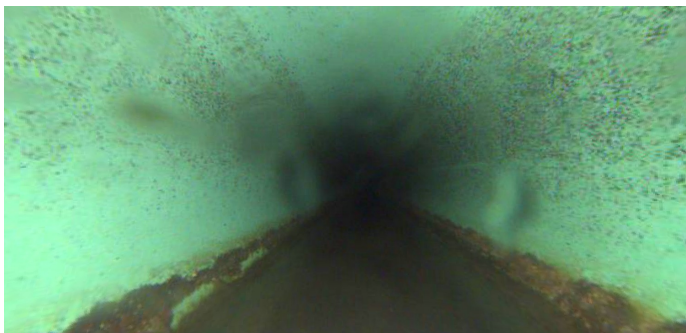
Code: **AMH**
Description: **Manhole**

Distance (ft): **.0**
Structural Grade: **0**
O&M Grade: **0**
Clock Start/From:
Clock To:
1st Value:
2nd Value:
Value Percent:
Continuous Index:
Within 8" of Joint: **NO**
Remarks: **M-707-009**

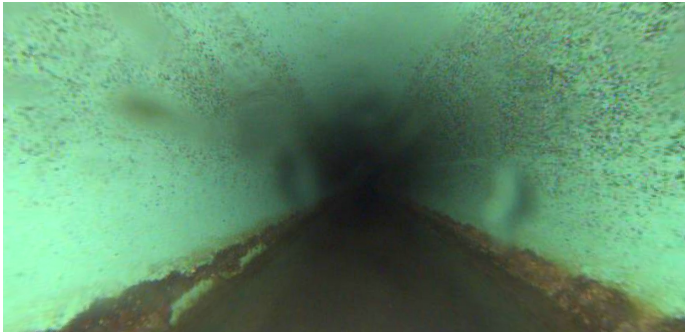
Code:	MWL
Description:	Water Level

Distance (ft):	.0
Structural Grade:	0
O&M Grade:	0
Clock Start/From:	
Clock To:	
1st Value:	
2nd Value:	
Value Percent:	10.000
Continuous Index:	
Within 8" of Joint:	NO
Remarks:

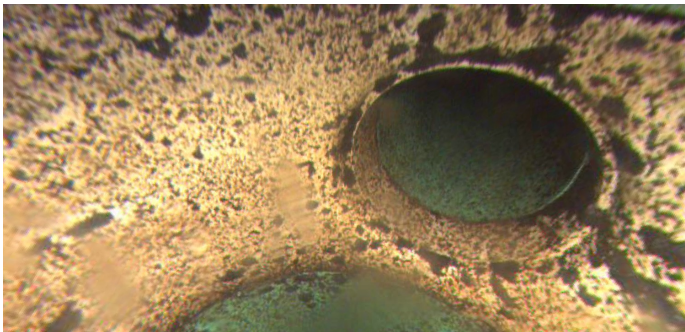
Code:	TF
Description:	Tap Factory

Distance (ft):	28.5
Structural Grade:	0
O&M Grade:	0
Clock Start/From:	1
Clock To:	
1st Value:	4.000
2nd Value:	
Value Percent:	
Continuous Index:	
Within 8" of Joint:	
Remarks:

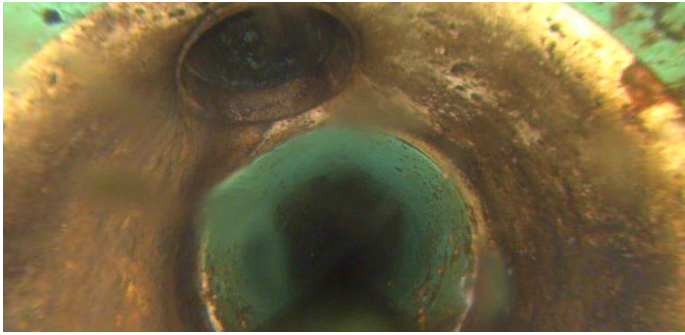
Code: **TF**
Description: **Tap Factory**

Distance (ft): **64.2**
Structural Grade: **0**
O&M Grade: **0**
Clock Start/From: **11**
Clock To:
1st Value: **4.000**
2nd Value:
Value Percent:
Continuous Index:
Within 8" of Joint:
Remarks:

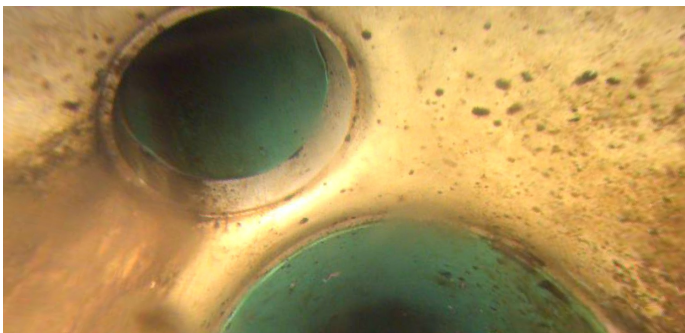
Code: **TF**
Description: **Tap Factory**

Distance (ft): **87.5**
Structural Grade: **0**
O&M Grade: **0**
Clock Start/From: **11**
Clock To:
1st Value: **4.000**
2nd Value:
Value Percent:
Continuous Index:
Within 8" of Joint:
Remarks:

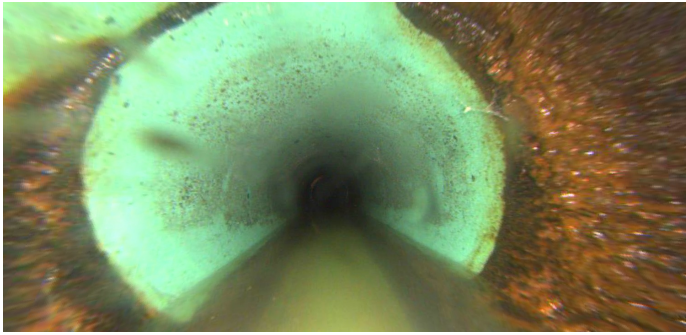
Code: **DAE**
Description: **Deposits Attached Encrustation**

Distance (ft): **137.8**
Structural Grade: **0**
O&M Grade: **2**
Clock Start/From: **8**
Clock To: **4**
1st Value:
2nd Value:
Value Percent: **5.000**
Continuous Index:
Within 8" of Joint: **YES**
Remarks:

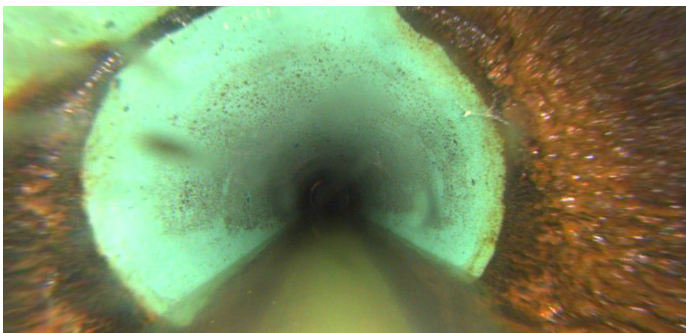
Code: **IW**
Description: **Infil Weeper**

Distance (ft): **137.8**
Structural Grade: **0**
O&M Grade: **2**
Clock Start/From: **8**
Clock To: **4**
1st Value:
2nd Value:
Value Percent:
Continuous Index:
Within 8" of Joint: **YES**
Remarks:

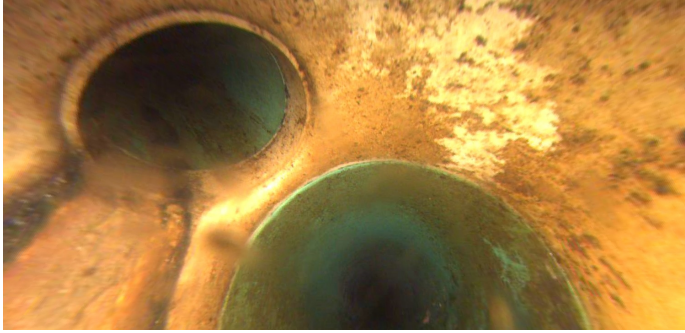
Code: **TF**
Description: **Tap Factory**

Distance (ft): **142.8**
Structural Grade: **0**
O&M Grade: **0**
Clock Start/From: **11**
Clock To:
1st Value: **4.000**
2nd Value:
Value Percent:
Continuous Index:
Within 8" of Joint:
Remarks:

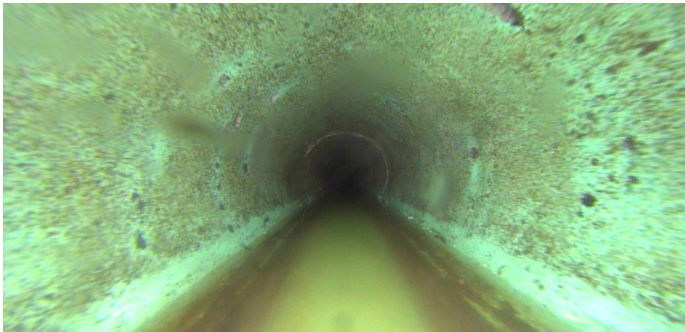
Code: **MSA**
Description: **Abandoned Survey**

Distance (ft): **161.6**
Structural Grade: **0**
O&M Grade: **0**
Clock Start/From:
Clock To:
1st Value:
2nd Value:
Value Percent:
Continuous Index:
Within 8" of Joint: **NO**
Remarks: **UNKNOWN**
