## Profile/Photo Observation Report

Street:	<b>Capitol</b>	Flow Control:	<b>Not Controlled</b>
City:	<b>Hobart, IN</b>	Year Renewed:	
Location:	<b>Light Highway</b>	Tape/Media #:	
Purpose:	<b>Maintenance Related</b>	Dia/Height:	<b>12"</b>
Use:	<b>Sanitary</b>	Material:	<b>PVC</b>
Drain Area:	<b>NA</b>	Lining:	<b>Cured in Place</b>
Category:	<b>NA</b>		
Comment:	<b>battery at 200'.-flow incorrect.</b>

Location Details:		Direction of Survey:	<b>Downstream</b>
US MH:	<b>M-707-011</b>	DS MH:	<b>M-707-009</b>
		Total Length Surveyed (ft):	<b>201.6</b>

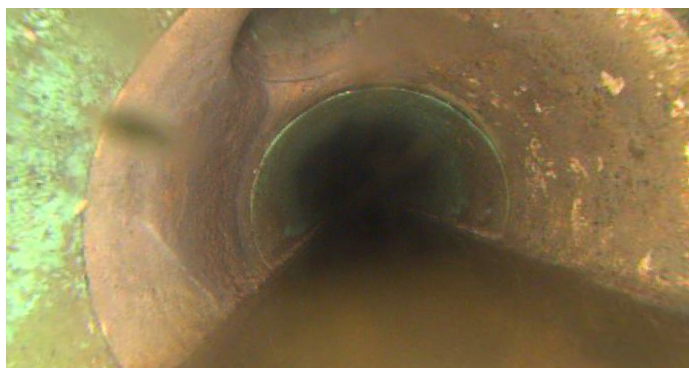
Code: **AMH**  
 Description: **Manhole**

Distance (ft): **.0**  
 Structural Grade: **0**  
 O&M Grade: **0**  
 Clock Start/From:  
 Clock To:  
 1st Value:  
 2nd Value:  
 Value Percent:  
 Continuous Index:  
 Within 8" of Joint: **NO**  
 Remarks: **M-707-011**

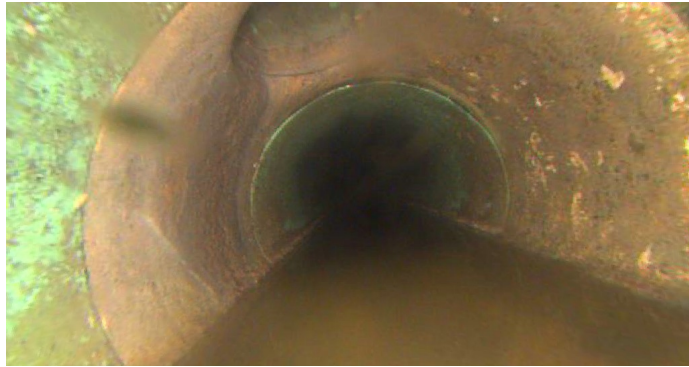
Code: **MWL**  
Description: **Water Level**

Distance (ft): **.0**  
Structural Grade: **0**  
O&M Grade: **0**  
Clock Start/From:  
Clock To:  
1st Value:  
2nd Value:  
Value Percent: **10.000**  
Continuous Index:  
Within 8" of Joint: **NO**  
Remarks:

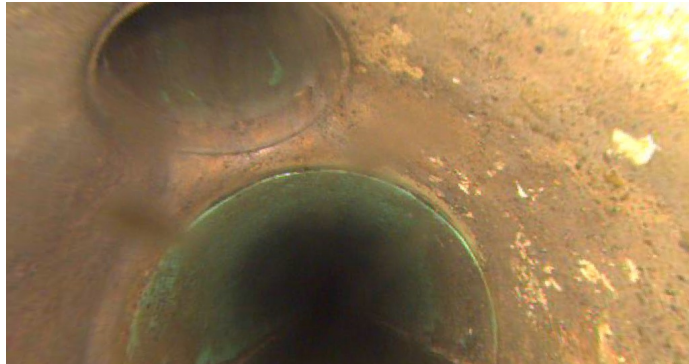
Code: **TF**  
Description: **Tap Factory**

Distance (ft): **1.9**  
Structural Grade: **0**  
O&M Grade: **0**  
Clock Start/From: **11**  
Clock To:  
1st Value: **4.000**  
2nd Value:  
Value Percent:  
Continuous Index:  
Within 8" of Joint:  
Remarks:

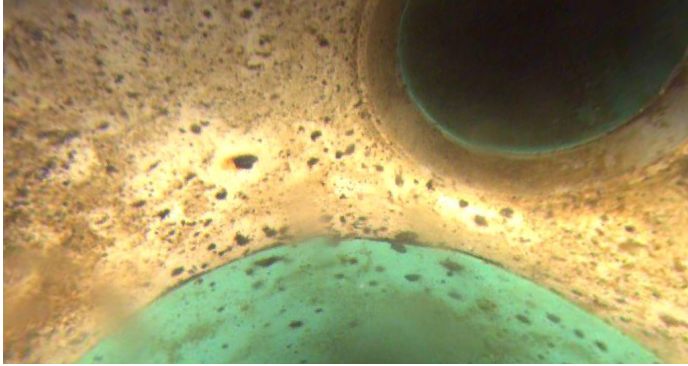
Code: **TF**  
Description: **Tap Factory**

Distance (ft): **90.4**  
Structural Grade: **0**  
O&M Grade: **0**  
Clock Start/From: **2**  
Clock To:  
1st Value: **4.000**  
2nd Value:  
Value Percent:  
Continuous Index:  
Within 8" of Joint:  
Remarks:

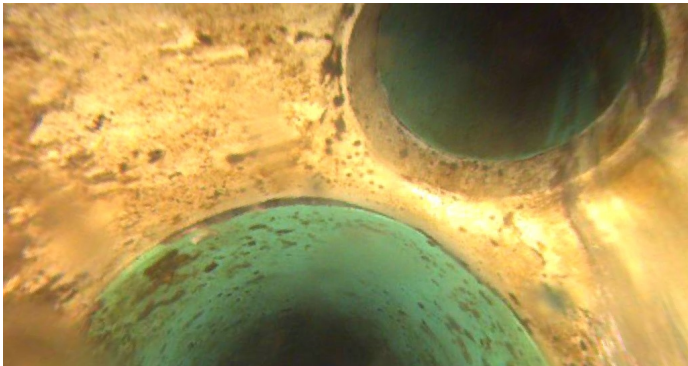
Code: **TFA**  
Description: **Tap Factory Active**

Distance (ft): **93.6**  
Structural Grade: **0**  
O&M Grade: **0**  
Clock Start/From: **2**  
Clock To:  
1st Value: **4.000**  
2nd Value:  
Value Percent:  
Continuous Index:  
Within 8" of Joint:  
Remarks:

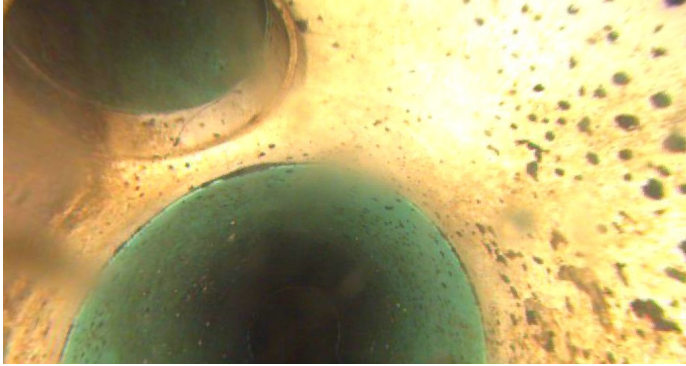
Code: **TF**  
Description: **Tap Factory**

Distance (ft): **147.5**  
Structural Grade: **0**  
O&M Grade: **0**  
Clock Start/From: **10**  
Clock To:  
1st Value: **4.000**  
2nd Value:  
Value Percent:  
Continuous Index:  
Within 8" of Joint:  
Remarks:

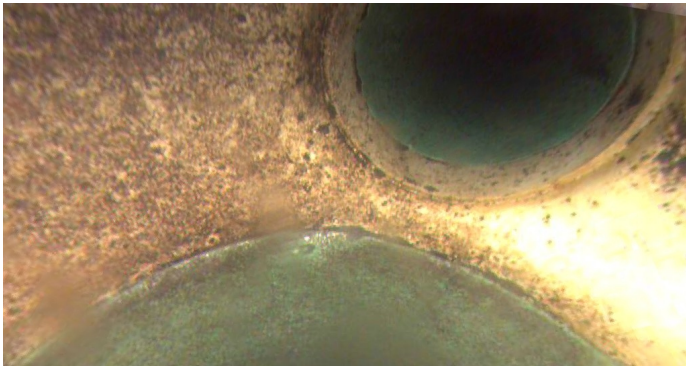
Code: **TF**  
Description: **Tap Factory**

Distance (ft): **187.8**  
Structural Grade: **0**  
O&M Grade: **0**  
Clock Start/From: **2**  
Clock To:  
1st Value: **4.000**  
2nd Value:  
Value Percent:  
Continuous Index:  
Within 8" of Joint:  
Remarks:

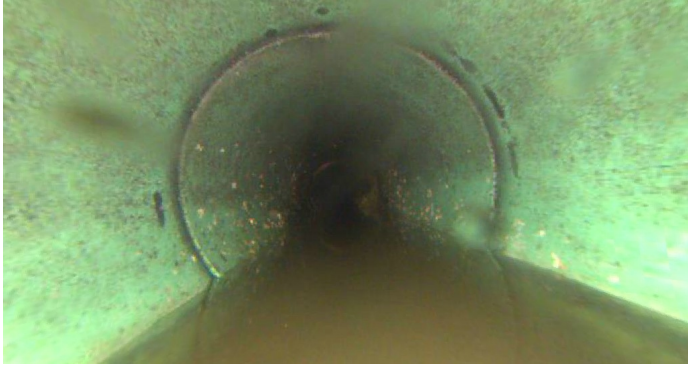
Code:	<b>MSA</b>
Description:	<b>Abandoned Survey</b>
Distance (ft):	<b>201.6</b>
Structural Grade:	<b>0</b>
O&M Grade:	<b>0</b>
Clock Start/From:	
Clock To:	
1st Value:	
2nd Value:	
Value Percent:	
Continuous Index:	
Within 8" of Joint:	<b>NO</b>
Remarks:	<b>No blockage</b>
