Profile/Photo Observation Report

Date:	04/10/2018	Weather:		Coding:	PACP 6.0
Pipe Length (ft):	335.8	Owner:	NA	Pre Clean:	Not Known
P.O.#:		Surveyor:	Mark Ruby	PSR:	P-707-009-011
Customer:		Clean Date:	01/01/1900	Shape:	C

Street:	GARFIELD ST & E 12TH ST	Flow Control:	Not Controlled
City:	Hobart, IN	Year Renewed:	
Location:	Light Highway	Tape/Media #:	
Purpose:	Maintenance Related	Dia/Height:	12"
Use:	Sanitary	Material:	PVC
Drain Area:	NA	Lining:	Cured in Place
Category:	NA		
Comment:	Reverse setup. user set max-flow incorrect.		
Location Details:		Direction of Survey:	Upstream
US MH:	M-707-011	DS MH:	M-707-009
		Total Length Surveyed (ft):	166.5

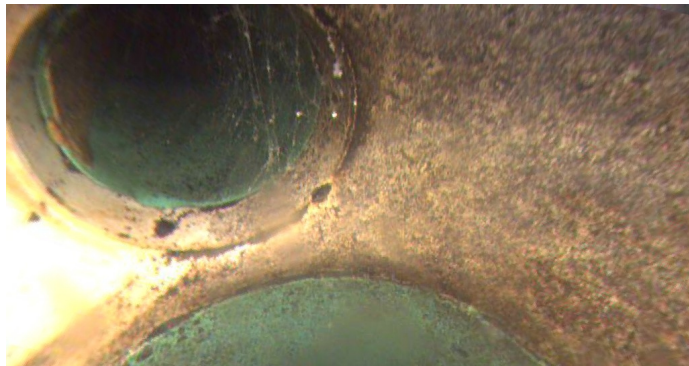
Code:	MWL
Description:	Water Level
Distance (ft):	.0
Structural Grade:	0
O&M Grade:	0
Clock Start/From:	
Clock To:	
1st Value:	
2nd Value:	
Value Percent:	10.000
Continuous Index:	
Within 8" of Joint:	NO
Remarks:

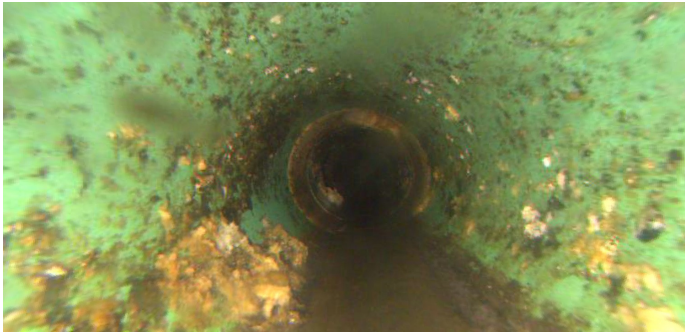
Code: **DAGS**
Description: **Deposits Attached Grease**

Distance (ft): **124.3**
Structural Grade: **0**
O&M Grade: **2**
Clock Start/From: **8**
Clock To: **4**
1st Value:
2nd Value:
Value Percent: **5.000**
Continuous Index:
Within 8" of Joint: **NO**
Remarks:

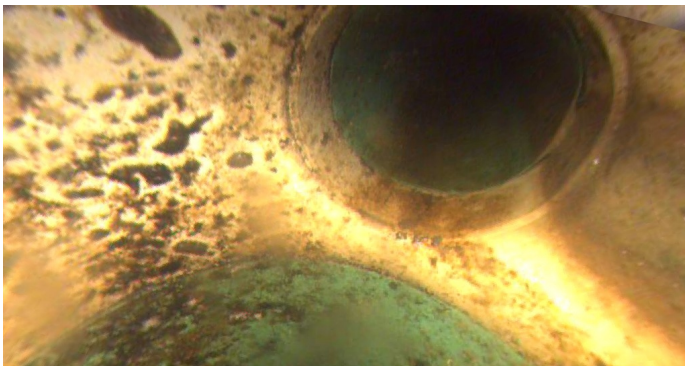
Code: **TF**
Description: **Tap Factory**

Distance (ft): **126.6**
Structural Grade: **0**
O&M Grade: **0**
Clock Start/From: **2**
Clock To:
1st Value: **4.000**
2nd Value:
Value Percent:
Continuous Index:
Within 8" of Joint:
Remarks:

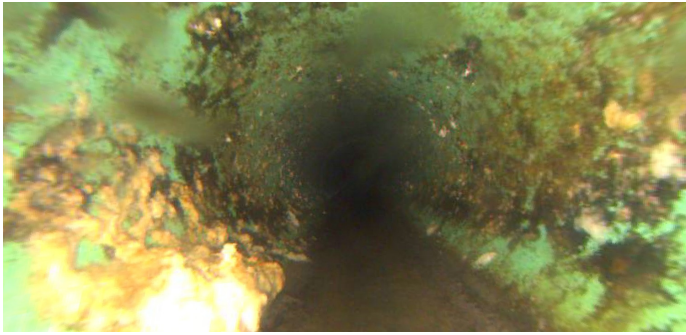
Code: **DAGS**
Description: **Deposits Attached Grease**

Distance (ft): **127.3**
Structural Grade: **0**
O&M Grade: **2**
Clock Start/From: **8**
Clock To: **4**
1st Value:
2nd Value:
Value Percent: **5.000**
Continuous Index:
Within 8" of Joint: **NO**
Remarks:

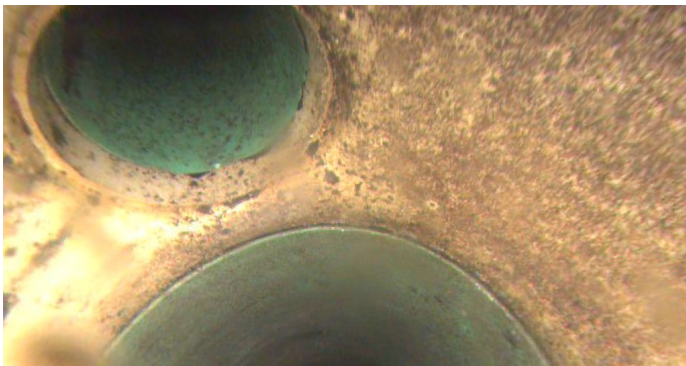
Code: **TF**
Description: **Tap Factory**

Distance (ft): **141.7**
Structural Grade: **0**
O&M Grade: **0**
Clock Start/From: **10**
Clock To:
1st Value: **4.000**
2nd Value:
Value Percent:
Continuous Index:
Within 8" of Joint:
Remarks:

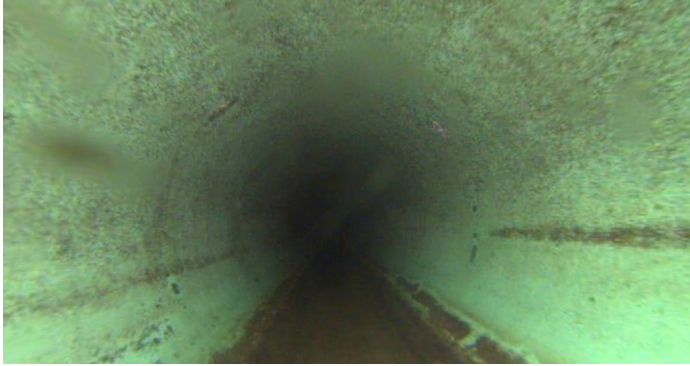
Code:	MSA
Description:	Abandoned Survey
Distance (ft):	166.5
Structural Grade:	0
O&M Grade:	0
Clock Start/From:	
Clock To:	
1st Value:	
2nd Value:	
Value Percent:	
Continuous Index:	
Within 8" of Joint:	NO
Remarks:	No blockage
