## Profile/Photo Observation Report

Date:	<b>04/10/2018</b>	Weather:		Coding:	<b>PACP 6.0</b>
Pipe Length (ft):	<b>335.8</b>	Owner:	<b>NA</b>	Pre Clean:	<b>Not Known</b>
P.O.#:		Surveyor:	<b>Mark Ruby</b>	PSR:	<b>P-707-009-011</b>
Customer:		Clean Date:	<b>01/01/1900</b>	Shape:	<b>C</b>

Street:	<b>Capitol</b>	Flow Control:	<b>Not Controlled</b>
City:	<b>Hobart, IN</b>	Year Renewed:	
Location:	<b>Light Highway</b>	Tape/Media #:	
Purpose:	<b>Maintenance Related</b>	Dia/Height:	<b>12"</b>
Use:	<b>Sanitary</b>	Material:	<b>PVC</b>
Drain Area:	<b>NA</b>	Lining:	<b>Cured in Place</b>
Category:	<b>NA</b>		
Comment:	<b>Reverse setup. user set max-flow incorrect.</b>		
Location Details:		Direction of Survey:	<b>Upstream</b>
US MH:	<b>M-707-011</b>	DS MH:	<b>M-707-009</b>
		Total Length Surveyed (ft):	<b>166.5</b>

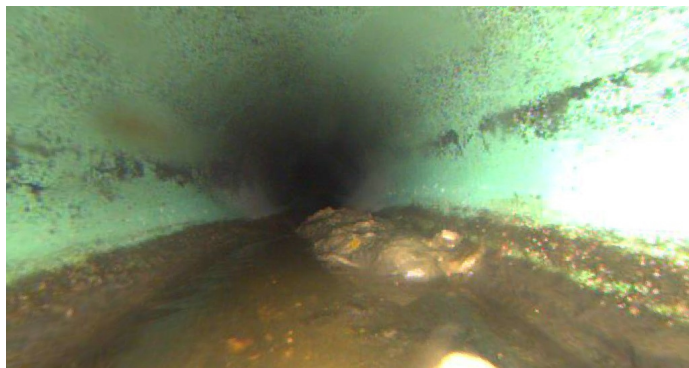
Code: **AMH**  
 Description: **Manhole**

Distance (ft): **.0**  
 Structural Grade: **0**  
 O&M Grade: **0**  
 Clock Start/From:  
 Clock To:  
 1st Value:  
 2nd Value:  
 Value Percent:  
 Continuous Index:  
 Within 8" of Joint: **NO**  
 Remarks: **M-707-009**

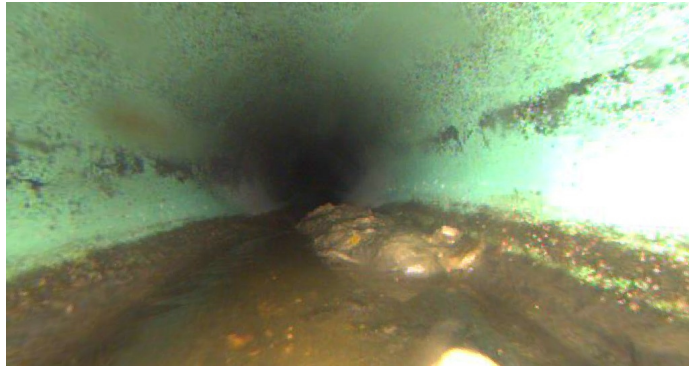
Code:	<b>MWL</b>
Description:	<b>Water Level</b>
Distance (ft):	<b>.0</b>
Structural Grade:	<b>0</b>
O&M Grade:	<b>0</b>
Clock Start/From:	
Clock To:	
1st Value:	
2nd Value:	
Value Percent:	<b>10.000</b>
Continuous Index:	
Within 8" of Joint:	<b>NO</b>
Remarks:

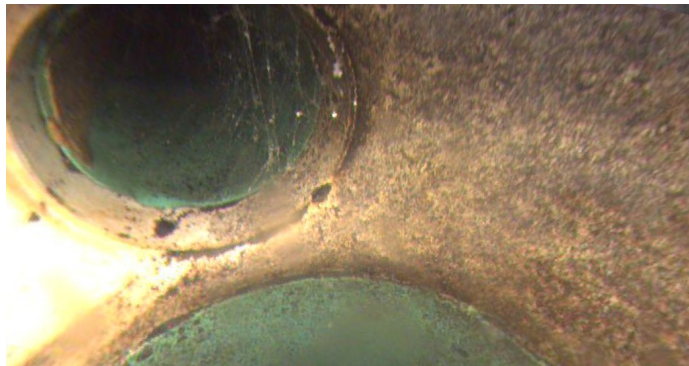
Code:	<b>TF</b>
Description:	<b>Tap Factory</b>
Distance (ft):	<b>83.2</b>
Structural Grade:	<b>0</b>
O&M Grade:	<b>0</b>
Clock Start/From:	<b>10</b>
Clock To:	
1st Value:	<b>4.000</b>
2nd Value:	
Value Percent:	
Continuous Index:	
Within 8" of Joint:	
Remarks:

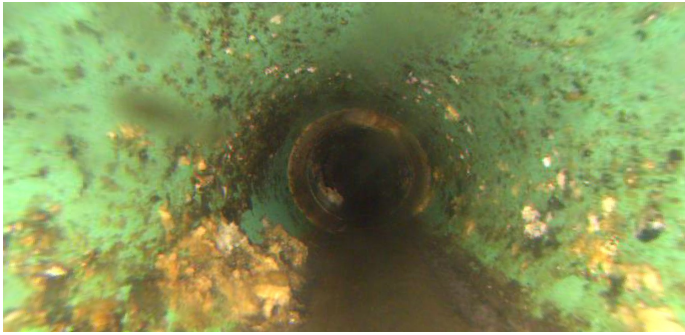
Code: **DAGS**  
Description: **Deposits Attached Grease**

Distance (ft): **124.3**  
Structural Grade: **0**  
O&M Grade: **2**  
Clock Start/From: **8**  
Clock To: **4**  
1st Value:  
2nd Value:  
Value Percent: **5.000**  
Continuous Index:  
Within 8" of Joint: **NO**  
Remarks:

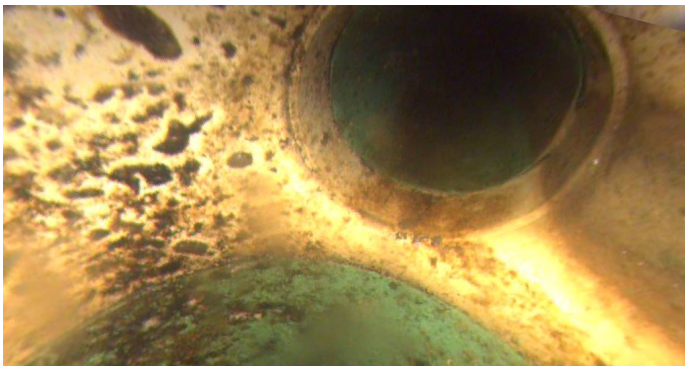
Code: **TF**  
Description: **Tap Factory**

Distance (ft): **126.6**  
Structural Grade: **0**  
O&M Grade: **0**  
Clock Start/From: **2**  
Clock To:  
1st Value: **4.000**  
2nd Value:  
Value Percent:  
Continuous Index:  
Within 8" of Joint:  
Remarks:

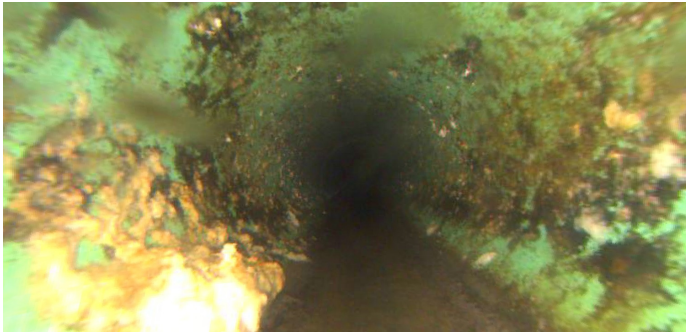
Code: **DAGS**  
Description: **Deposits Attached Grease**

Distance (ft): **127.3**  
Structural Grade: **0**  
O&M Grade: **2**  
Clock Start/From: **8**  
Clock To: **4**  
1st Value:  
2nd Value:  
Value Percent: **5.000**  
Continuous Index:  
Within 8" of Joint: **NO**  
Remarks:

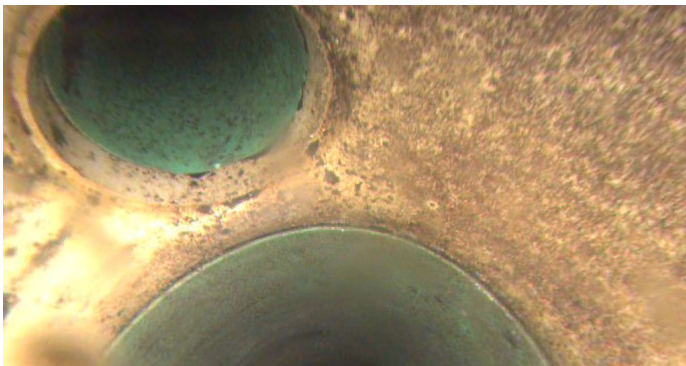
Code: **TF**  
Description: **Tap Factory**

Distance (ft): **141.7**  
Structural Grade: **0**  
O&M Grade: **0**  
Clock Start/From: **10**  
Clock To:  
1st Value: **4.000**  
2nd Value:  
Value Percent:  
Continuous Index:  
Within 8" of Joint:  
Remarks:

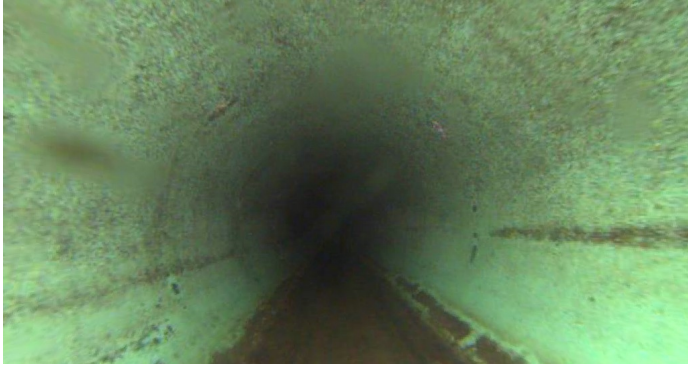
Code:	<b>MSA</b>
Description:	<b>Abandoned Survey</b>
Distance (ft):	<b>166.5</b>
Structural Grade:	<b>0</b>
O&M Grade:	<b>0</b>
Clock Start/From:	
Clock To:	
1st Value:	
2nd Value:	
Value Percent:	
Continuous Index:	
Within 8" of Joint:	<b>NO</b>
Remarks:	<b>No blockage</b>
