## Profile/Photo Observation Report

Street:	<b>GARFIELD ST</b>	Flow Control:	<b>Not Controlled</b>
City:	<b>Hobart, IN</b>	Year Renewed:	
Location:	<b>Light Highway</b>	Tape/Media #:	
Purpose:	<b>Maintenance Related</b>	Dia/Height:	<b>12"</b>
Use:	<b>Sanitary</b>	Material:	<b>PVC</b>
Drain Area:	<b>NA</b>	Lining:	<b>Cured in Place</b>
Category:	<b>NA</b>		
Comment:	<b>blk silt at 219'-flow incorrect.</b>		
Location Details:		Direction of Survey:	<b>Upstream</b>
US MH:	<b>M-707-012</b>	DS MH:	<b>M-707-011</b>
		Total Length Surveyed (ft):	<b>220.1</b>

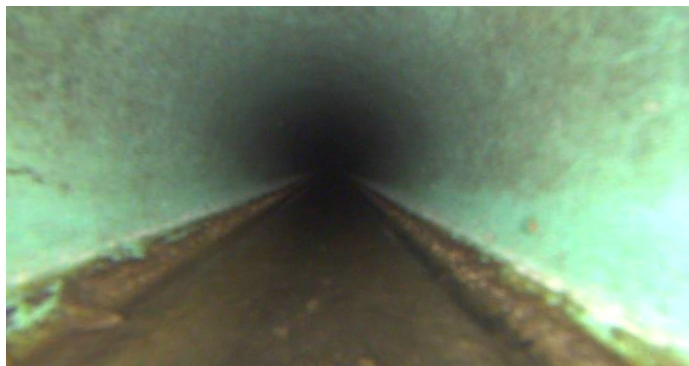
Code: **AMH**  
Description: **Manhole**

Distance (ft): **.0**  
Structural Grade: **0**  
O&M Grade: **0**  
Clock Start/From:  
Clock To:  
1st Value:  
2nd Value:  
Value Percent:  
Continuous Index:  
Within 8" of Joint: **NO**  
Remarks: **M-707-011**

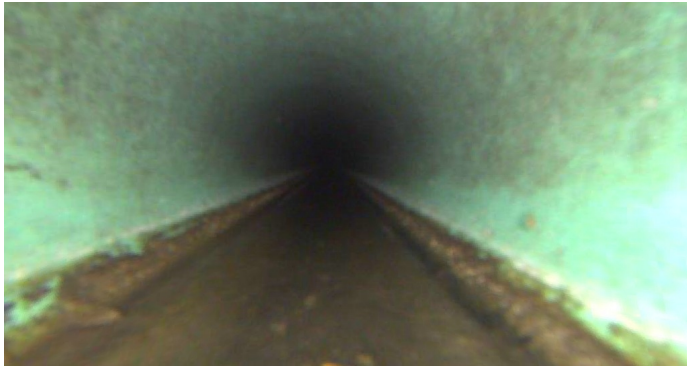
Code:	<b>MWL</b>
Description:	<b>Water Level</b>
Distance (ft):	<b>.0</b>
Structural Grade:	<b>0</b>
O&M Grade:	<b>0</b>
Clock Start/From:	
Clock To:	
1st Value:	
2nd Value:	
Value Percent:	<b>10.000</b>
Continuous Index:	
Within 8" of Joint:	<b>NO</b>
Remarks:

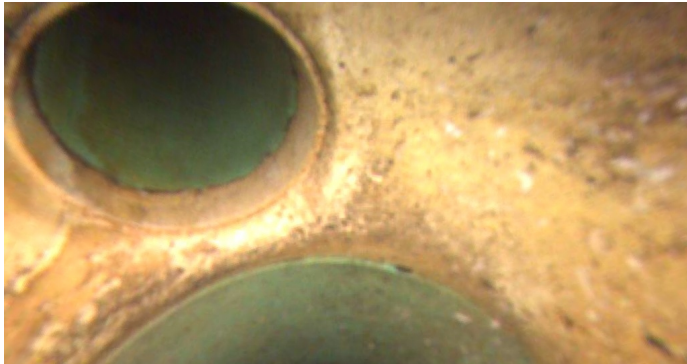
Code:	<b>TF</b>
Description:	<b>Tap Factory</b>
Distance (ft):	<b>28.7</b>
Structural Grade:	<b>0</b>
O&M Grade:	<b>0</b>
Clock Start/From:	<b>11</b>
Clock To:	
1st Value:	<b>4.000</b>
2nd Value:	
Value Percent:	
Continuous Index:	
Within 8" of Joint:	
Remarks:

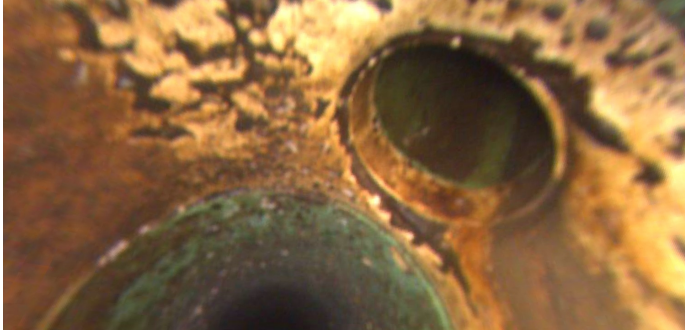
Code: **TF**  
Description: **Tap Factory**

Distance (ft): **45.6**  
Structural Grade: **0**  
O&M Grade: **0**  
Clock Start/From: **2**  
Clock To:  
1st Value: **4.000**  
2nd Value:  
Value Percent:  
Continuous Index:  
Within 8" of Joint:  
Remarks:

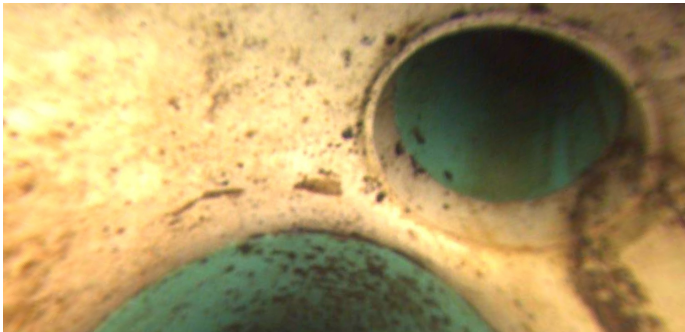
Code: **TF**  
Description: **Tap Factory**

Distance (ft): **98.5**  
Structural Grade: **0**  
O&M Grade: **0**  
Clock Start/From: **1**  
Clock To:  
1st Value: **4.000**  
2nd Value:  
Value Percent:  
Continuous Index:  
Within 8" of Joint:  
Remarks:

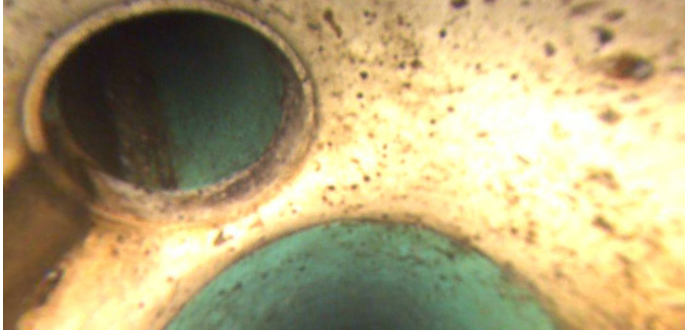
Code: **TF**  
Description: **Tap Factory**

Distance (ft): **108.5**  
Structural Grade: **0**  
O&M Grade: **0**  
Clock Start/From: **11**  
Clock To:  
1st Value: **4.000**  
2nd Value:  
Value Percent:  
Continuous Index:  
Within 8" of Joint:  
Remarks:

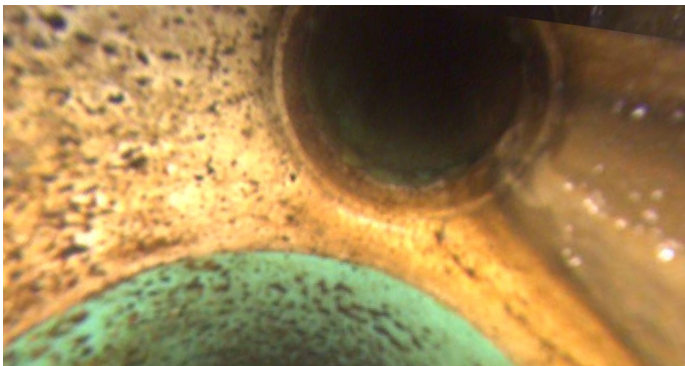
Code: **TF**  
Description: **Tap Factory**

Distance (ft): **146.6**  
Structural Grade: **0**  
O&M Grade: **0**  
Clock Start/From: **2**  
Clock To:  
1st Value: **4.000**  
2nd Value:  
Value Percent:  
Continuous Index:  
Within 8" of Joint:  
Remarks:

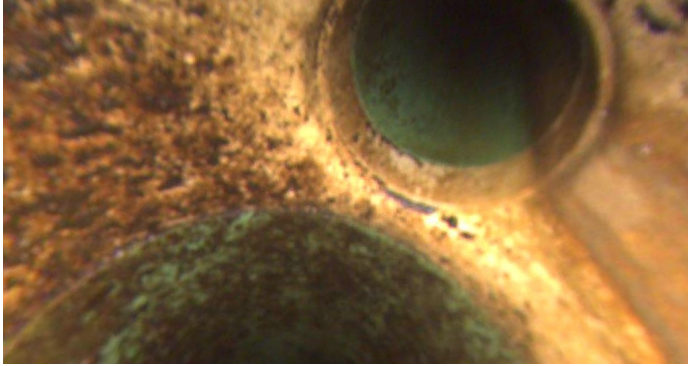
Code: **TF**  
Description: **Tap Factory**

Distance (ft): **171.9**  
Structural Grade: **0**  
O&M Grade: **0**  
Clock Start/From: **2**  
Clock To:  
1st Value: **4.000**  
2nd Value:  
Value Percent:  
Continuous Index:  
Within 8" of Joint:  
Remarks:

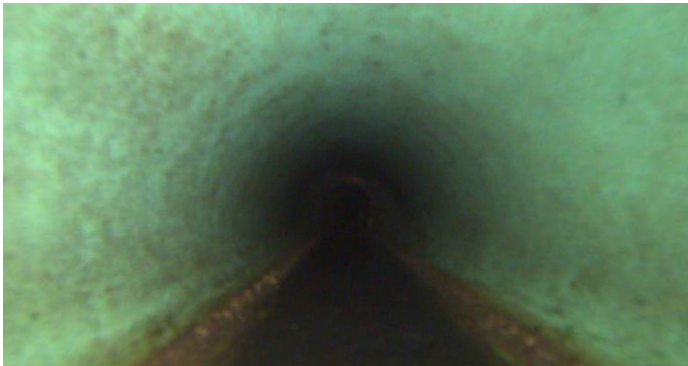
Code: **MSA**  
Description: **Abandoned Survey**

Distance (ft): **220.1**  
Structural Grade: **0**  
O&M Grade: **0**  
Clock Start/From:  
Clock To:  
1st Value:  
2nd Value:  
Value Percent:  
Continuous Index:  
Within 8" of Joint: **NO**  
Remarks: **debris**
