## Profile/Photo Observation Report

Date:	<b>04/10/2018</b>	Weather:		Coding:	<b>PACP 6.0</b>
Pipe Length (ft):	<b>348.5</b>	Owner:	<b>NA</b>	Pre Clean:	<b>Not Known</b>
P.O.#:		Surveyor:	<b>Mark Ruby</b>	PSR:	<b>P-707-011-012</b>
Customer:		Clean Date:	<b>01/01/1900</b>	Shape:	<b>C</b>

Street:	<b>Capitol</b>	Flow Control:	<b>Not Controlled</b>
City:	<b>Hobart, IN</b>	Year Renewed:	
Location:	<b>Light Highway</b>	Tape/Media #:	
Purpose:	<b>Maintenance Related</b>	Dia/Height:	<b>12"</b>
Use:	<b>Sanitary</b>	Material:	<b>PVC</b>
Drain Area:	<b>NA</b>	Lining:	<b>Cured in Place</b>
Category:	<b>NA</b>		
Comment:	<b>blk silt at 219'-flow incorrect.</b>		
Location Details:		Direction of Survey:	<b>Upstream</b>
US MH:	<b>M-707-012</b>	DS MH:	<b>M-707-011</b>
		Total Length Surveyed (ft):	<b>220.1</b>

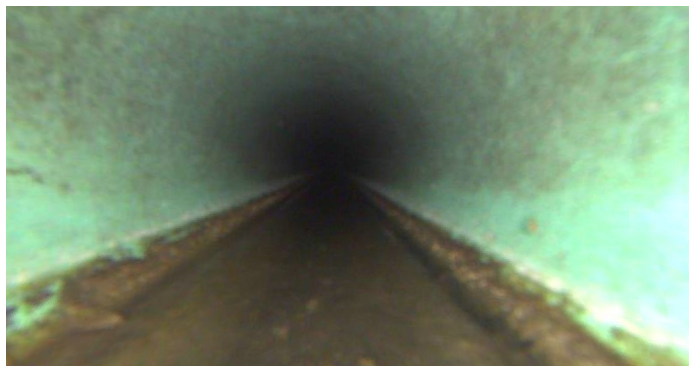
Code: **AMH**  
 Description: **Manhole**

Distance (ft): **.0**  
 Structural Grade: **0**  
 O&M Grade: **0**  
 Clock Start/From:  
 Clock To:  
 1st Value:  
 2nd Value:  
 Value Percent:  
 Continuous Index:  
 Within 8" of Joint: **NO**  
 Remarks: **M-707-011**

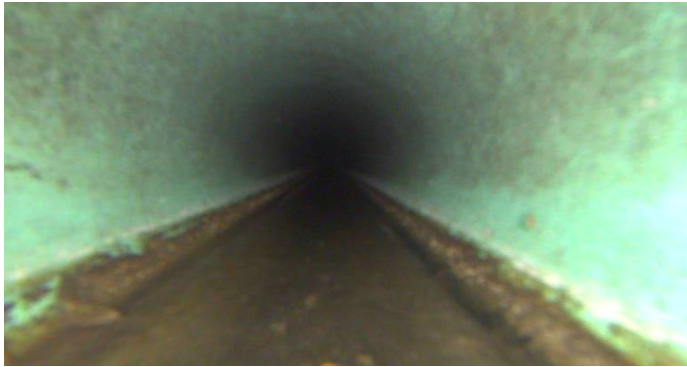
Code:	<b>MWL</b>
Description:	<b>Water Level</b>
Distance (ft):	<b>.0</b>
Structural Grade:	<b>0</b>
O&M Grade:	<b>0</b>
Clock Start/From:	
Clock To:	
1st Value:	
2nd Value:	
Value Percent:	<b>10.000</b>
Continuous Index:	
Within 8" of Joint:	<b>NO</b>
Remarks:

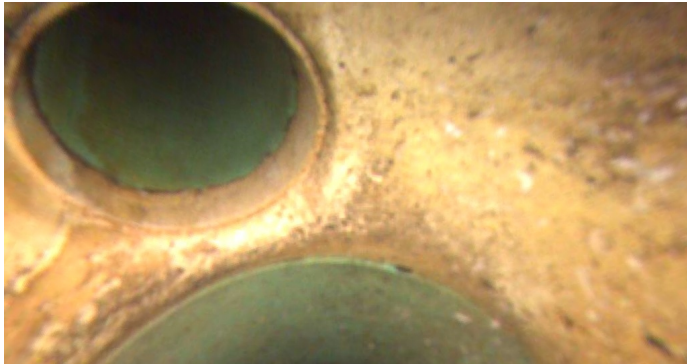
Code:	<b>TF</b>
Description:	<b>Tap Factory</b>
Distance (ft):	<b>28.7</b>
Structural Grade:	<b>0</b>
O&M Grade:	<b>0</b>
Clock Start/From:	<b>11</b>
Clock To:	
1st Value:	<b>4.000</b>
2nd Value:	
Value Percent:	
Continuous Index:	
Within 8" of Joint:	
Remarks:

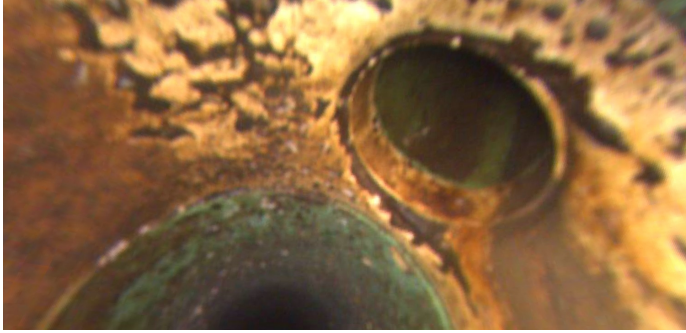
Code: **TF**  
Description: **Tap Factory**

Distance (ft): **45.6**  
Structural Grade: **0**  
O&M Grade: **0**  
Clock Start/From: **2**  
Clock To:  
1st Value: **4.000**  
2nd Value:  
Value Percent:  
Continuous Index:  
Within 8" of Joint:  
Remarks:

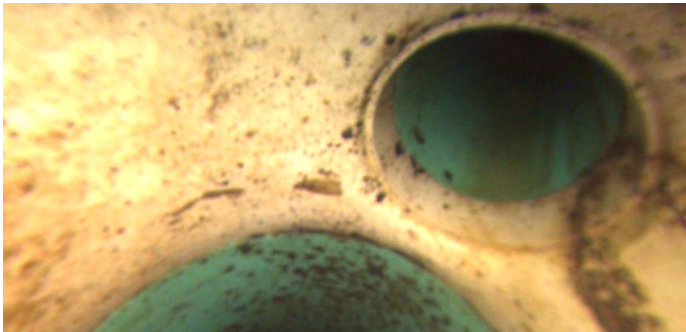
Code: **TF**  
Description: **Tap Factory**

Distance (ft): **98.5**  
Structural Grade: **0**  
O&M Grade: **0**  
Clock Start/From: **1**  
Clock To:  
1st Value: **4.000**  
2nd Value:  
Value Percent:  
Continuous Index:  
Within 8" of Joint:  
Remarks:

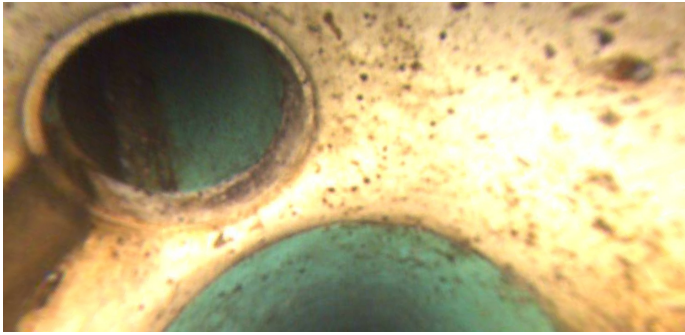
Code: **TF**  
Description: **Tap Factory**

Distance (ft): **108.5**  
Structural Grade: **0**  
O&M Grade: **0**  
Clock Start/From: **11**  
Clock To:  
1st Value: **4.000**  
2nd Value:  
Value Percent:  
Continuous Index:  
Within 8" of Joint:  
Remarks:

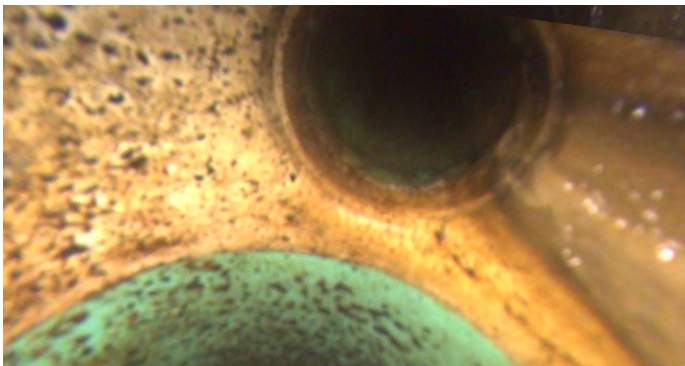
Code: **TF**  
Description: **Tap Factory**

Distance (ft): **146.6**  
Structural Grade: **0**  
O&M Grade: **0**  
Clock Start/From: **2**  
Clock To:  
1st Value: **4.000**  
2nd Value:  
Value Percent:  
Continuous Index:  
Within 8" of Joint:  
Remarks:

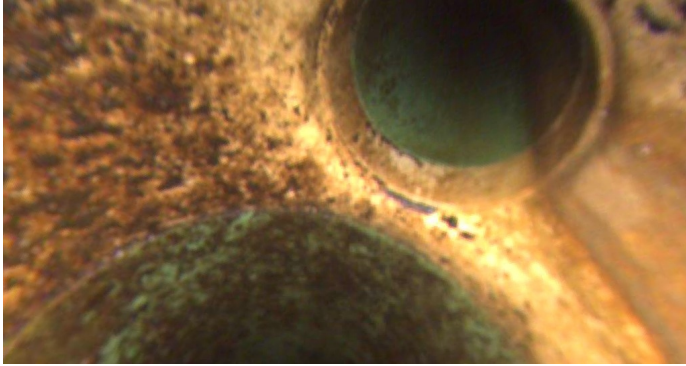
Code: **TF**  
Description: **Tap Factory**

Distance (ft): **171.9**  
Structural Grade: **0**  
O&M Grade: **0**  
Clock Start/From: **2**  
Clock To:  
1st Value: **4.000**  
2nd Value:  
Value Percent:  
Continuous Index:  
Within 8" of Joint:  
Remarks:

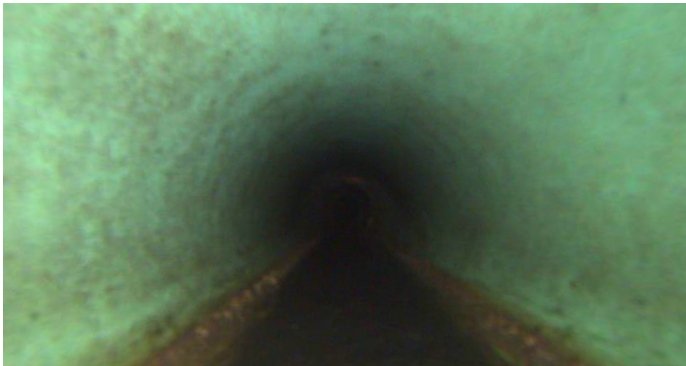
Code: **MSA**  
Description: **Abandoned Survey**

Distance (ft): **220.1**  
Structural Grade: **0**  
O&M Grade: **0**  
Clock Start/From:  
Clock To:  
1st Value:  
2nd Value:  
Value Percent:  
Continuous Index:  
Within 8" of Joint: **NO**  
Remarks: **debris**
