Profile/Photo Observation Report

Street:	GARFIELD ST	Flow Control:	Not Controlled
City:	Hobart, IN	Year Renewed:	
Location:	Light Highway	Tape/Media #:	
Purpose:	Maintenance Related	Dia/Height:	12"
Use:	Sanitary	Material:	PVC
Drain Area:	NA	Lining:	Cured in Place
Category:	NA		
Comment:	Reverse setup. underwater debris at 16'.-flow incorrect.		
Location Details:		Direction of Survey:	Downstream
US MH:	M-707-012	DS MH:	M-707-011
		Total Length Surveyed (ft):	17.2

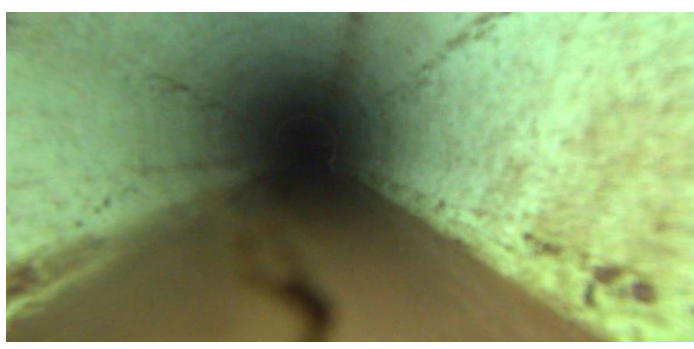
Code: **AMH**
Description: **Manhole**

Distance (ft): **.0**
Structural Grade: **0**
O&M Grade: **0**
Clock Start/From:
Clock To:
1st Value:
2nd Value:
Value Percent:
Continuous Index:
Within 8" of Joint: **NO**
Remarks: **M-707-012**

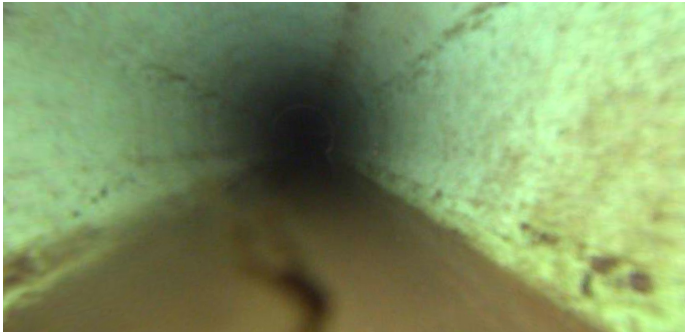
Code:	MWL
Description:	Water Level

Distance (ft):	.0
Structural Grade:	0
O&M Grade:	0
Clock Start/From:	
Clock To:	
1st Value:	
2nd Value:	
Value Percent:	10.000
Continuous Index:	
Within 8" of Joint:	NO
Remarks:

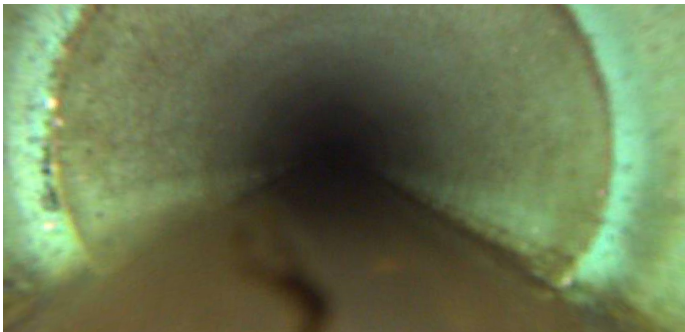
Code:	MSA
Description:	Abandoned Survey

Distance (ft):	17.2
Structural Grade:	0
O&M Grade:	0
Clock Start/From:	
Clock To:	
1st Value:	
2nd Value:	
Value Percent:	
Continuous Index:	
Within 8" of Joint:	NO
Remarks:	debris under water
