Profile/Photo Observation Report

Date:	04/10/2018	Weather:		Coding:	PACP 6.0
Pipe Length (ft):	348.5	Owner:	NA	Pre Clean:	Not Known
P.O.#:		Surveyor:	Jen Costello	PSR:	P-707-011-012
Customer:		Clean Date:	01/01/1900	Shape:	C

Street:	Capitol	Flow Control:	Not Controlled
City:	Hobart, IN	Year Renewed:	
Location:	Light Highway	Tape/Media #:	
Purpose:	Maintenance Related	Dia/Height:	12"
Use:	Sanitary	Material:	PVC
Drain Area:	NA	Lining:	Cured in Place
Category:	NA		
Comment:	Reverse setup. underwater debris at 16'.-flow incorrect.		
Location Details:		Direction of Survey:	Downstream
US MH:	M-707-012	DS MH:	M-707-011
		Total Length Surveyed (ft):	17.2

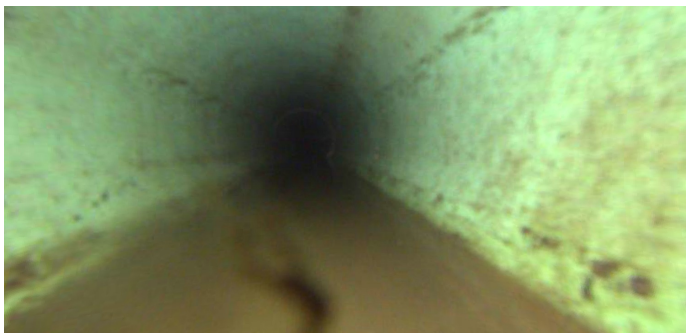
Code: **AMH**
Description: **Manhole**

Distance (ft): **.0**
Structural Grade: **0**
O&M Grade: **0**
Clock Start/From:
Clock To:
1st Value:
2nd Value:
Value Percent:
Continuous Index:
Within 8" of Joint: **NO**
Remarks: **M-707-012**

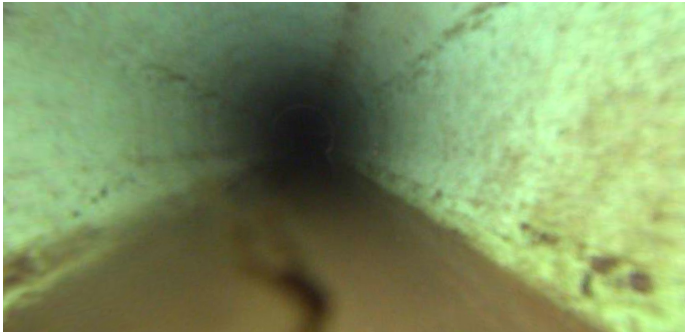
Code:	MWL
Description:	Water Level

Distance (ft):	.0
Structural Grade:	0
O&M Grade:	0
Clock Start/From:	
Clock To:	
1st Value:	
2nd Value:	
Value Percent:	10.000
Continuous Index:	
Within 8" of Joint:	NO
Remarks:

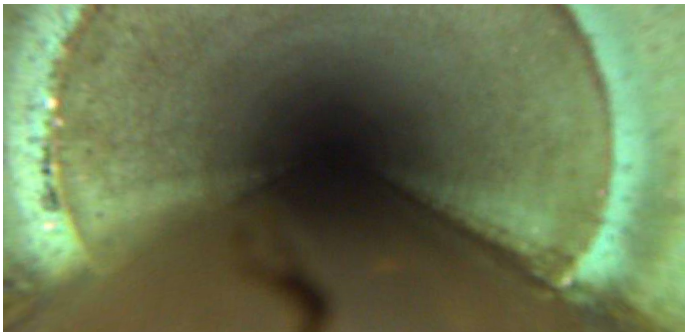
Code:	MSA
Description:	Abandoned Survey

Distance (ft):	17.2
Structural Grade:	0
O&M Grade:	0
Clock Start/From:	
Clock To:	
1st Value:	
2nd Value:	
Value Percent:	
Continuous Index:	
Within 8" of Joint:	NO
Remarks:	debris under water
