Profile/Photo Observation Report

| Street: | GARFIELD ST & E 11TH ST | Flow Control: | Not Controlled |
| City: | Hobart, IN | Year Renewed: | |
| US MH: | M-707-013 | DS MH: | M-707-014 |

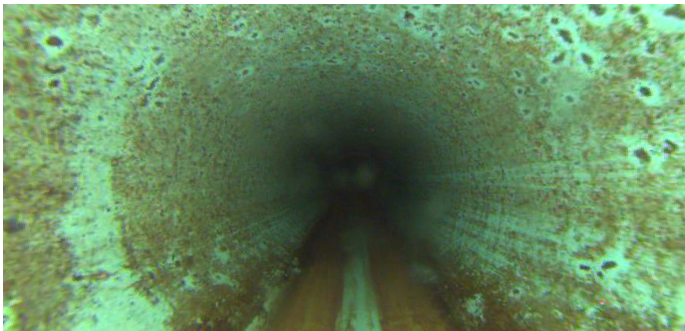
Code: **AMH**
Description: **Manhole**

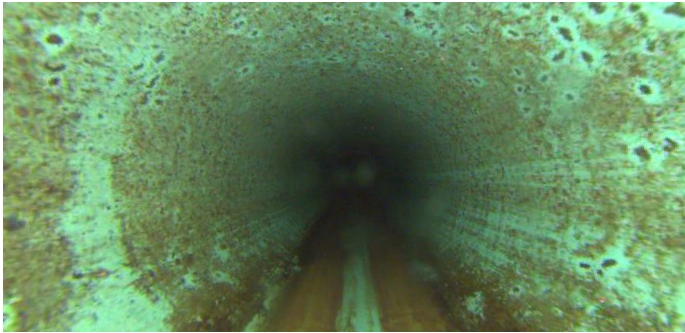
| Code: | MWL |
| Description: | Water Level |

| Distance (ft): | .0 |
| Value Percent: | 5.000 |

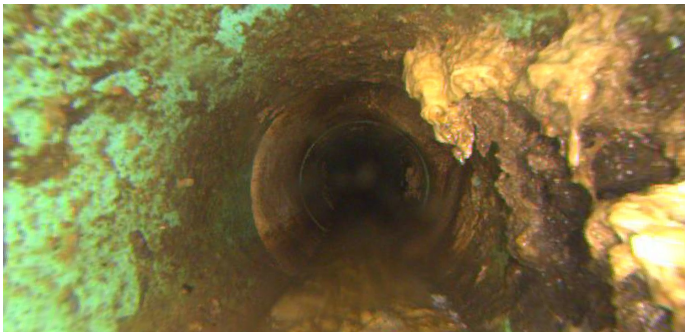
| Code: | DAGS |
| Description: | Deposits Attached Grease |

| Distance (ft): | 9.3 |
| O&M Grade: | 2 |
| Clock Start/From: | 12 |
| Clock To: | 4 |
| Value Percent: | 10.000 |

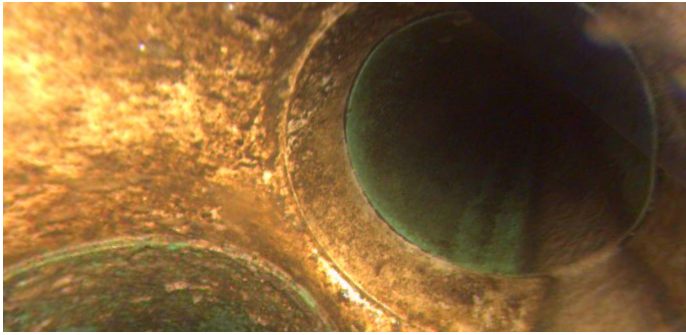
Code: **TFA**
Description: **Tap Factory Active**

Distance (ft): **10.3**
Structural Grade: **0**
O&M Grade: **0**
Clock Start/From: **2**
Clock To:
1st Value: **4.000**
2nd Value:
Value Percent:
Continuous Index:
Within 8" of Joint:
Remarks:

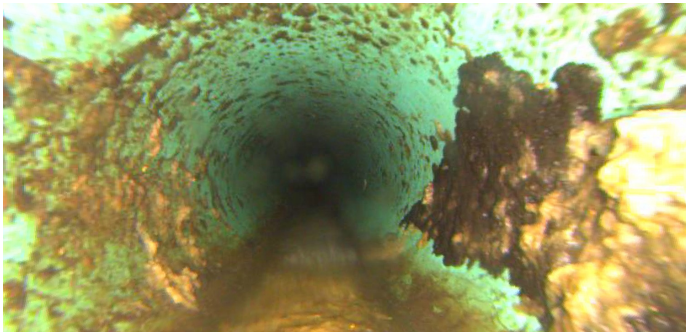
Code: **DAGS**
Description: **Deposits Attached Grease**

Distance (ft): **10.9**
Structural Grade: **0**
O&M Grade: **2**
Clock Start/From: **8**
Clock To: **4**
1st Value:
2nd Value:
Value Percent: **5.000**
Continuous Index:
Within 8" of Joint: **NO**
Remarks:

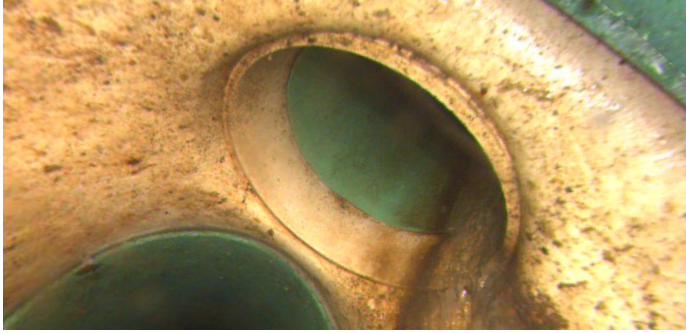
Code: **TF**
Description: **Tap Factory**

Distance (ft): **21.1**
Structural Grade: **0**
O&M Grade: **0**
Clock Start/From: **2**
Clock To:
1st Value: **4.000**
2nd Value:
Value Percent:
Continuous Index:
Within 8" of Joint:
Remarks:

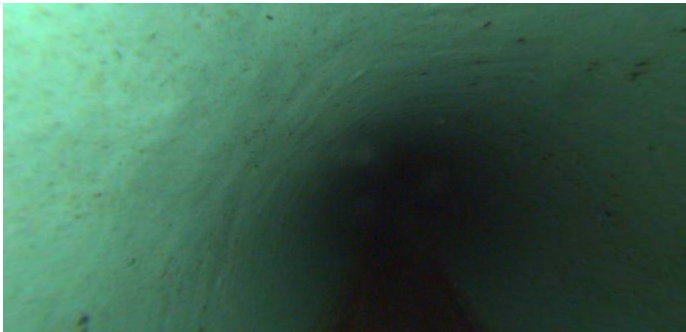
| Comment: | unknown rollover at 54'.-flow incorrect. | | |

Code: **MSA**
Description: **Abandoned Survey**

Distance (ft): **56.0**
Structural Grade: **0**
O&M Grade: **0**
Clock Start/From:
Clock To:
1st Value:
2nd Value:
Value Percent:
Continuous Index:
Within 8" of Joint: **NO**
Remarks: **unknown**
