Profile/Photo Observation Report

Date:	04/13/2018	Weather:		Coding:	PACP 6.0
Pipe Length (ft):	359.4	Owner:	NA	Pre Clean:	Not Known
P.O.#:		Surveyor:	Jen Costello	PSR:	P-707-014-013
Customer:		Clean Date:	01/01/1900	Shape:	C

Street:	Capitol	Flow Control:	Not Controlled
City:	Hobart, IN	Year Renewed:	
Location:	Light Highway	Tape/Media #:	
Purpose:	Maintenance Related	Dia/Height:	8"
Use:	Sanitary	Material:	PVC
Drain Area:	NA	Lining:	Cured in Place
Category:	NA		
Comment:	unknown rollover at 54'.-flow incorrect.		
Location Details:		Direction of Survey:	Upstream
US MH:	M-707-013	DS MH:	M-707-014
		Total Length Surveyed (ft):	56.0

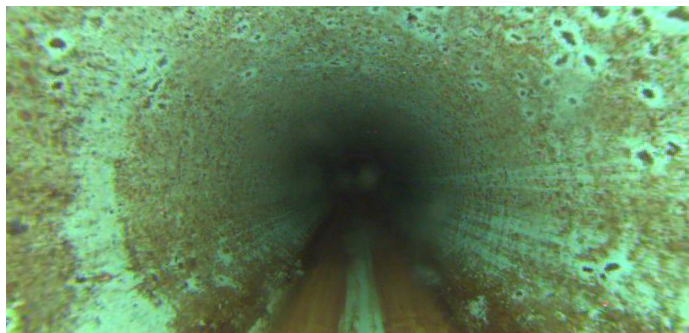
Code: **AMH**
 Description: **Manhole**

Distance (ft): **.0**
 Structural Grade: **0**
 O&M Grade: **0**
 Clock Start/From:
 Clock To:
 1st Value:
 2nd Value:
 Value Percent:
 Continuous Index:
 Within 8" of Joint: **NO**
 Remarks: **M-707-014**

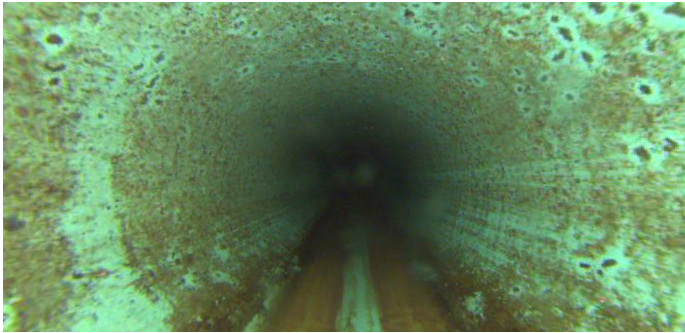
Code:	MWL
Description:	Water Level

Distance (ft):	.0
Structural Grade:	0
O&M Grade:	0
Clock Start/From:	
Clock To:	
1st Value:	
2nd Value:	
Value Percent:	5.000
Continuous Index:	
Within 8" of Joint:	NO
Remarks:

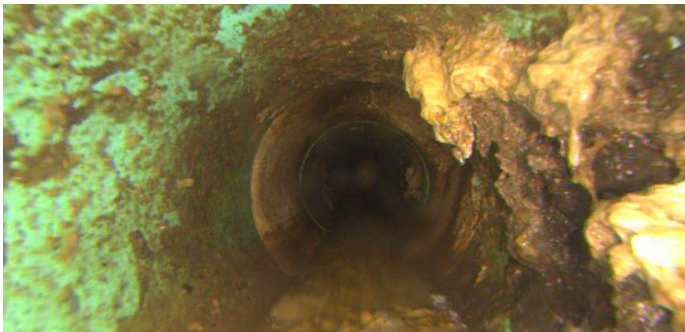
Code:	DAGS
Description:	Deposits Attached Grease

Distance (ft):	9.3
Structural Grade:	0
O&M Grade:	2
Clock Start/From:	12
Clock To:	4
1st Value:	
2nd Value:	
Value Percent:	10.000
Continuous Index:	
Within 8" of Joint:	NO
Remarks:

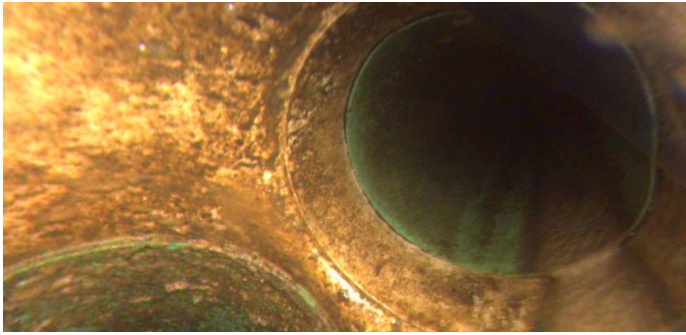
Code: **TFA**
Description: **Tap Factory Active**

Distance (ft): **10.3**
Structural Grade: **0**
O&M Grade: **0**
Clock Start/From: **2**
Clock To:
1st Value: **4.000**
2nd Value:
Value Percent:
Continuous Index:
Within 8" of Joint:
Remarks:

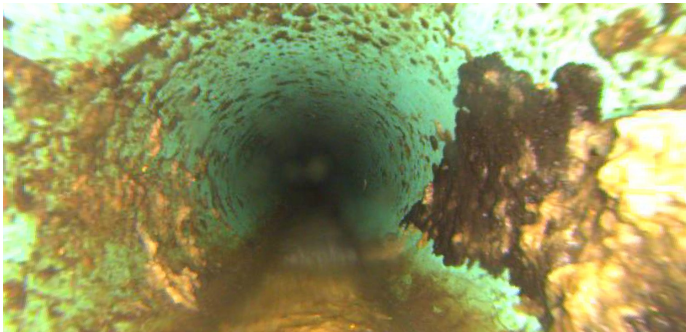
Code: **DAGS**
Description: **Deposits Attached Grease**

Distance (ft): **10.9**
Structural Grade: **0**
O&M Grade: **2**
Clock Start/From: **8**
Clock To: **4**
1st Value:
2nd Value:
Value Percent: **5.000**
Continuous Index:
Within 8" of Joint: **NO**
Remarks:

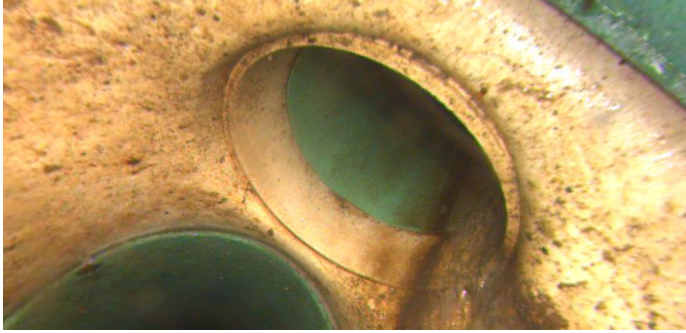
Code: **TF**
Description: **Tap Factory**

Distance (ft): **21.1**
Structural Grade: **0**
O&M Grade: **0**
Clock Start/From: **2**
Clock To:
1st Value: **4.000**
2nd Value:
Value Percent:
Continuous Index:
Within 8" of Joint:
Remarks:

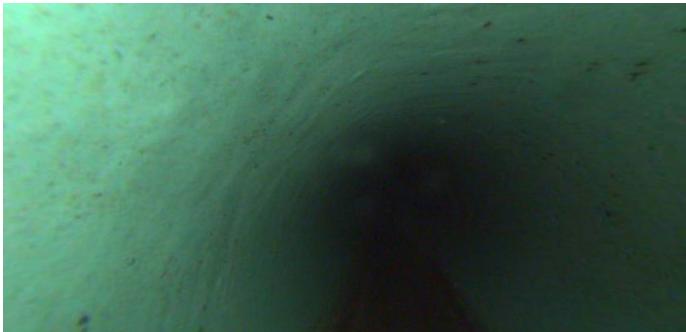
Code: **MSA**
Description: **Abandoned Survey**

Distance (ft): **56.0**
Structural Grade: **0**
O&M Grade: **0**
Clock Start/From:
Clock To:
1st Value:
2nd Value:
Value Percent:
Continuous Index:
Within 8" of Joint: **NO**
Remarks: **unknown**
