Profile/Photo Observation Report

Street:	Capitol	Flow Control:	Not Controlled
City:	Hobart, IN	Year Renewed:	
Location:	Light Highway	Tape/Media #:	
Purpose:	Maintenance Related	Dia/Height:	12"
Use:	Sanitary	Material:	VCP
Drain Area:	NA	Lining:	Cured in Place
Category:	NA		
Comment:	larger than 12" pipe, possible 14".		
Location Details:		Direction of Survey:	Downstream
US MH:	M-707-015	DS MH:	M-707-013
		Total Length Surveyed (ft):	9.9

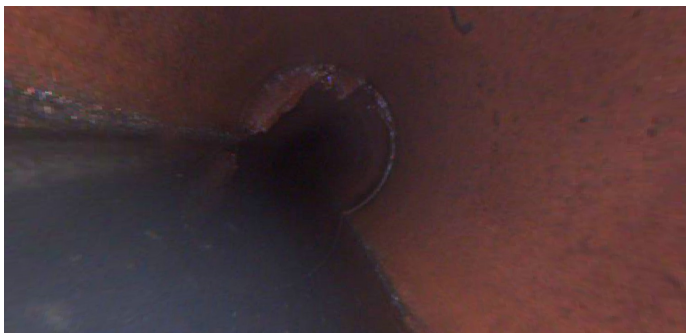
Code: **AMH**
Description: **Manhole**

Distance (ft): **.0**
Structural Grade: **0**
O&M Grade: **0**
Clock Start/From:
Clock To:
1st Value:
2nd Value:
Value Percent:
Continuous Index:
Within 8" of Joint: **NO**
Remarks: **M-707-015**

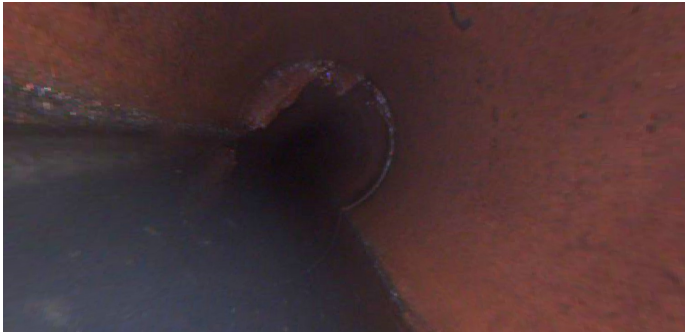
Code:	MWL
Description:	Water Level

Distance (ft):	.0
Structural Grade:	0
O&M Grade:	0
Clock Start/From:	
Clock To:	
1st Value:	
2nd Value:	
Value Percent:	5.000
Continuous Index:	
Within 8" of Joint:	NO
Remarks:

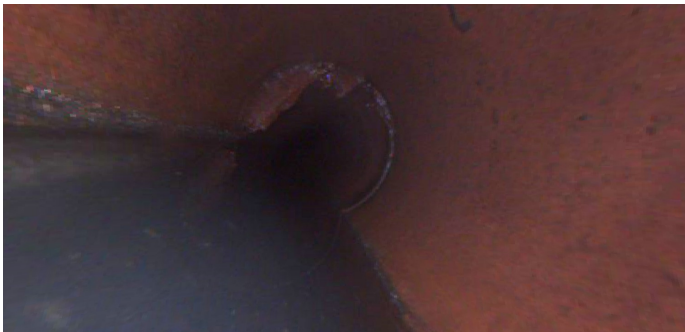
Code:	DAE
Description:	Deposits Attached Encrustation

Distance (ft):	.0
Structural Grade:	0
O&M Grade:	3
Clock Start/From:	7
Clock To:	5
1st Value:	
2nd Value:	
Value Percent:	15.000
Continuous Index:	
Within 8" of Joint:	YES
Remarks:

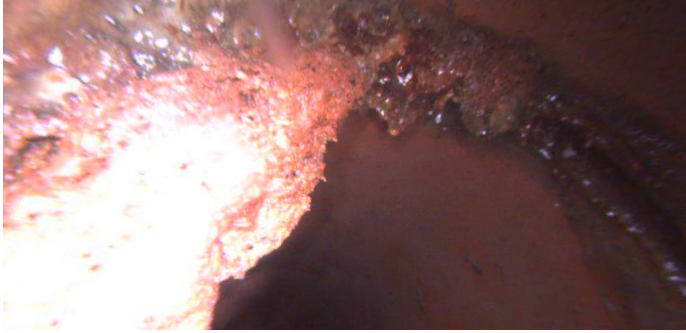
Code: **ID**
Description: **Infil Dripper**

Distance (ft): **2.7**
Structural Grade: **0**
O&M Grade: **3**
Clock Start/From: **11**
Clock To: **1**
1st Value:
2nd Value:
Value Percent:
Continuous Index:
Within 8" of Joint: **YES**
Remarks:
