Profile/Photo Observation Report

Date:	02/09/2022	Weather:		Coding:	PACP 7.0
Pipe Length (ft):	226.8	Owner:	City of Hobart	Pre Clean:	Heavy Cleaning
P.O.#:	YES502259	Surveyor:	S. Bucklin	PSR:	P-707-019-020
Customer:	City of Hobart	Clean Date:	02/09/2022	Shape:	C

Street:	South Lincoln Street	Flow Control:	Not Controlled
City:	Hobart, IN	Year Renewed:	
Location:	Local rural streets with light traffic, t	Tape/Media #:	
Purpose:	Routine Assessment	Dia/Height:	8"
Use:	Sanitary Sewage Pipe	Material:	VCP
Drain Area:		Lining:	None
Category:	NA		
Comment:			
Location Details:		Direction of Survey:	Downstream
US MH:	M-707-020	DS MH:	M-707-019
		Total Length Surveyed (ft):	226.8

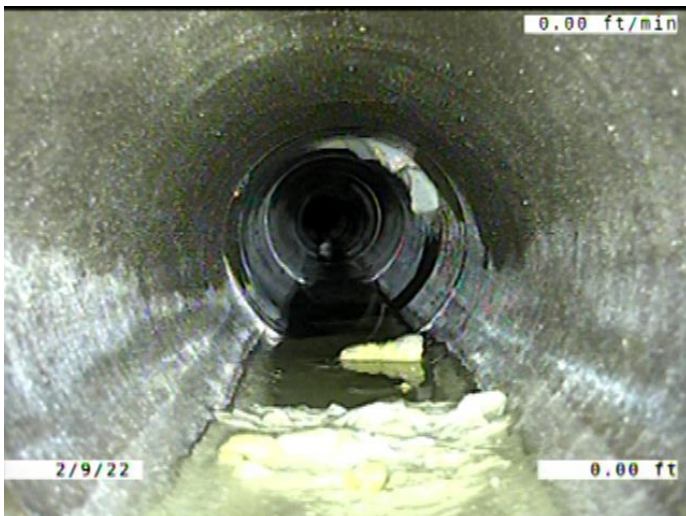
Code: **MWL**
Description: **Miscellaneous Water Level**

Distance (ft): **.0**
Structural Grade: **0**
O&M Grade: **0**
Clock Start/From:
Clock To:
1st Value:
2nd Value:
Value Percent: **5.000**
Continuous Index:
Within 8" of Joint: **NO**
Remarks:

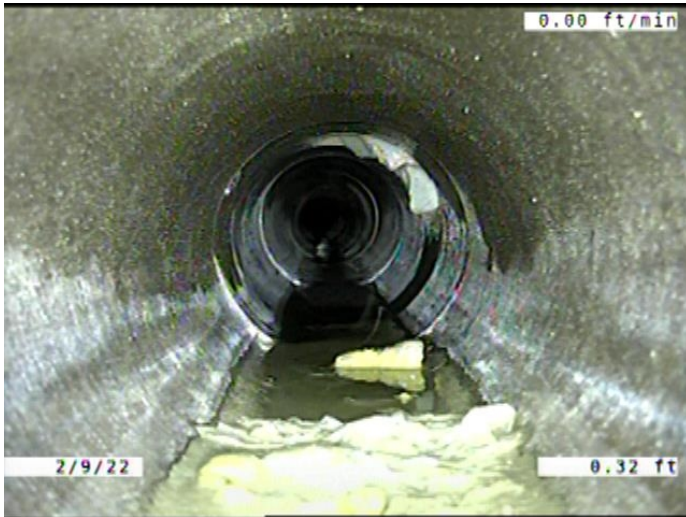
Code: **DSF**
 Description: **Deposits Settled Fine**

Distance (ft): **.3**
 Structural Grade: **0**
 O&M Grade: **2**
 Clock Start/From: **5**
 Clock To: **7**
 1st Value:
 2nd Value:
 Value Percent: **5.000**
 Continuous Index: **S01**
 Within 8" of Joint: **YES**
 Remarks:

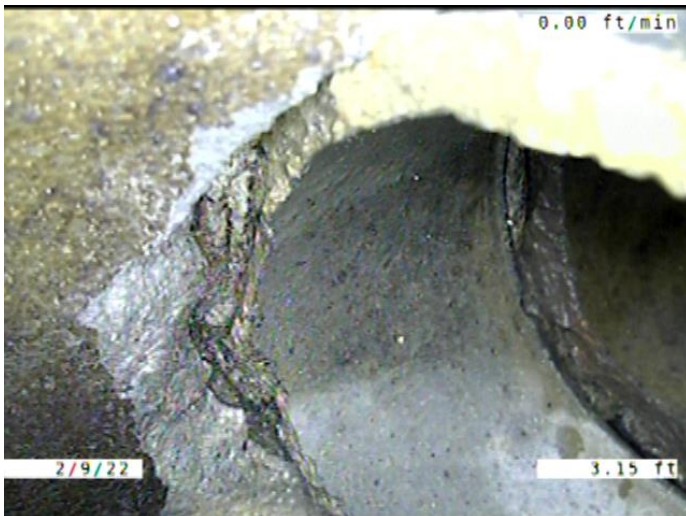
Code: **SSS**
 Description: **Surface Damage Surface Spalling**

Distance (ft): **3.1**
 Structural Grade: **2**
 O&M Grade: **0**
 Clock Start/From: **10**
 Clock To: **4**
 1st Value:
 2nd Value:
 Value Percent:
 Continuous Index:
 Within 8" of Joint: **YES**
 Remarks:

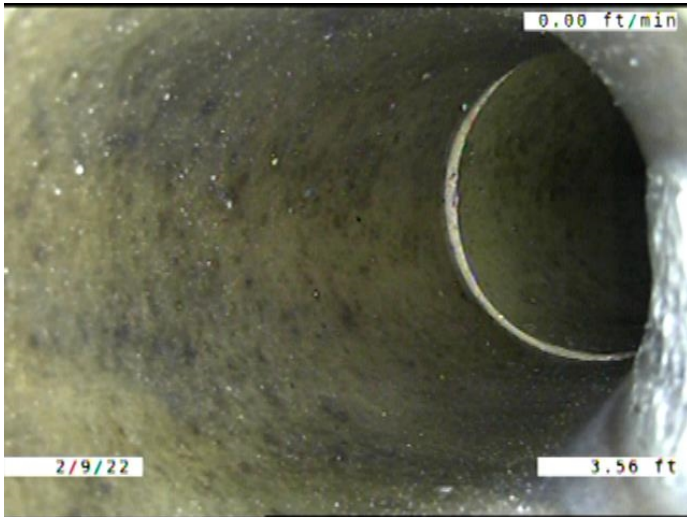
Code: **TBI**
 Description: **Tap Break-in Intruding**

Distance (ft): **3.6**
 Structural Grade: **0**
 O&M Grade: **2**
 Clock Start/From: **2**
 Clock To:
 1st Value: **4.000**
 2nd Value: **2.000**
 Value Percent:
 Continuous Index:
 Within 8" of Joint: **YES**
 Remarks:

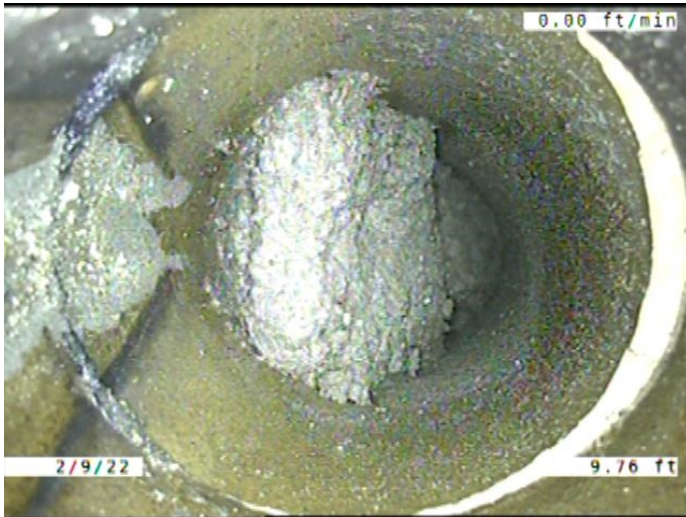
Code: **TF**
 Description: **Tap Factory**

Distance (ft): **9.8**
 Structural Grade: **0**
 O&M Grade: **0**
 Clock Start/From: **9**
 Clock To:
 1st Value: **4.000**
 2nd Value:
 Value Percent:
 Continuous Index:
 Within 8" of Joint: **YES**
 Remarks: **100% PLUGGED**

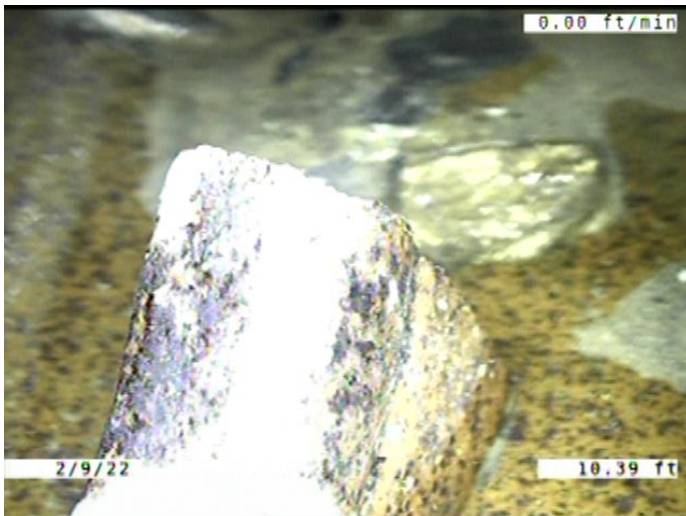
Code: **OBM**
 Description: **Obstruction Pipe Material in Invert**

Distance (ft): **10.4**
 Structural Grade: **0**
 O&M Grade: **2**
 Clock Start/From: **6**
 Clock To: **7**
 1st Value:
 2nd Value:
 Value Percent: **5.000**
 Continuous Index:
 Within 8" of Joint: **YES**
 Remarks:

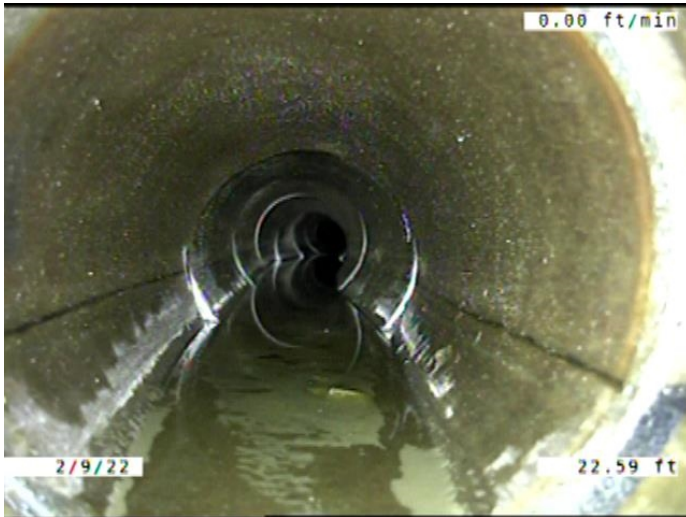
Code: **MWLS**
Description: **Miscellaneous Water Level Sag**

Distance (ft): **22.6**
Structural Grade: **2**
O&M Grade: **0**
Clock Start/From:
Clock To:
1st Value:
2nd Value:
Value Percent: **5.000**
Continuous Index: **S02**
Within 8" of Joint: **NO**
Remarks:

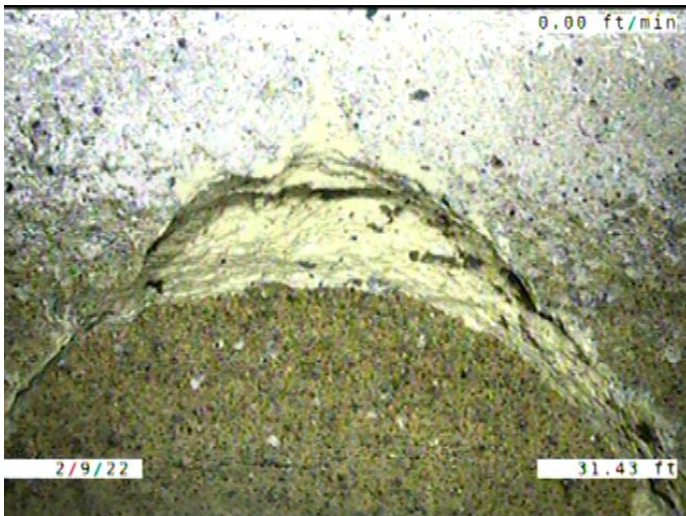
Code: **B**
Description: **Broken**

Distance (ft): **31.4**
Structural Grade: **4**
O&M Grade: **0**
Clock Start/From: **12**
Clock To: **1**
1st Value:
2nd Value:
Value Percent:
Continuous Index:
Within 8" of Joint: **YES**
Remarks:

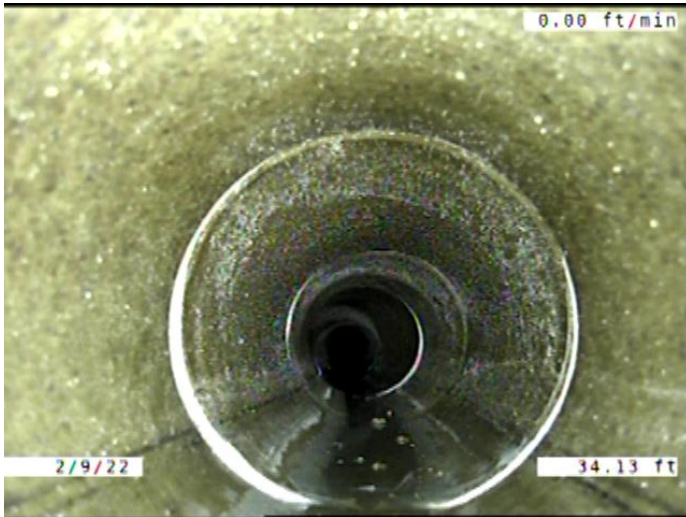
Code: **MWLS**
Description: **Miscellaneous Water Level Sag**

Distance (ft): **34.1**
Structural Grade: **2**
O&M Grade: **0**
Clock Start/From:
Clock To:
1st Value:
2nd Value:
Value Percent: **5.000**
Continuous Index: **F02**
Within 8" of Joint: **NO**
Remarks:

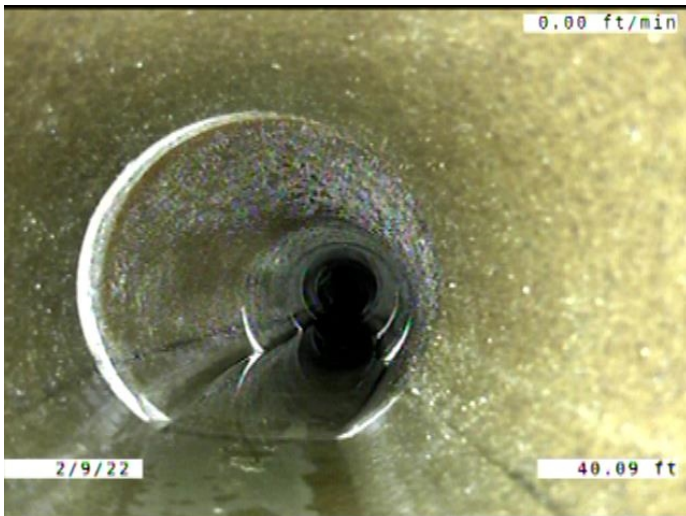
Code: **LL**
Description: **Line Left**

Distance (ft): **40.1**
Structural Grade: **0**
O&M Grade: **1**
Clock Start/From:
Clock To:
1st Value:
2nd Value:
Value Percent: **5.000**
Continuous Index:
Within 8" of Joint: **NO**
Remarks:

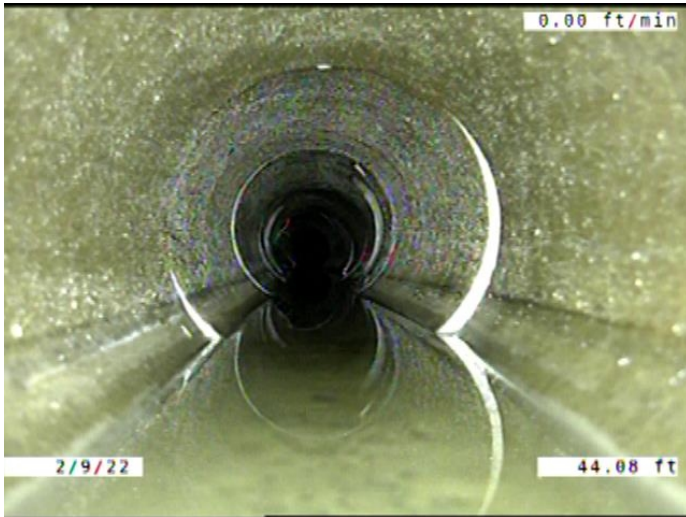
Code: **MWLS**
 Description: **Miscellaneous Water Level Sag**

Distance (ft): **44.1**
 Structural Grade: **2**
 O&M Grade: **0**
 Clock Start/From:
 Clock To:
 1st Value:
 2nd Value:
 Value Percent: **5.000**
 Continuous Index: **S03**
 Within 8" of Joint: **NO**
 Remarks:

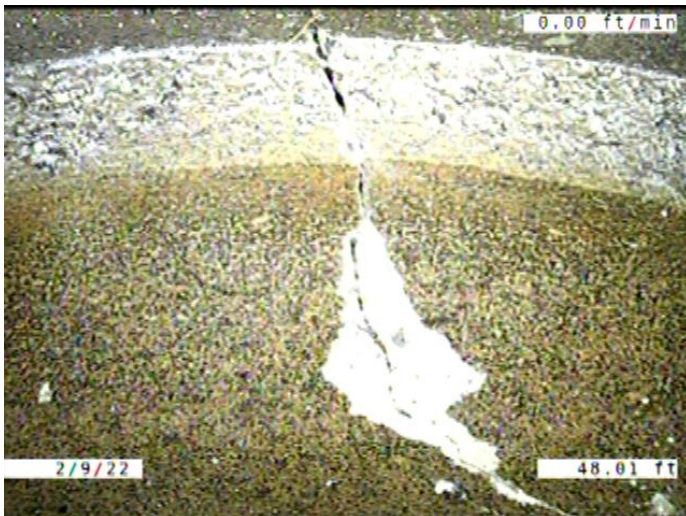
Code: **CC**
 Description: **Crack Circumferential**

Distance (ft): **48.0**
 Structural Grade: **1**
 O&M Grade: **0**
 Clock Start/From: **1**
 Clock To: **3**
 1st Value:
 2nd Value:
 Value Percent:
 Continuous Index:
 Within 8" of Joint: **YES**
 Remarks:

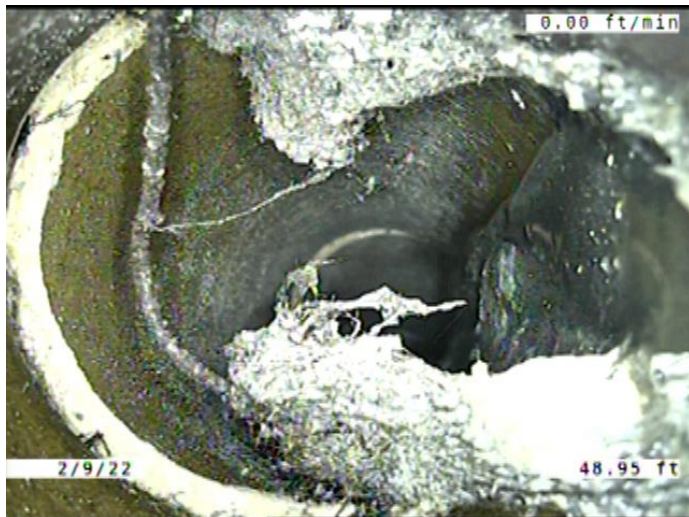
Code:	TF
Description:	Tap Factory
Distance (ft):	49.0
Structural Grade:	0
O&M Grade:	0
Clock Start/From:	3
Clock To:	
1st Value:	4.000
2nd Value:	
Value Percent:	
Continuous Index:	
Within 8" of Joint:	YES
Remarks:	ROOTS GROWING FROM THE SERVICE TO MAIN CONNECTION.

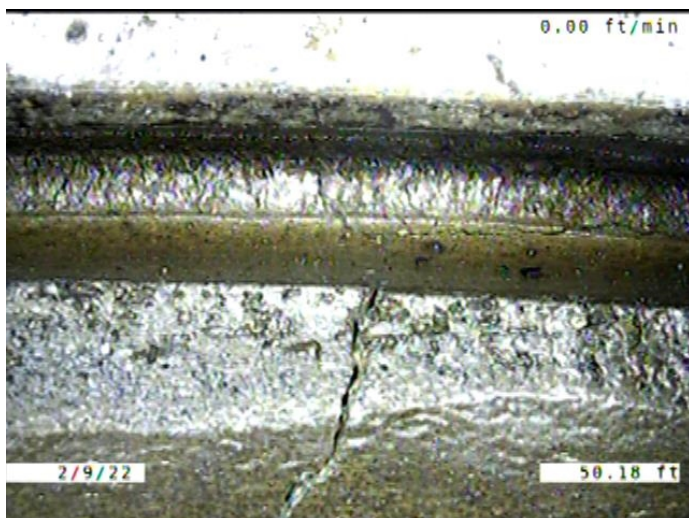
Code:	CM
Description:	Crack Multiple
Distance (ft):	50.2
Structural Grade:	3
O&M Grade:	0
Clock Start/From:	10
Clock To:	12
1st Value:	
2nd Value:	
Value Percent:	
Continuous Index:	
Within 8" of Joint:	YES
Remarks:

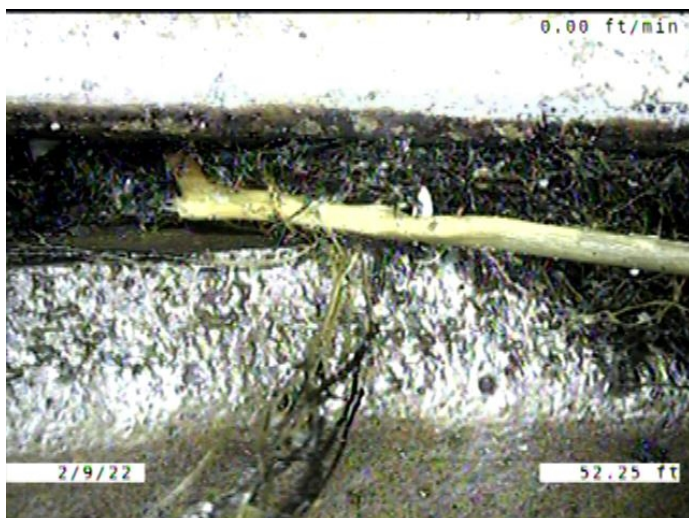
Code: **RFJ**
 Description: **Roots Fine Joint**

Distance (ft): **52.2**
 Structural Grade: **0**
 O&M Grade: **1**
 Clock Start/From: **9**
 Clock To: **11**
 1st Value:
 2nd Value:
 Value Percent:
 Continuous Index:
 Within 8" of Joint: **YES**
 Remarks:

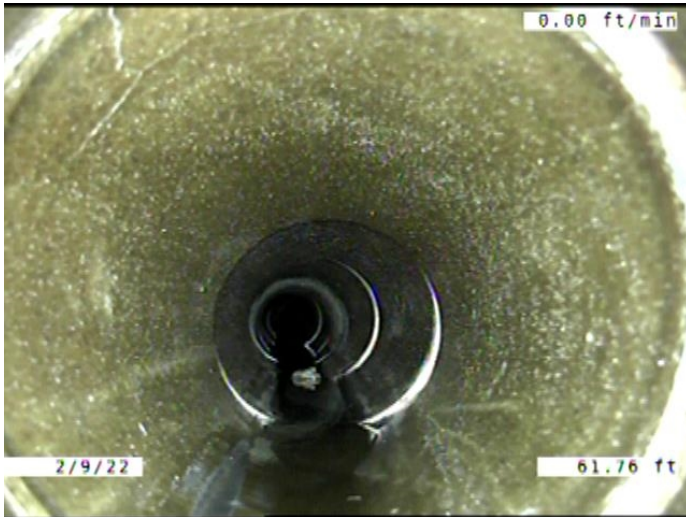
Code: **MWLS**
Description: **Miscellaneous Water Level Sag**

Distance (ft): **61.8**
Structural Grade: **2**
O&M Grade: **0**
Clock Start/From:
Clock To:
1st Value:
2nd Value:
Value Percent: **5.000**
Continuous Index: **F03**
Within 8" of Joint: **NO**
Remarks:

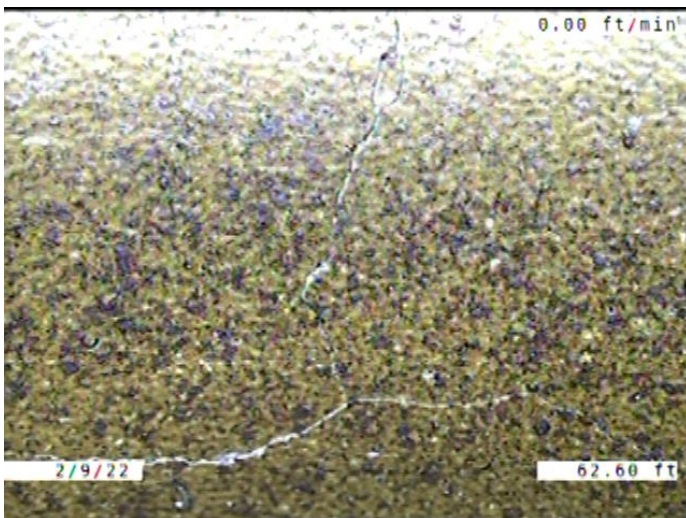
Code: **CM**
Description: **Crack Multiple**

Distance (ft): **62.6**
Structural Grade: **3**
O&M Grade: **0**
Clock Start/From: **9**
Clock To: **1**
1st Value:
2nd Value:
Value Percent:
Continuous Index:
Within 8" of Joint: **YES**
Remarks:

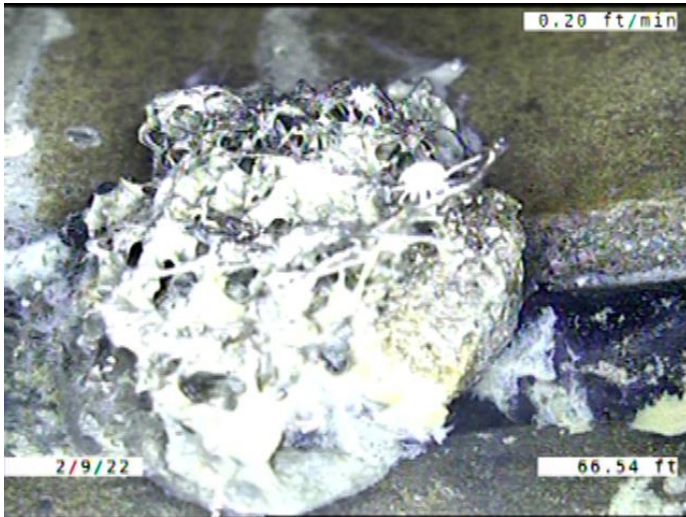
Code: **OBZ**
 Description: **Obstruction Other**

Distance (ft): **66.5**
 Structural Grade: **0**
 O&M Grade: **2**
 Clock Start/From: **6**
 Clock To:
 1st Value:
 2nd Value:
 Value Percent: **5.000**
 Continuous Index:
 Within 8" of Joint: **YES**
 Remarks: **ROOTS THAT HAVE BEEN CUT**

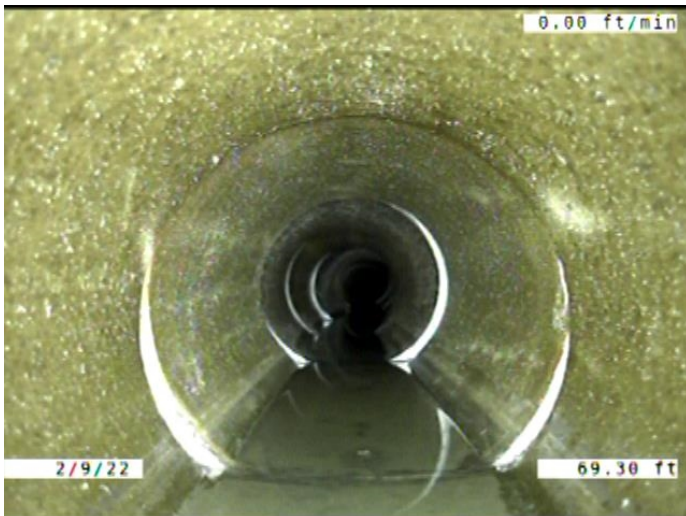
Code: **MWLS**
 Description: **Miscellaneous Water Level Sag**

Distance (ft): **69.3**
 Structural Grade: **2**
 O&M Grade: **0**
 Clock Start/From:
 Clock To:
 1st Value:
 2nd Value:
 Value Percent: **5.000**
 Continuous Index: **S04**
 Within 8" of Joint: **NO**
 Remarks:

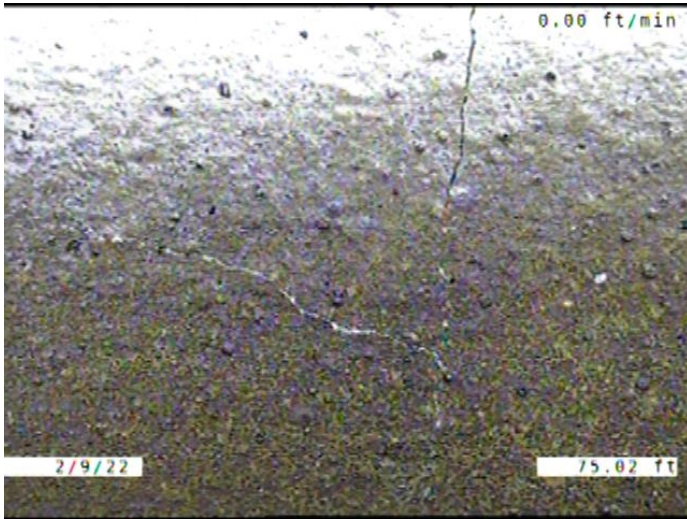
Code: **CM**
Description: **Crack Multiple**

Distance (ft): **75.0**
Structural Grade: **3**
O&M Grade: **0**
Clock Start/From: **9**
Clock To: **2**
1st Value:
2nd Value:
Value Percent:
Continuous Index:
Within 8" of Joint: **YES**
Remarks:

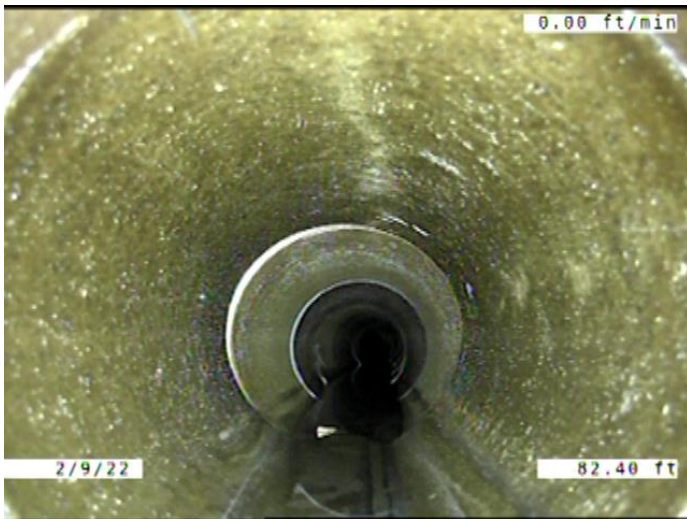
Code: **MWLS**
Description: **Miscellaneous Water Level Sag**

Distance (ft): **82.4**
Structural Grade: **2**
O&M Grade: **0**
Clock Start/From:
Clock To:
1st Value:
2nd Value:
Value Percent: **5.000**
Continuous Index: **F04**
Within 8" of Joint: **NO**
Remarks:

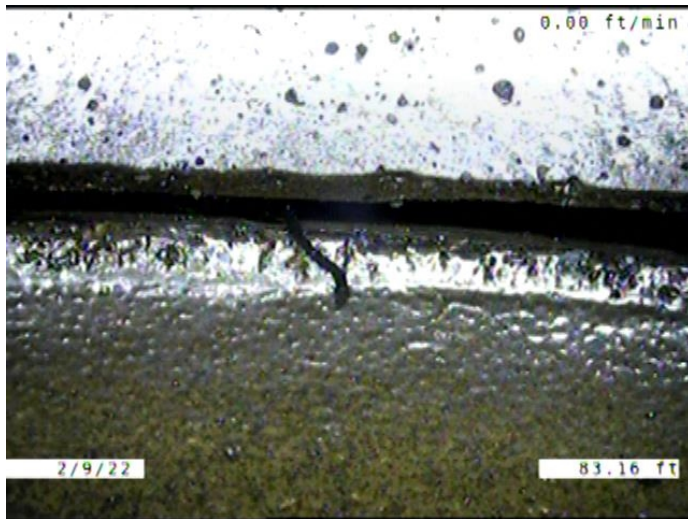
Code: **RFJ**
 Description: **Roots Fine Joint**

Distance (ft): **83.2**
 Structural Grade: **0**
 O&M Grade: **1**
 Clock Start/From: **11**
 Clock To:
 1st Value:
 2nd Value:
 Value Percent:
 Continuous Index:
 Within 8" of Joint: **YES**
 Remarks:

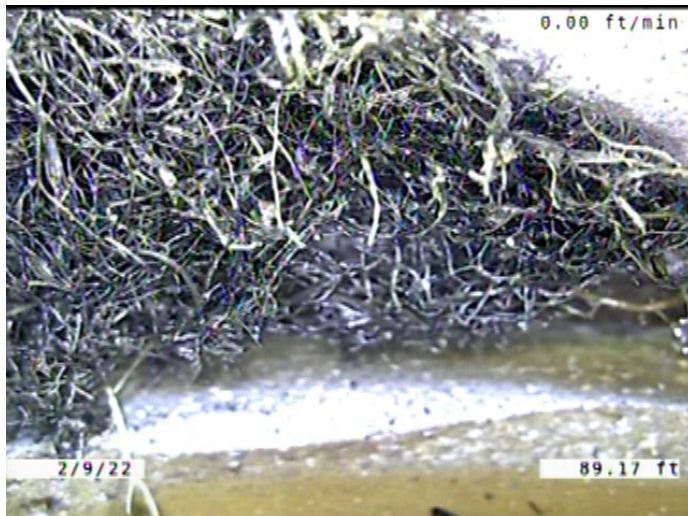
Code: **RFJ**
 Description: **Roots Fine Joint**

Distance (ft): **89.2**
 Structural Grade: **0**
 O&M Grade: **1**
 Clock Start/From: **8**
 Clock To: **10**
 1st Value:
 2nd Value:
 Value Percent:
 Continuous Index:
 Within 8" of Joint: **YES**
 Remarks:

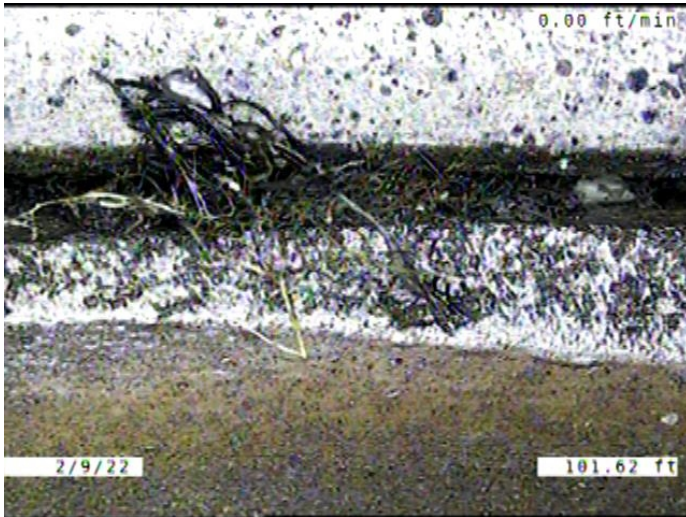
Code: **RFJ**
Description: **Roots Fine Joint**

Distance (ft): **101.6**
Structural Grade: **0**
O&M Grade: **1**
Clock Start/From: **8**
Clock To: **10**
1st Value:
2nd Value:
Value Percent:
Continuous Index:
Within 8" of Joint: **YES**
Remarks:

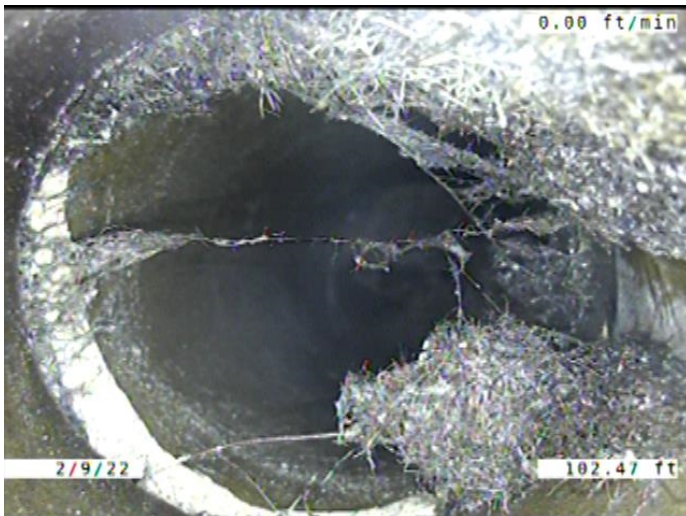
Code: **TF**
Description: **Tap Factory**

Distance (ft): **102.5**
Structural Grade: **0**
O&M Grade: **0**
Clock Start/From: **3**
Clock To:
1st Value: **4.000**
2nd Value:
Value Percent:
Continuous Index:
Within 8" of Joint: **YES**
Remarks: **ROOTS GROWING FROM THE SERVICE TO MAIN CONNECTION.**

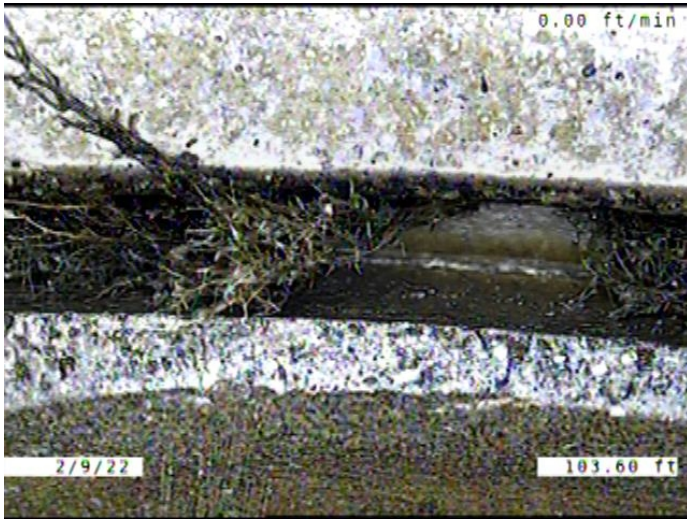
Code: **RFJ**
 Description: **Roots Fine Joint**

Distance (ft): **103.6**
 Structural Grade: **0**
 O&M Grade: **1**
 Clock Start/From: **8**
 Clock To: **10**
 1st Value:
 2nd Value:
 Value Percent:
 Continuous Index:
 Within 8" of Joint: **YES**
 Remarks:

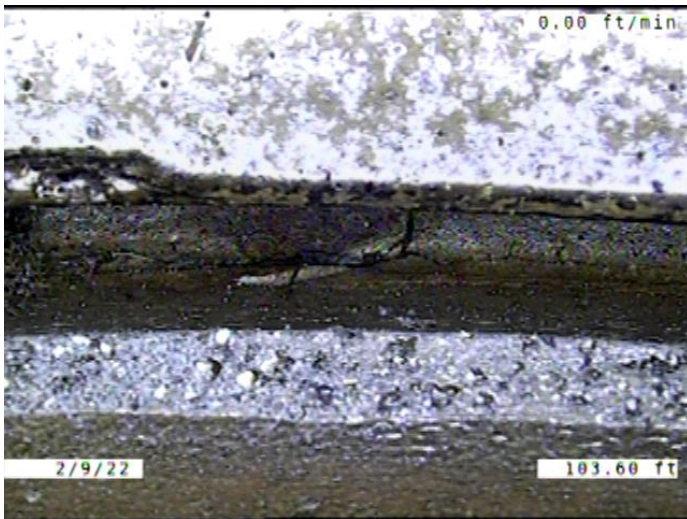
Code: **FM**
 Description: **Fracture Multiple**

Distance (ft): **103.6**
 Structural Grade: **4**
 O&M Grade: **0**
 Clock Start/From: **10**
 Clock To: **12**
 1st Value:
 2nd Value:
 Value Percent:
 Continuous Index:
 Within 8" of Joint: **YES**
 Remarks:

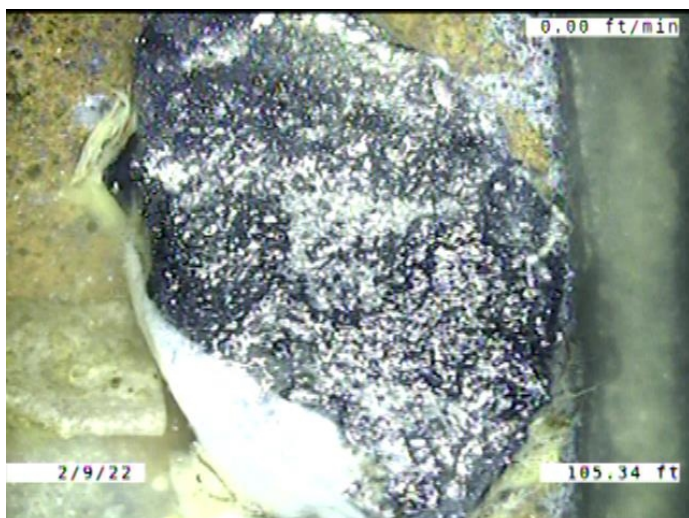
Code: **OBN**
 Description: **Obstruction Construction Debris**

Distance (ft): **105.3**
 Structural Grade: **0**
 O&M Grade: **2**
 Clock Start/From: **6**
 Clock To:
 1st Value:
 2nd Value:
 Value Percent: **5.000**
 Continuous Index:
 Within 8" of Joint: **YES**
 Remarks:

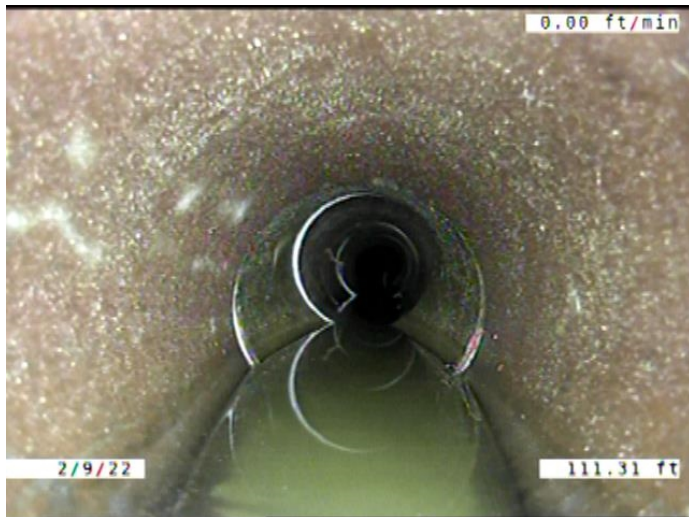
Code: **MWLS**
 Description: **Miscellaneous Water Level Sag**

Distance (ft): **111.3**
 Structural Grade: **2**
 O&M Grade: **0**
 Clock Start/From:
 Clock To:
 1st Value:
 2nd Value:
 Value Percent: **10.000**
 Continuous Index: **S05**
 Within 8" of Joint: **NO**
 Remarks:

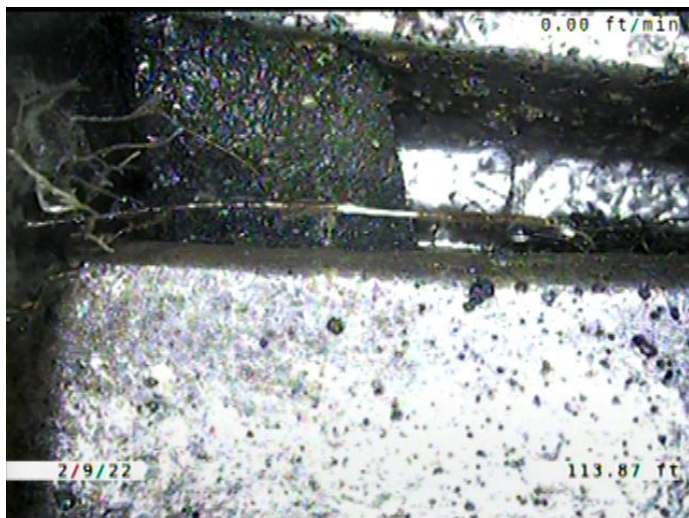
Code: **RFJ**
 Description: **Roots Fine Joint**

Distance (ft): **113.9**
 Structural Grade: **0**
 O&M Grade: **1**
 Clock Start/From: **3**
 Clock To: **4**
 1st Value:
 2nd Value:
 Value Percent:
 Continuous Index:
 Within 8" of Joint: **YES**
 Remarks:

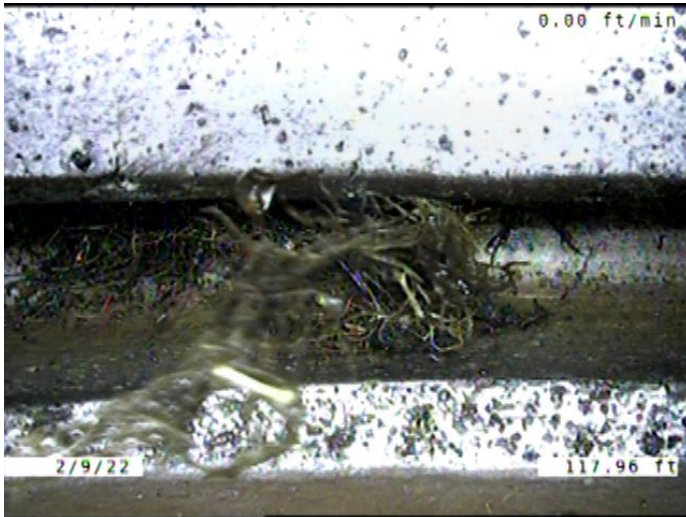
Code: **RFJ**
 Description: **Roots Fine Joint**

Distance (ft): **118.0**
 Structural Grade: **0**
 O&M Grade: **1**
 Clock Start/From: **9**
 Clock To: **10**
 1st Value:
 2nd Value:
 Value Percent:
 Continuous Index:
 Within 8" of Joint: **YES**
 Remarks:

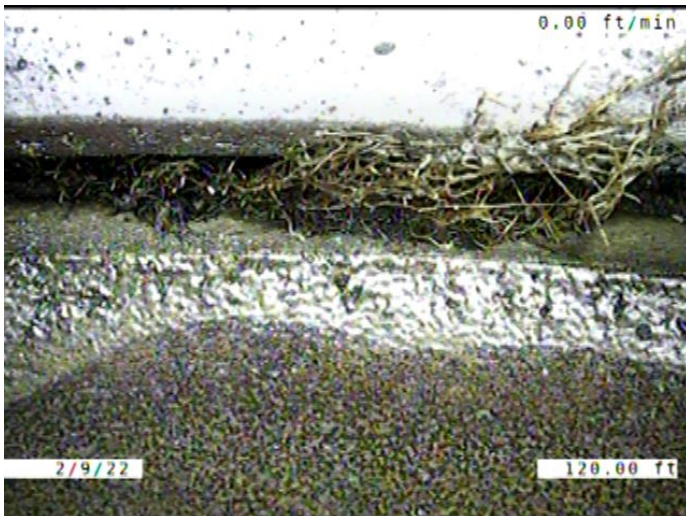
Code: **RFJ**
 Description: **Roots Fine Joint**

Distance (ft): **120.0**
 Structural Grade: **0**
 O&M Grade: **1**
 Clock Start/From: **2**
 Clock To: **3**
 1st Value:
 2nd Value:
 Value Percent:
 Continuous Index:
 Within 8" of Joint: **YES**
 Remarks:

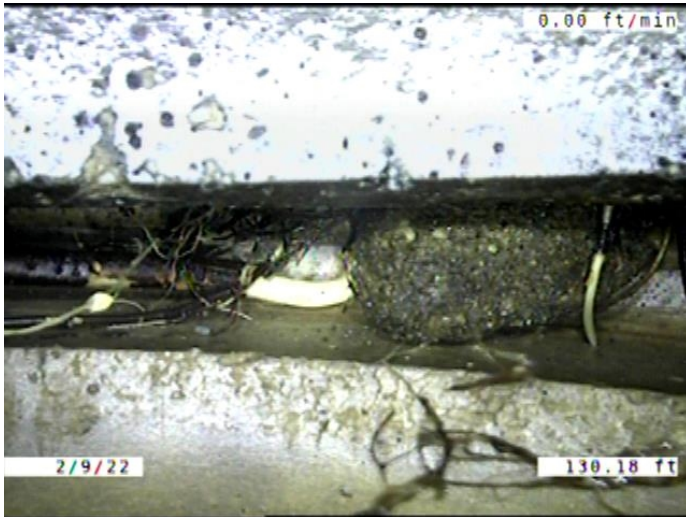
Code: **RFJ**
Description: **Roots Fine Joint**

Distance (ft): **130.2**
Structural Grade: **0**
O&M Grade: **1**
Clock Start/From: **9**
Clock To: **1**
1st Value:
2nd Value:
Value Percent:
Continuous Index:
Within 8" of Joint: **YES**
Remarks:

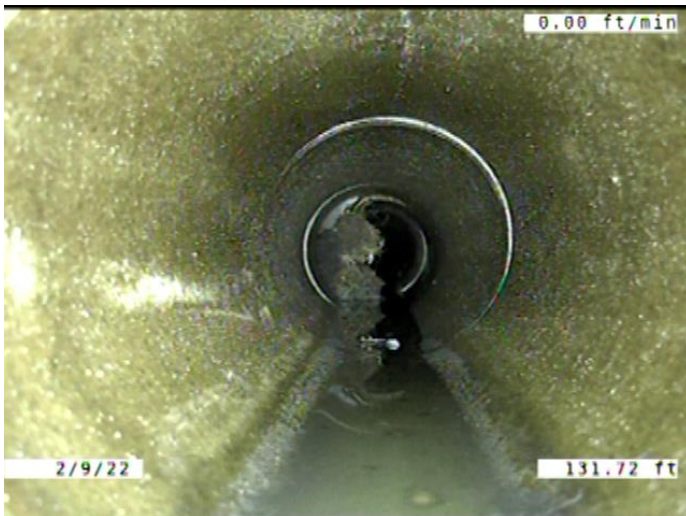
Code: **MWLS**
Description: **Miscellaneous Water Level Sag**

Distance (ft): **131.7**
Structural Grade: **2**
O&M Grade: **0**
Clock Start/From:
Clock To:
1st Value:
2nd Value:
Value Percent: **10.000**
Continuous Index: **F05**
Within 8" of Joint: **NO**
Remarks:

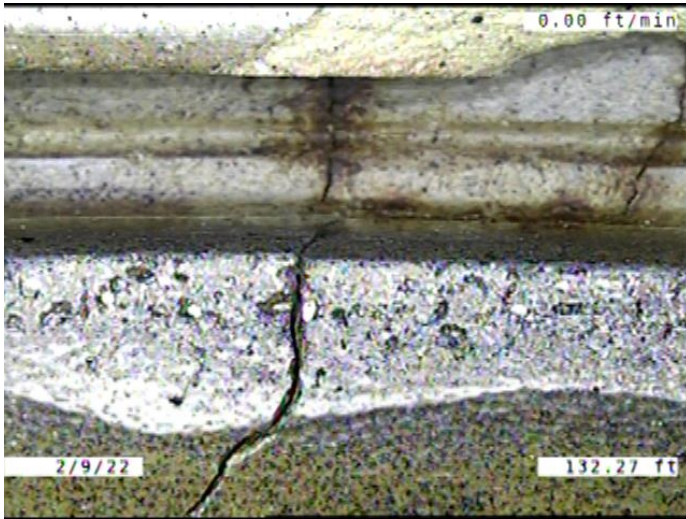
Code: **B**
 Description: **Broken**

Distance (ft): **132.3**
 Structural Grade: **4**
 O&M Grade: **0**
 Clock Start/From: **9**
 Clock To: **1**
 1st Value:
 2nd Value:
 Value Percent:
 Continuous Index:
 Within 8" of Joint: **YES**
 Remarks:

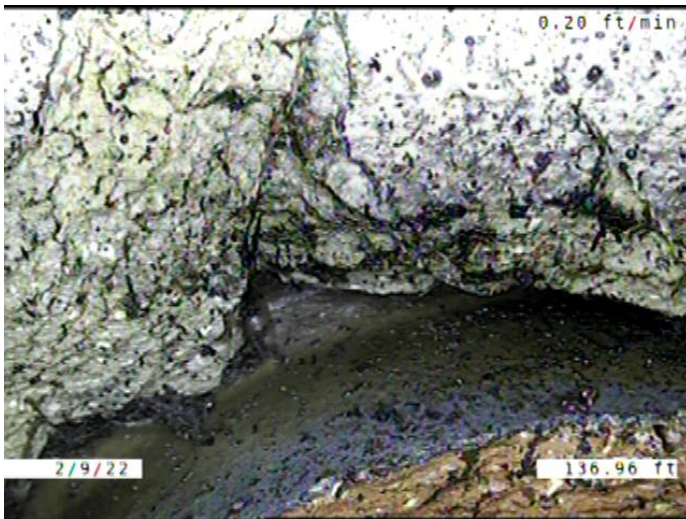
Code: **SSS**
 Description: **Surface Damage Surface Spalling**

Distance (ft): **137.0**
 Structural Grade: **2**
 O&M Grade: **0**
 Clock Start/From: **9**
 Clock To: **1**
 1st Value:
 2nd Value:
 Value Percent:
 Continuous Index:
 Within 8" of Joint: **YES**
 Remarks:

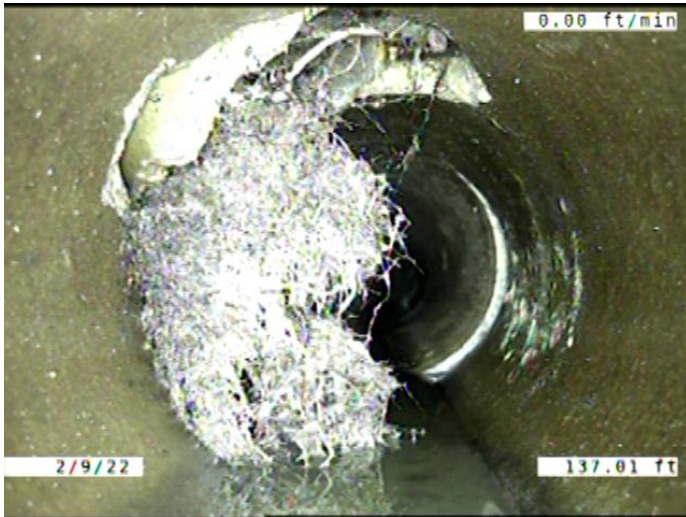
Code: **RML**
 Description: **Roots Medium Lateral**

Distance (ft): **137.0**
 Structural Grade: **0**
 O&M Grade: **3**
 Clock Start/From: **9**
 Clock To: **1**
 1st Value:
 2nd Value:
 Value Percent: **35.000**
 Continuous Index:
 Within 8" of Joint: **NO**
 Remarks:

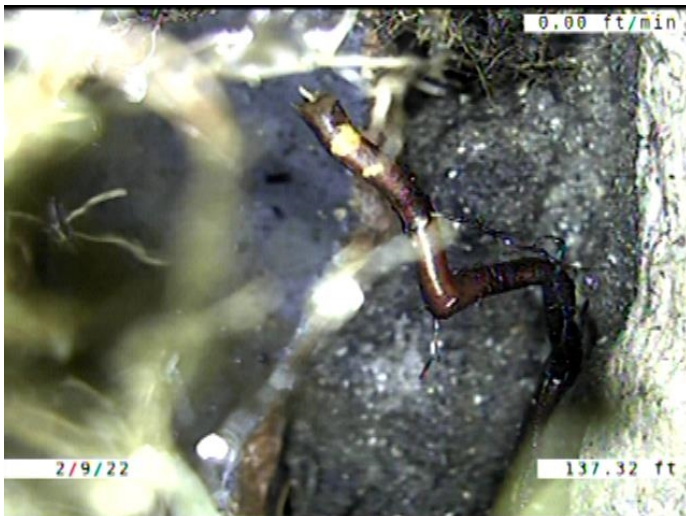
Code: **TBD**
 Description: **Tap Break-in/Hammer Defective**

Distance (ft): **137.3**
 Structural Grade: **0**
 O&M Grade: **3**
 Clock Start/From: **11**
 Clock To:
 1st Value: **4.000**
 2nd Value:
 Value Percent:
 Continuous Index:
 Within 8" of Joint: **YES**
 Remarks: **ROOTS GROWING FROM THE SERVICE TO MAIN CONNECTION. AL**

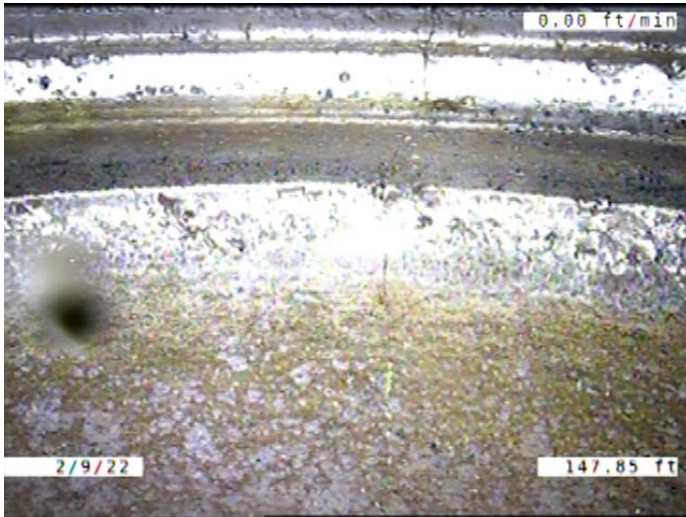
Code: **CL**
Description: **Crack Longitudinal**

Distance (ft): **147.8**
Structural Grade: **2**
O&M Grade: **0**
Clock Start/From: **1**
Clock To:
1st Value:
2nd Value:
Value Percent:
Continuous Index:
Within 8" of Joint: **YES**
Remarks:

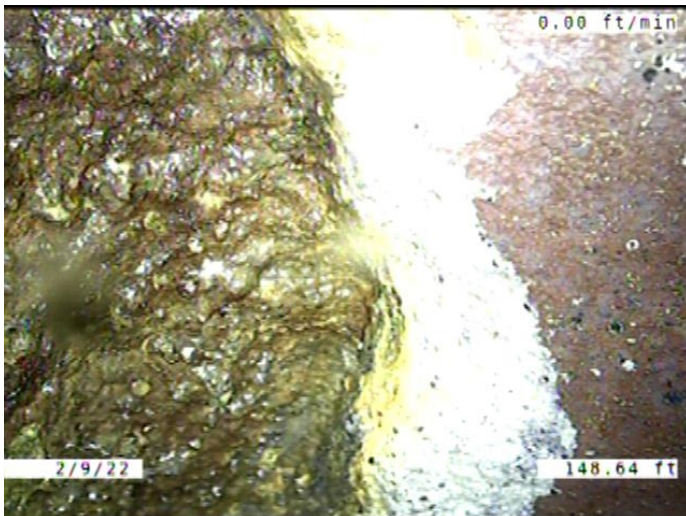
Code: **H**
Description: **Hole**

Distance (ft): **148.6**
Structural Grade: **5**
O&M Grade: **0**
Clock Start/From: **11**
Clock To: **1**
1st Value:
2nd Value:
Value Percent:
Continuous Index:
Within 8" of Joint: **YES**
Remarks:

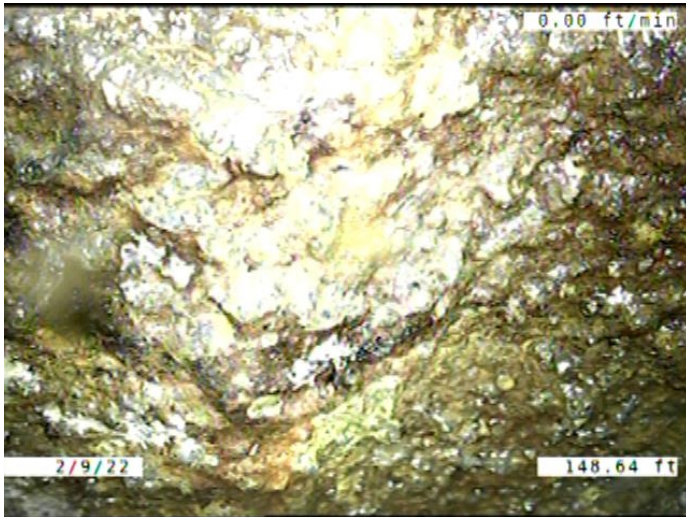
Code: **RPP**
 Description: **Point Repair Patch**

Distance (ft): **148.6**
 Structural Grade: **0**
 O&M Grade: **0**
 Clock Start/From: **11**
 Clock To: **1**
 1st Value:
 2nd Value:
 Value Percent:
 Continuous Index:
 Within 8" of Joint: **YES**
 Remarks: **LOOKS TO HAVE BEEN REPAIRED WITH CAST IRON PIPE**

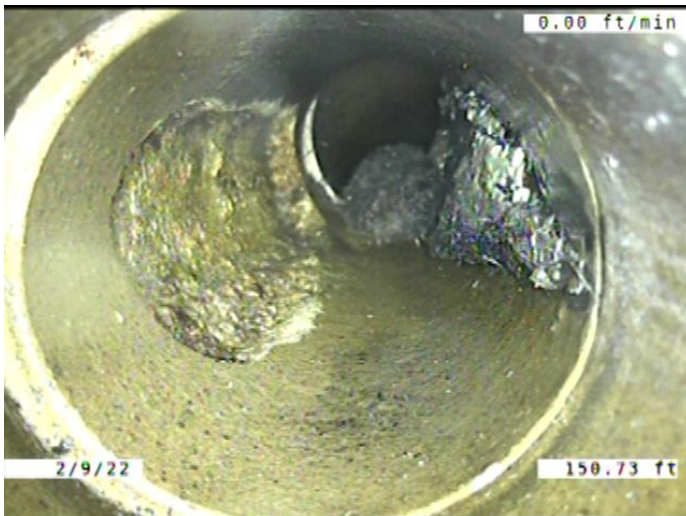
Code: **TFD**
 Description: **Tap Factory Defective**

Distance (ft): **150.7**
 Structural Grade: **0**
 O&M Grade: **3**
 Clock Start/From: **3**
 Clock To:
 1st Value: **4.000**
 2nd Value:
 Value Percent:
 Continuous Index:
 Within 8" of Joint: **YES**
 Remarks: **TAP BROKEN. SERVICE LINE HAS A HOLE IN IT AND ROOTS GROWING IN**

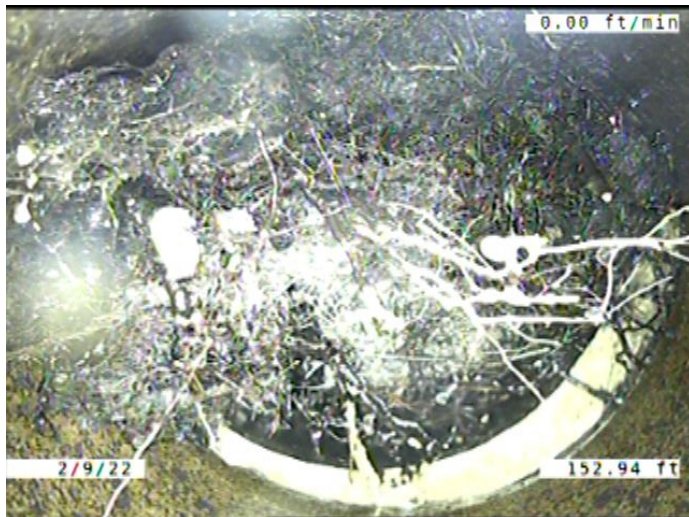
Code: **TF**
Description: **Tap Factory**

Distance (ft): **152.9**
Structural Grade: **0**
O&M Grade: **0**
Clock Start/From: **9**
Clock To:
1st Value: **4.000**
2nd Value:
Value Percent:
Continuous Index:
Within 8" of Joint: **YES**
Remarks: **ROOTS GROWING FROM THE SERVICE TO MAIN CONNECTION. LO**

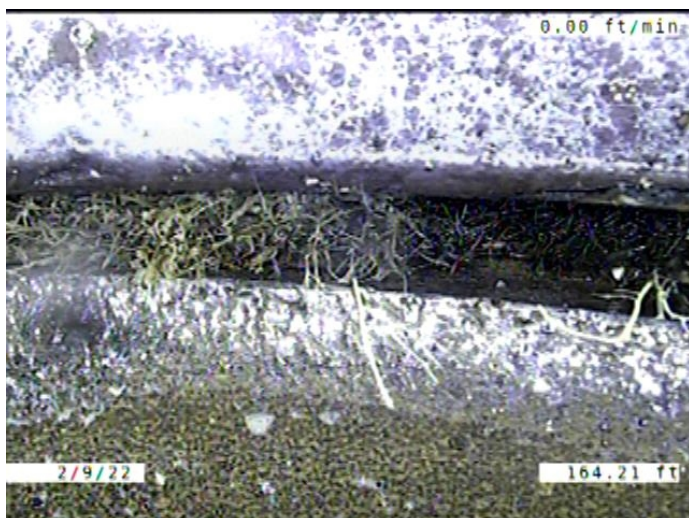
Code: **RFJ**
Description: **Roots Fine Joint**

Distance (ft): **164.2**
Structural Grade: **0**
O&M Grade: **1**
Clock Start/From: **1**
Clock To: **4**
1st Value:
2nd Value:
Value Percent:
Continuous Index:
Within 8" of Joint: **YES**
Remarks:

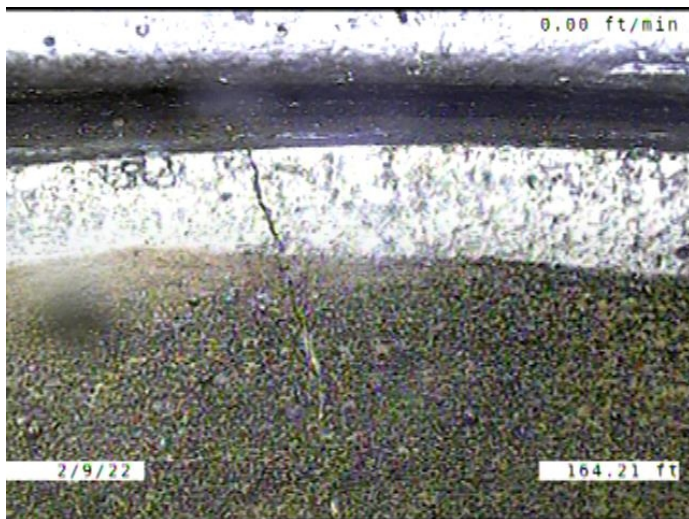
Code: **CM**
 Description: **Crack Multiple**

Distance (ft): **164.2**
 Structural Grade: **3**
 O&M Grade: **0**
 Clock Start/From: **9**
 Clock To: **1**
 1st Value:
 2nd Value:
 Value Percent:
 Continuous Index:
 Within 8" of Joint: **YES**
 Remarks:

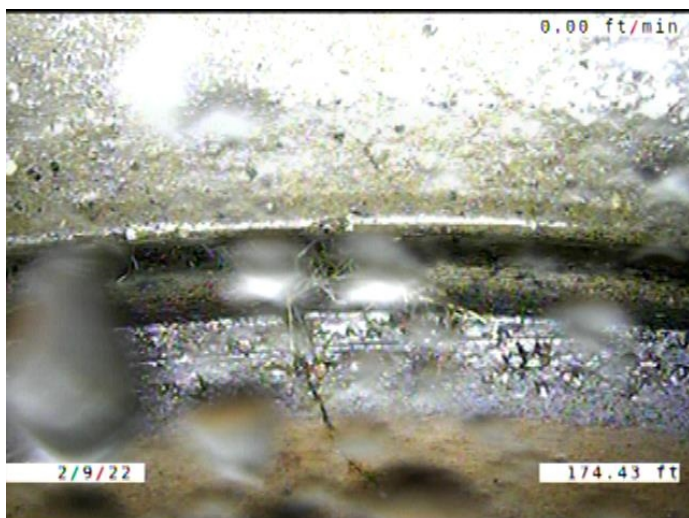
Code: **RFJ**
 Description: **Roots Fine Joint**

Distance (ft): **174.4**
 Structural Grade: **0**
 O&M Grade: **1**
 Clock Start/From: **10**
 Clock To: **11**
 1st Value:
 2nd Value:
 Value Percent:
 Continuous Index:
 Within 8" of Joint: **YES**
 Remarks:

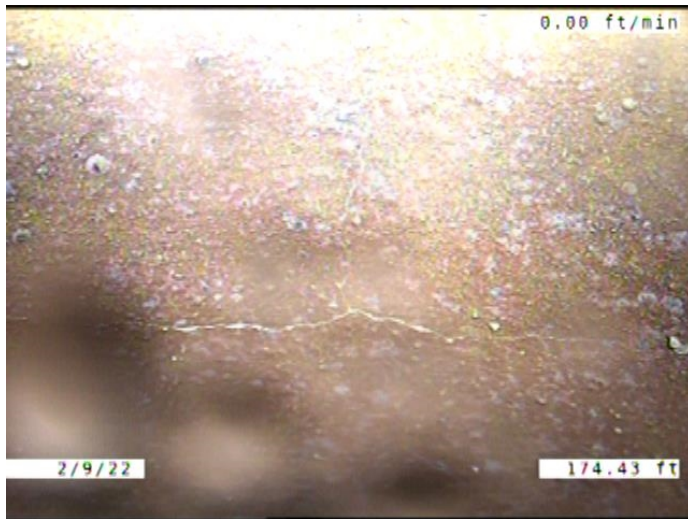
Code: **CM**
Description: **Crack Multiple**

Distance (ft): **174.4**
Structural Grade: **3**
O&M Grade: **0**
Clock Start/From: **10**
Clock To: **2**
1st Value:
2nd Value:
Value Percent:
Continuous Index:
Within 8" of Joint: **YES**
Remarks:

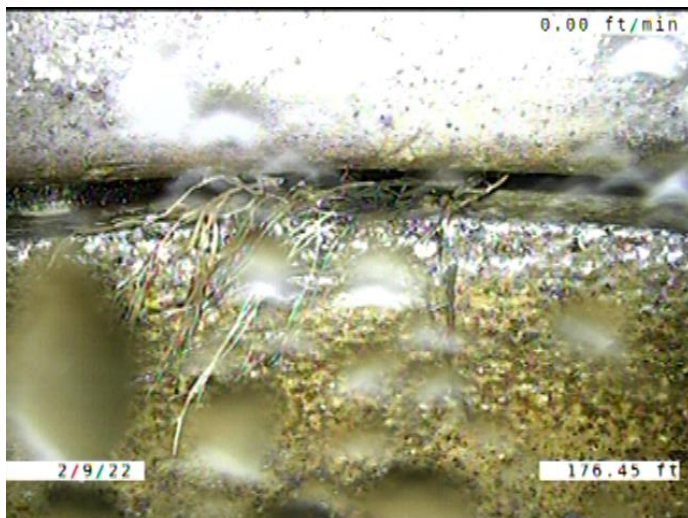
Code: **RFJ**
Description: **Roots Fine Joint**

Distance (ft): **176.4**
Structural Grade: **0**
O&M Grade: **1**
Clock Start/From: **9**
Clock To:
1st Value:
2nd Value:
Value Percent:
Continuous Index:
Within 8" of Joint: **YES**
Remarks:

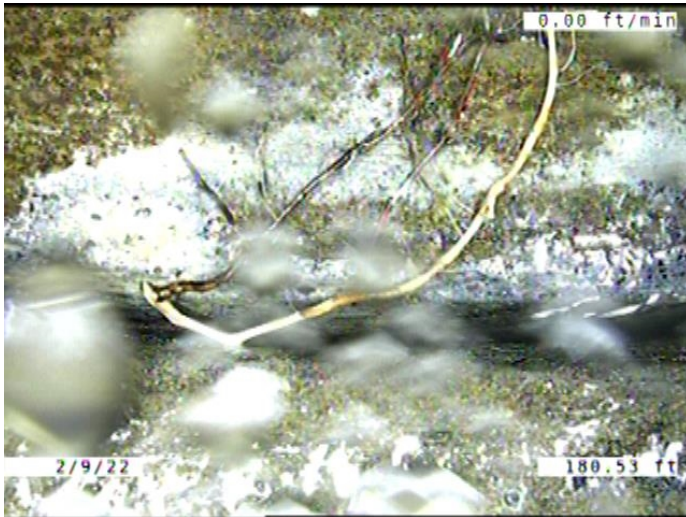
Code: **OBZ**
 Description: **Obstruction Other**

Distance (ft): **180.5**
 Structural Grade: **0**
 O&M Grade: **2**
 Clock Start/From: **6**
 Clock To: **7**
 1st Value:
 2nd Value:
 Value Percent: **5.000**
 Continuous Index:
 Within 8" of Joint: **YES**
 Remarks: **ROOTS THAT HAVE BEEN CUT**

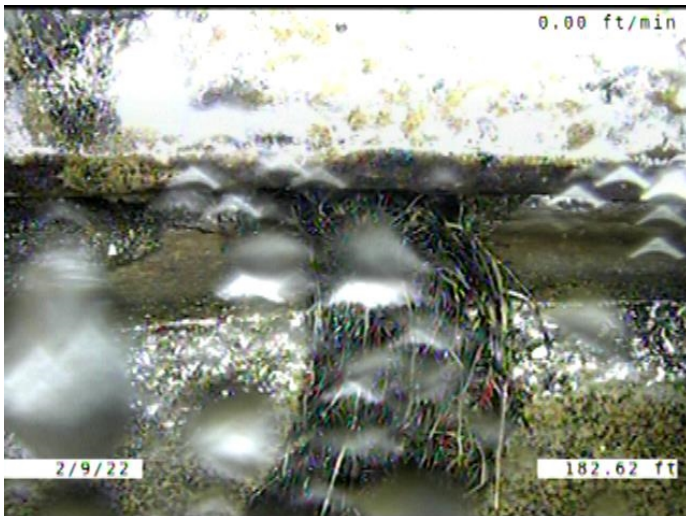
Code: **RFJ**
 Description: **Roots Fine Joint**

Distance (ft): **182.6**
 Structural Grade: **0**
 O&M Grade: **1**
 Clock Start/From: **9**
 Clock To: **10**
 1st Value:
 2nd Value:
 Value Percent:
 Continuous Index:
 Within 8" of Joint: **YES**
 Remarks:

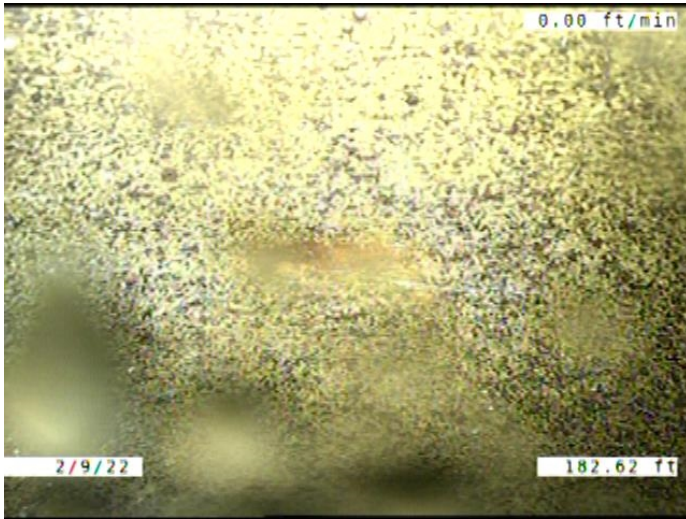
Code: **CM**
Description: **Crack Multiple**

Distance (ft): **182.6**
Structural Grade: **3**
O&M Grade: **0**
Clock Start/From: **9**
Clock To: **1**
1st Value:
2nd Value:
Value Percent:
Continuous Index:
Within 8" of Joint: **YES**
Remarks:

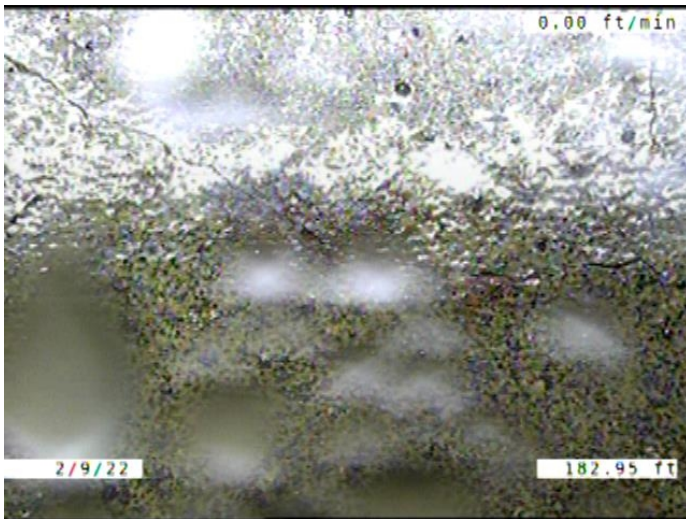
Code: **ISB**
Description: **Infiltration Stain Barrel**

Distance (ft): **182.9**
Structural Grade: **0**
O&M Grade: **1**
Clock Start/From: **11**
Clock To:
1st Value:
2nd Value:
Value Percent:
Continuous Index:
Within 8" of Joint: **NO**
Remarks:

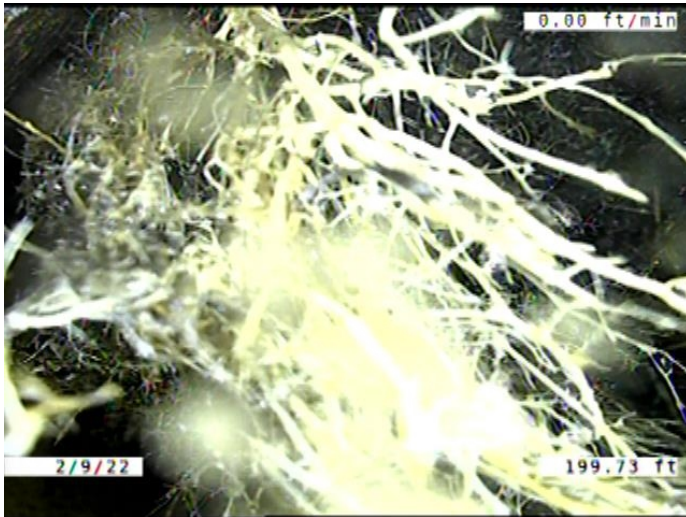
Code: **RML**
 Description: **Roots Medium Lateral**

Distance (ft): **199.7**
 Structural Grade: **0**
 O&M Grade: **3**
 Clock Start/From: **2**
 Clock To: **3**
 1st Value:
 2nd Value:
 Value Percent: **5.000**
 Continuous Index:
 Within 8" of Joint: **NO**
 Remarks:
