Profile/Photo Observation Report

Date:	02/09/2022	Weather:		Coding:	PACP 7.0
Pipe Length (ft):	226.8	Owner:	City of Hobart	Pre Clean:	Heavy Cleaning
P.O.#:	YES502259	Surveyor:	S. Bucklin	PSR:	P-707-019-020
Customer:	City of Hobart	Clean Date:	02/09/2022	Shape:	C

Street:	South Lincoln Street	Flow Control:	Not Controlled
City:	Hobart, IN	Year Renewed:	
Location:	Local rural streets with light traffic, t	Tape/Media #:	
Purpose:	Routine Assessment	Dia/Height:	8"
Use:	Sanitary Sewage Pipe	Material:	VCP
Drain Area:		Lining:	None
Category:	NA		
Comment:			
Location Details:		Direction of Survey:	Downstream
US MH:	M-707-020	DS MH:	M-707-019
		Total Length Surveyed (ft):	226.8

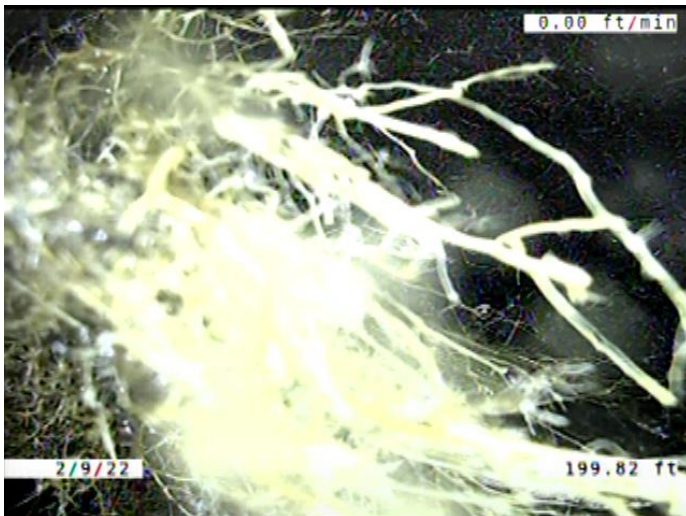
Code: **TF**
 Description: **Tap Factory**

Distance (ft): **199.8**
 Structural Grade: **0**
 O&M Grade: **0**
 Clock Start/From: **3**
 Clock To:
 1st Value: **4.000**
 2nd Value:
 Value Percent:
 Continuous Index:
 Within 8" of Joint: **YES**
 Remarks: **LOOKS TO BE 100% PLUGGED WITH ROOTS**

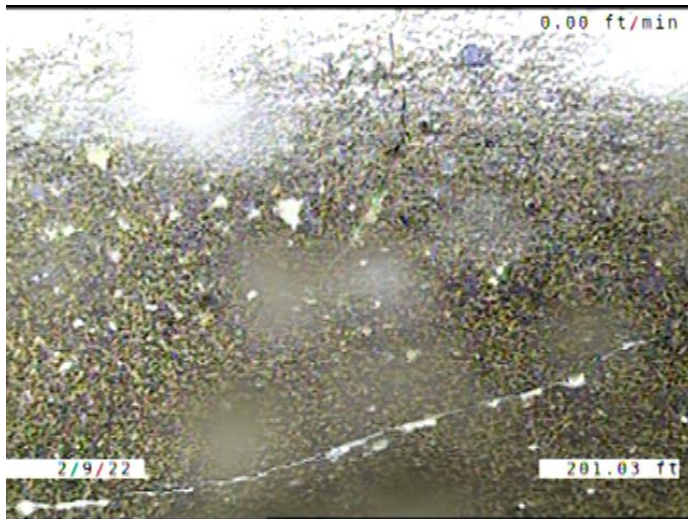
Code: **CM**
Description: **Crack Multiple**

Distance (ft): **201.0**
Structural Grade: **3**
O&M Grade: **0**
Clock Start/From: **9**
Clock To: **2**
1st Value:
2nd Value:
Value Percent:
Continuous Index:
Within 8" of Joint: **YES**
Remarks:

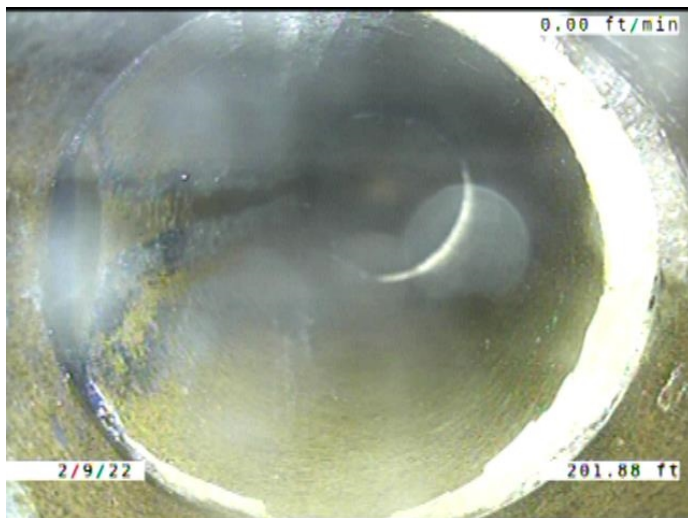
Code: **TF**
Description: **Tap Factory**

Distance (ft): **201.9**
Structural Grade: **0**
O&M Grade: **0**
Clock Start/From: **9**
Clock To:
1st Value: **4.000**
2nd Value:
Value Percent:
Continuous Index:
Within 8" of Joint: **YES**
Remarks: **OFFSET JOINT IN THE SERVICE**

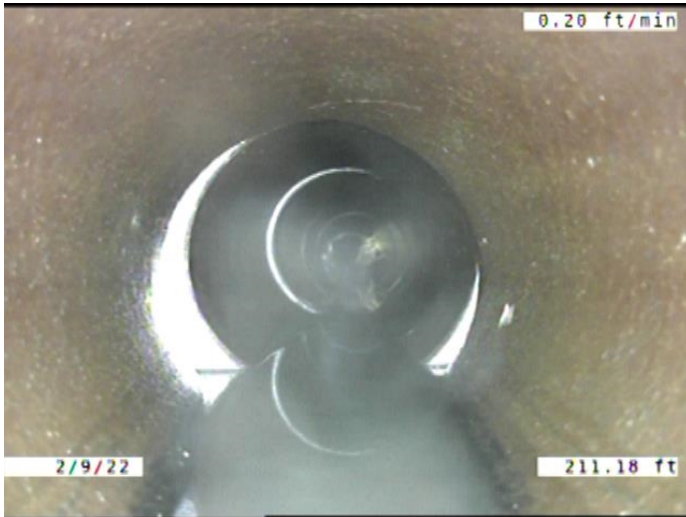
Code: **MWLS**
Description: **Miscellaneous Water Level Sag**

Distance (ft): **211.2**
Structural Grade: **2**
O&M Grade: **0**
Clock Start/From:
Clock To:
1st Value:
2nd Value:
Value Percent: **5.000**
Continuous Index: **S06**
Within 8" of Joint: **NO**
Remarks:

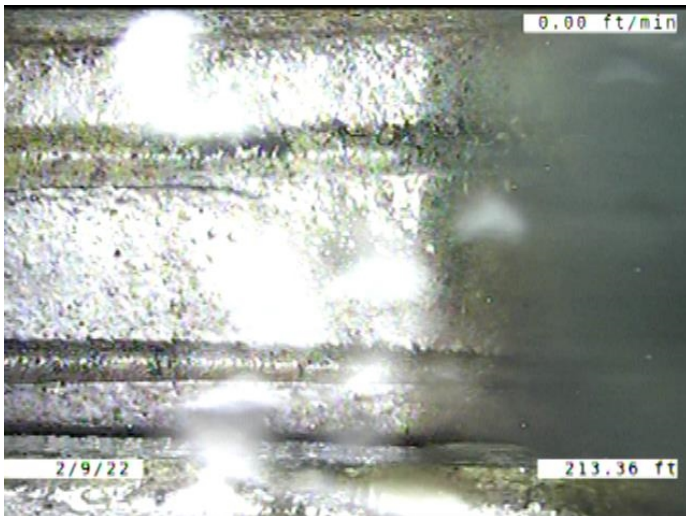
Code: **JAL**
Description: **Joint Angular Large**

Distance (ft): **213.4**
Structural Grade: **4**
O&M Grade: **0**
Clock Start/From:
Clock To:
1st Value:
2nd Value:
Value Percent:
Continuous Index:
Within 8" of Joint: **NO**
Remarks:

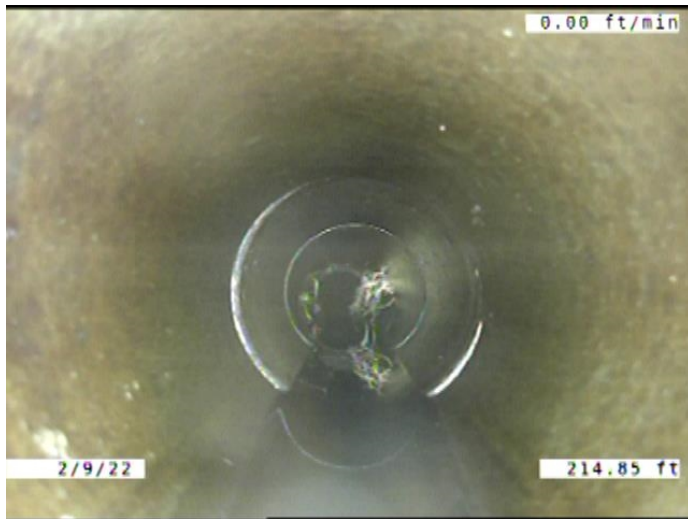
Code: **MWLS**
 Description: **Miscellaneous Water Level Sag**

Distance (ft): **214.8**
 Structural Grade: **2**
 O&M Grade: **0**
 Clock Start/From:
 Clock To:
 1st Value:
 2nd Value:
 Value Percent: **5.000**
 Continuous Index: **F06**
 Within 8" of Joint: **NO**
 Remarks:

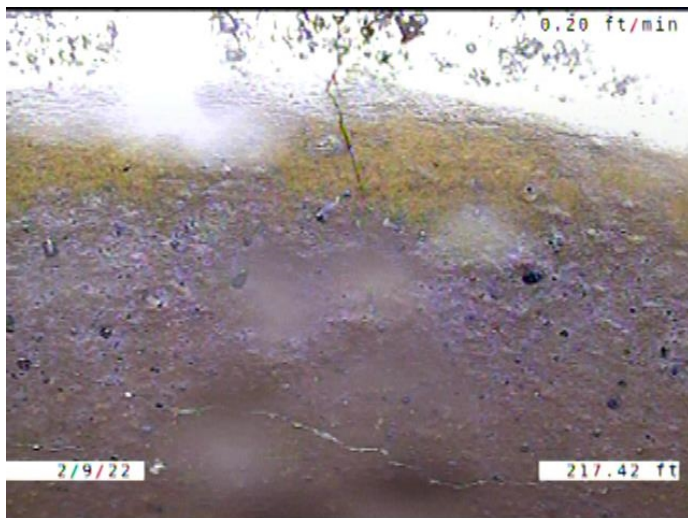
Code: **CM**
 Description: **Crack Multiple**

Distance (ft): **217.4**
 Structural Grade: **3**
 O&M Grade: **0**
 Clock Start/From: **10**
 Clock To: **2**
 1st Value:
 2nd Value:
 Value Percent:
 Continuous Index:
 Within 8" of Joint: **YES**
 Remarks:

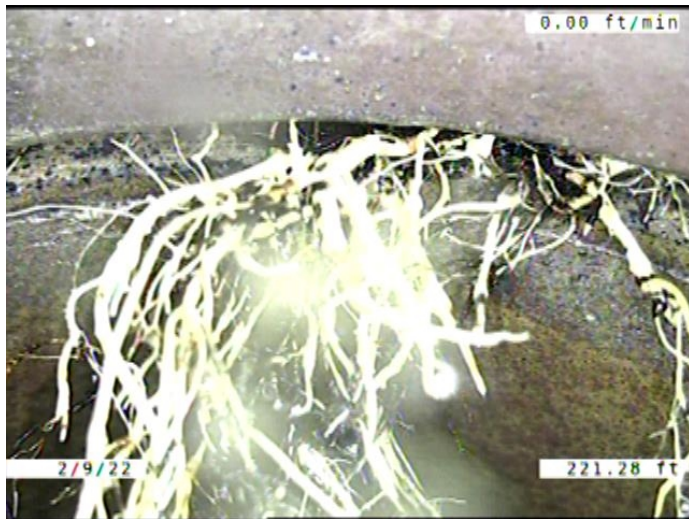
Code: **RMJ**
 Description: **Roots Medium Joint**

Distance (ft): **221.3**
 Structural Grade: **0**
 O&M Grade: **3**
 Clock Start/From: **9**
 Clock To: **3**
 1st Value:
 2nd Value:
 Value Percent: **5.000**
 Continuous Index:
 Within 8" of Joint: **YES**
 Remarks:

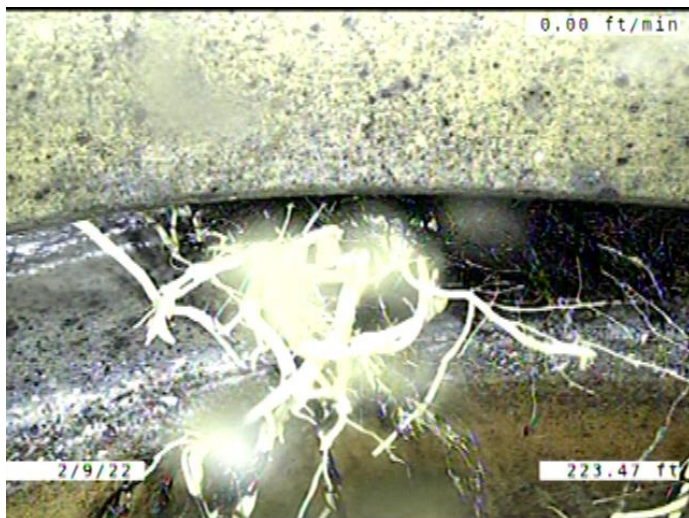
Code: **RMJ**
 Description: **Roots Medium Joint**

Distance (ft): **223.5**
 Structural Grade: **0**
 O&M Grade: **3**
 Clock Start/From: **9**
 Clock To: **2**
 1st Value:
 2nd Value:
 Value Percent: **5.000**
 Continuous Index:
 Within 8" of Joint: **YES**
 Remarks:

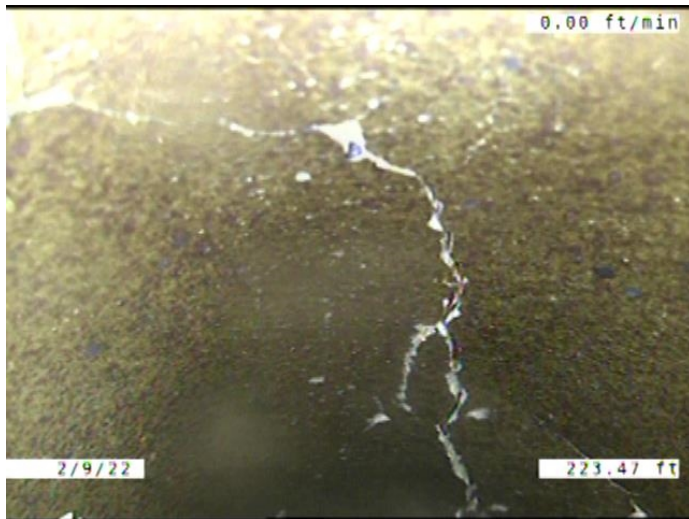
Code: **B**
Description: **Broken**

Distance (ft): **223.5**
Structural Grade: **4**
O&M Grade: **0**
Clock Start/From: **9**
Clock To: **3**
1st Value:
2nd Value:
Value Percent:
Continuous Index:
Within 8" of Joint: **YES**
Remarks:

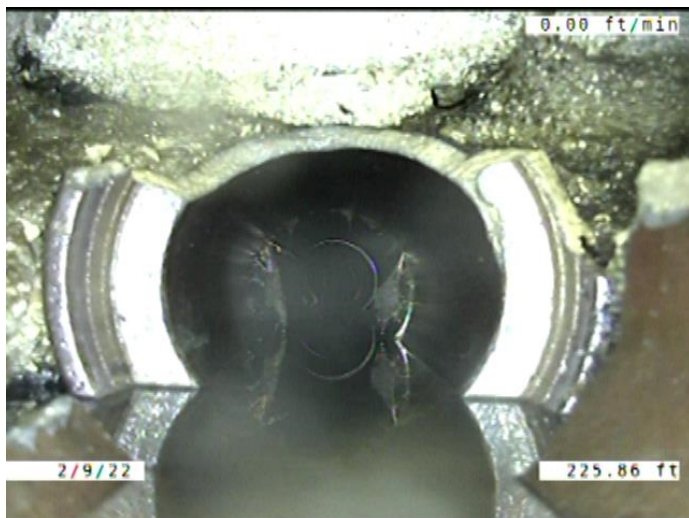
Code: **DSF**
Description: **Deposits Settled Fine**

Distance (ft): **225.9**
Structural Grade: **0**
O&M Grade: **2**
Clock Start/From: **5**
Clock To: **7**
1st Value:
2nd Value:
Value Percent: **5.000**
Continuous Index: **F01**
Within 8" of Joint: **YES**
Remarks:
