## Profile/Photo Observation Report

Date:	<b>04/09/2018</b>	Weather:		Coding:	<b>PACP 6.0</b>
Pipe Length (ft):	<b>162.1</b>	Owner:	<b>NA</b>	Pre Clean:	<b>Not Known</b>
P.O.#:		Surveyor:	<b>Mark Ruby</b>	PSR:	<b>P-707-023-022</b>
Customer:		Clean Date:	<b>01/01/1900</b>	Shape:	<b>C</b>

Street:	<b>Capitol</b>	Flow Control:	<b>Not Controlled</b>
City:	<b>Hobart, IN</b>	Year Renewed:	
Location:	<b>Light Highway</b>	Tape/Media #:	
Purpose:	<b>Maintenance Related</b>	Dia/Height:	<b>8"</b>
Use:	<b>Sanitary</b>	Material:	<b>PVC</b>
Drain Area:	<b>NA</b>	Lining:	<b>Cured in Place</b>
Category:	<b>NA</b>		
Comment:	<b>under water and debris at 104', flow incorrect.</b>		
Location Details:		Direction of Survey:	<b>Upstream</b>
US MH:	<b>M-707-022</b>	DS MH:	<b>M-707-023</b>
		Total Length Surveyed (ft):	<b>105.4</b>

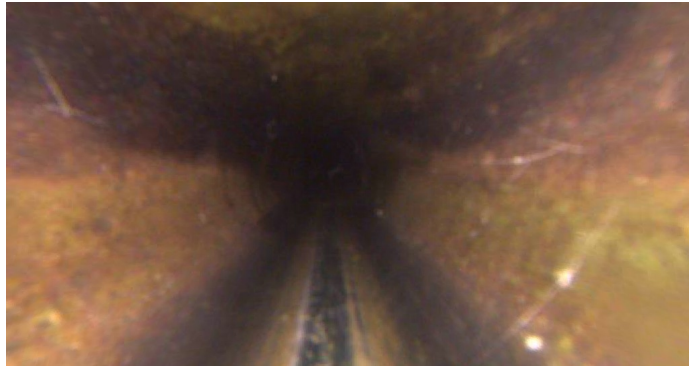
Code:	<b>MWL</b>
Description:	<b>Water Level</b>
Distance (ft):	<b>.0</b>
Structural Grade:	<b>0</b>
O&M Grade:	<b>0</b>
Clock Start/From:	
Clock To:	
1st Value:	
2nd Value:	
Value Percent:	<b>10.000</b>
Continuous Index:	
Within 8" of Joint:	<b>NO</b>
Remarks:

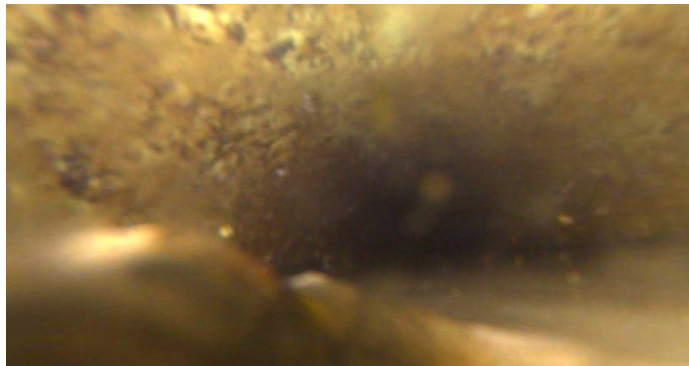
Code:	<b>MWL</b>
Description:	<b>Water Level</b>
Distance (ft):	<b>89.9</b>
Structural Grade:	<b>0</b>
O&M Grade:	<b>0</b>
Clock Start/From:	
Clock To:	
1st Value:	
2nd Value:	
Value Percent:	<b>30.000</b>
Continuous Index:	
Within 8" of Joint:	<b>NO</b>
Remarks:

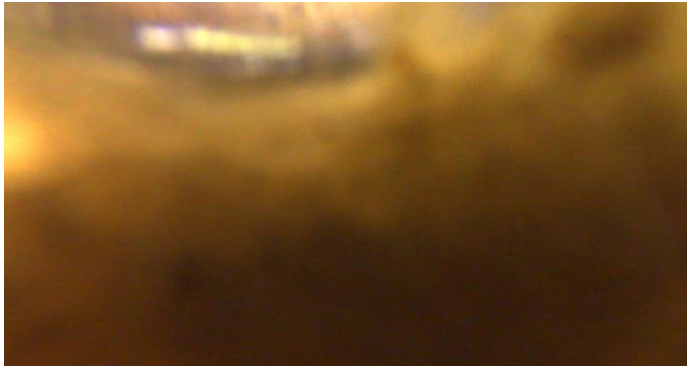
Code: **MCU**  
Description: **Camera Underwater**

Distance (ft): **104.7**  
Structural Grade: **0**  
O&M Grade: **4**  
Clock Start/From:  
Clock To:  
1st Value:  
2nd Value:  
Value Percent:  
Continuous Index:  
Within 8" of Joint: **NO**  
Remarks:

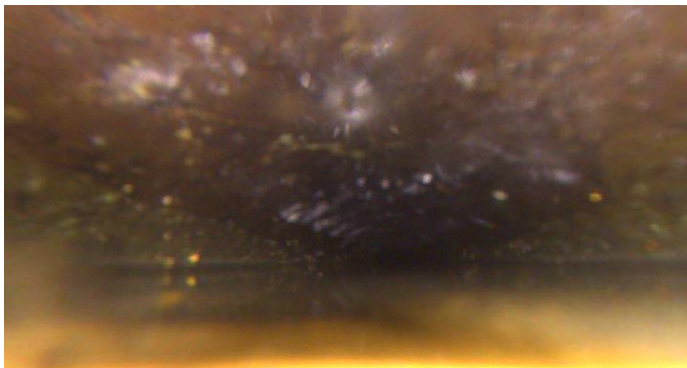
Code: **MSA**  
Description: **Abandoned Survey**

Distance (ft): **105.4**  
Structural Grade: **0**  
O&M Grade: **0**  
Clock Start/From:  
Clock To:  
1st Value:  
2nd Value:  
Value Percent:  
Continuous Index:  
Within 8" of Joint: **NO**  
Remarks: **MCU**
