## Profile/Photo Observation Report

Street:	<b>E 13TH ST</b>	Flow Control:	<b>Not Controlled</b>
City:	<b>Hobart, IN</b>	Year Renewed:	
Location:	<b>Light Highway</b>	Tape/Media #:	
Purpose:	<b>Maintenance Related</b>	Dia/Height:	<b>10"</b>
Use:	<b>Sanitary</b>	Material:	<b>VCP</b>
Drain Area:	<b>NA</b>	Lining:	<b>Cured in Place</b>
Category:	<b>NA</b>		
Comment:	<b>blk silt at 30', flow incorrect.</b>		
Location Details:		Direction of Survey:	<b>Downstream</b>
US MH:	<b>M-707-023</b>	DS MH:	<b>M-707-025</b>
		Total Length Surveyed (ft):	<b>31.5</b>

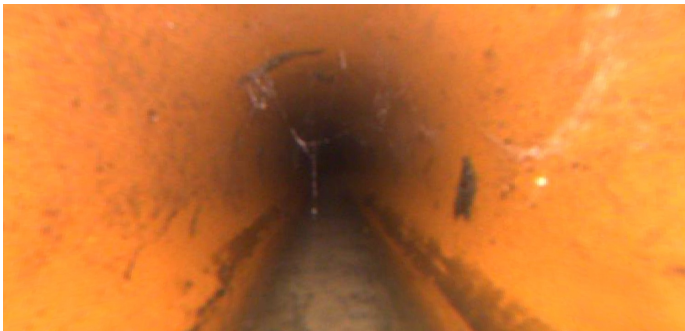
Code: **AMH**  
Description: **Manhole**

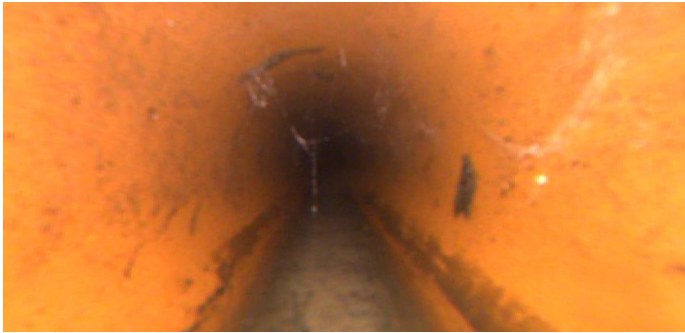
Code:	<b>MWL</b>
Description:	<b>Water Level</b>

Distance (ft):	<b>.0</b>
Structural Grade:	<b>0</b>
O&M Grade:	<b>0</b>
Clock Start/From:	
Clock To:	
1st Value:	
2nd Value:	
Value Percent:	<b>5.000</b>
Continuous Index:	
Within 8" of Joint:	<b>NO</b>
Remarks:

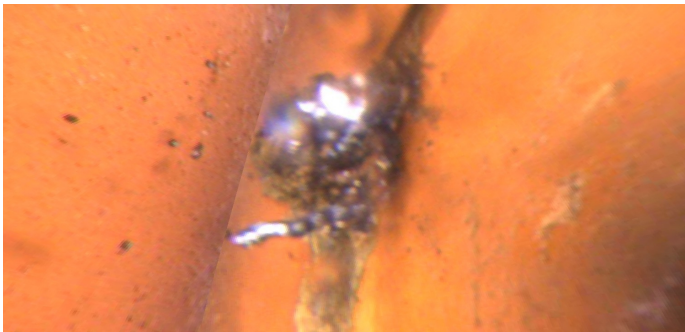
Code:	<b>RFJ</b>
Description:	<b>Roots Fine Joint</b>

Distance (ft):	<b>9.3</b>
Structural Grade:	<b>0</b>
O&M Grade:	<b>1</b>
Clock Start/From:	<b>10</b>
Clock To:	
1st Value:	
2nd Value:	
Value Percent:	
Continuous Index:	
Within 8" of Joint:	<b>YES</b>
Remarks:

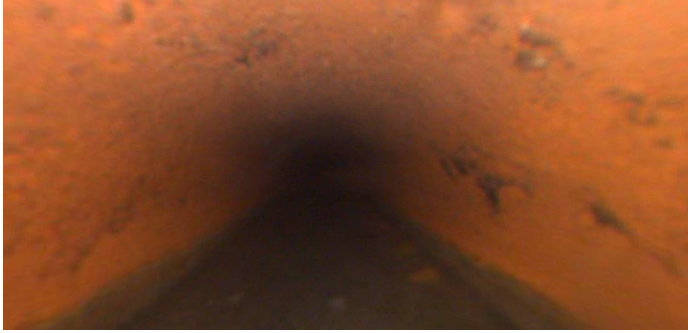
Code:	<b>MSA</b>
Description:	<b>Abandoned Survey</b>
Distance (ft):	<b>31.5</b>
Structural Grade:	<b>0</b>
O&M Grade:	<b>0</b>
Clock Start/From:	
Clock To:	
1st Value:	
2nd Value:	
Value Percent:	
Continuous Index:	
Within 8" of Joint:	<b>NO</b>
Remarks:	<b>debris</b>
