Profile/Photo Observation Report

Street:	Capitol	Flow Control:	Not Controlled
City:	Hobart, IN	Year Renewed:	
Location:	Light Highway	Tape/Media #:	
Purpose:	Maintenance Related	Dia/Height:	10"
Use:	Sanitary	Material:	VCP
Drain Area:	NA	Lining:	Cured in Place
Category:	NA		
Comment:	blk silt at 30', flow incorrect.		
Location Details:		Direction of Survey:	Downstream
US MH:	M-707-023	DS MH:	M-707-025
		Total Length Surveyed (ft):	31.5

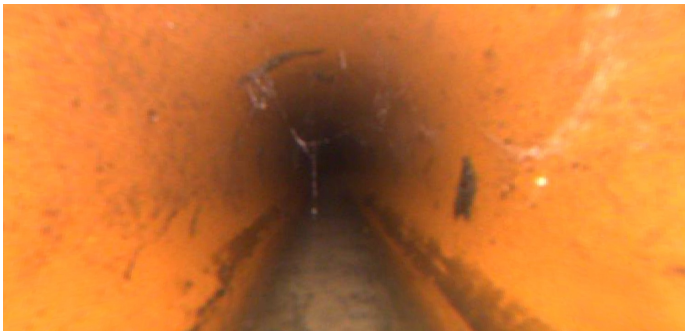
Code: **AMH**
Description: **Manhole**

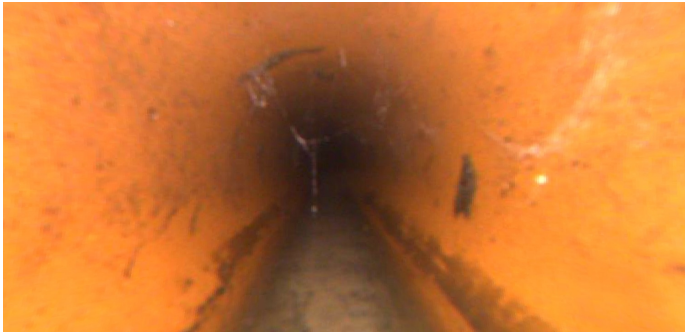
Code:	MWL
Description:	Water Level

Distance (ft):	.0
Structural Grade:	0
O&M Grade:	0
Clock Start/From:	
Clock To:	
1st Value:	
2nd Value:	
Value Percent:	5.000
Continuous Index:	
Within 8" of Joint:	NO
Remarks:

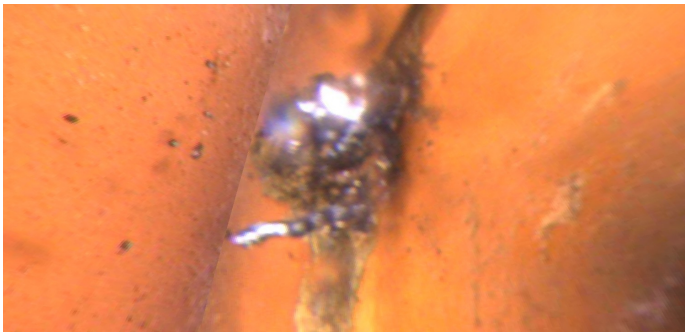
Code:	RFJ
Description:	Roots Fine Joint

Distance (ft):	9.3
Structural Grade:	0
O&M Grade:	1
Clock Start/From:	10
Clock To:	
1st Value:	
2nd Value:	
Value Percent:	
Continuous Index:	
Within 8" of Joint:	YES
Remarks:

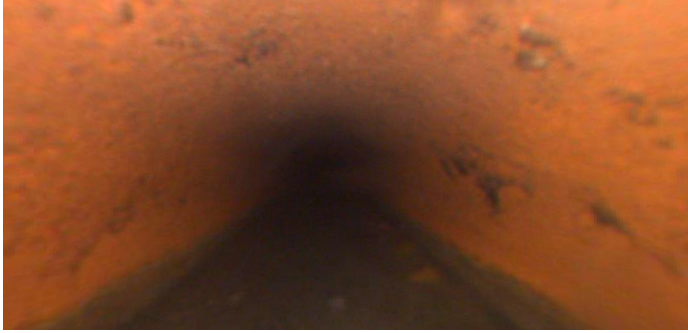
Code:	MSA
Description:	Abandoned Survey
Distance (ft):	31.5
Structural Grade:	0
O&M Grade:	0
Clock Start/From:	
Clock To:	
1st Value:	
2nd Value:	
Value Percent:	
Continuous Index:	
Within 8" of Joint:	NO
Remarks:	debris
