## Profile/Photo Observation Report

Date:	<b>04/09/2018</b>	Weather:		Coding:	<b>PACP 6.0</b>
Pipe Length (ft):	<b>324.9</b>	Owner:	<b>NA</b>	Pre Clean:	<b>Not Known</b>
P.O.#:		Surveyor:	<b>Mark Ruby</b>	PSR:	<b>P-707-025-023</b>
Customer:		Clean Date:	<b>01/01/1900</b>	Shape:	<b>C</b>

Street:	<b>E 13TH ST</b>	Flow Control:	<b>Not Controlled</b>
City:	<b>Hobart, IN</b>	Year Renewed:	
Location:	<b>Alley</b>	Tape/Media #:	
Purpose:	<b>Maintenance Related</b>	Dia/Height:	<b>8"</b>
Use:	<b>Sanitary</b>	Material:	<b>VCP</b>
Drain Area:	<b>NA</b>	Lining:	<b>Cured in Place</b>
Category:	<b>NA</b>		
Comment:	<b>Reverse setup. sand and silt at 120', flow incorrect.</b>		
Location Details:		Direction of Survey:	<b>Upstream</b>
US MH:	<b>M-707-023</b>	DS MH:	<b>M-707-025</b>
		Total Length Surveyed (ft):	<b>121.4</b>

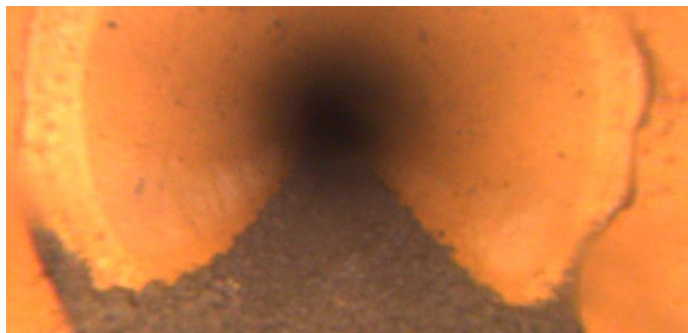
Code: **DSF**  
Description: **Deposits Settled Fine**

Distance (ft): **.0**  
Structural Grade: **0**  
O&M Grade: **2**  
Clock Start/From: **6**  
Clock To:  
1st Value:  
2nd Value:  
Value Percent: **5.000**  
Continuous Index: **S01**  
Within 8" of Joint: **NO**  
Remarks:

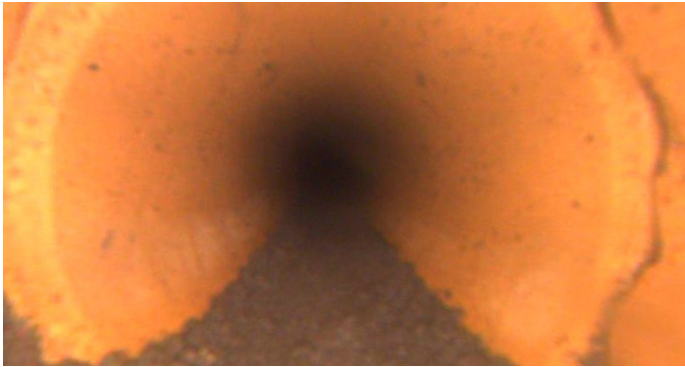
Code:	<b>AMH</b>
Description:	<b>Manhole</b>

Distance (ft):	<b>.0</b>
Structural Grade:	<b>0</b>
O&M Grade:	<b>0</b>
Clock Start/From:	
Clock To:	
1st Value:	
2nd Value:	
Value Percent:	
Continuous Index:	
Within 8" of Joint:	<b>NO</b>
Remarks:	<b>M-707-025</b>

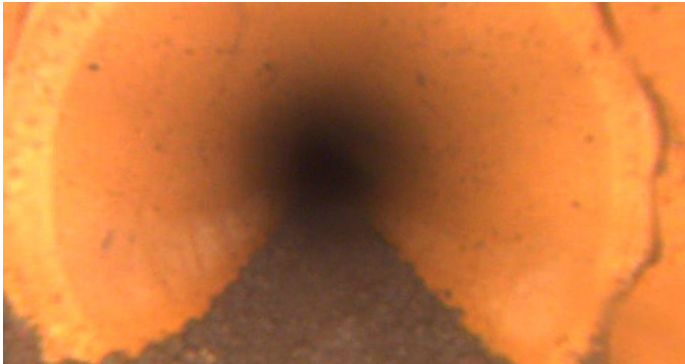
Code:	<b>MWL</b>
Description:	<b>Water Level</b>

Distance (ft):	<b>.0</b>
Structural Grade:	<b>0</b>
O&M Grade:	<b>0</b>
Clock Start/From:	
Clock To:	
1st Value:	
2nd Value:	
Value Percent:	<b>10.000</b>
Continuous Index:	
Within 8" of Joint:	<b>NO</b>
Remarks:

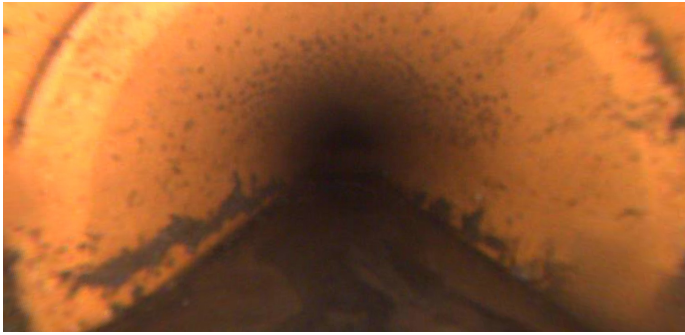
Code: **DSF**  
Description: **Deposits Settled Fine**

Distance (ft): **16.0**  
Structural Grade: **0**  
O&M Grade: **2**  
Clock Start/From: **6**  
Clock To:  
1st Value:  
2nd Value:  
Value Percent: **5.000**  
Continuous Index: **F01**  
Within 8" of Joint: **NO**  
Remarks:

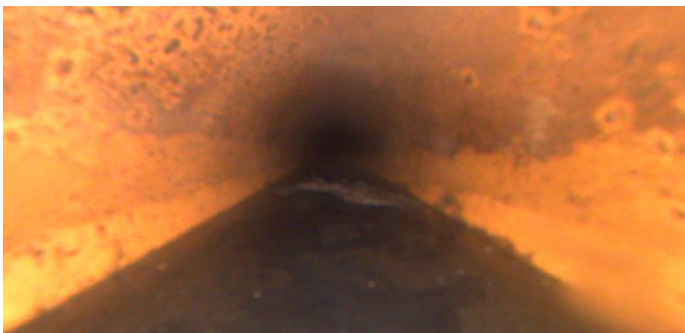
Code: **MWL**  
Description: **Water Level**

Distance (ft): **22.0**  
Structural Grade: **0**  
O&M Grade: **0**  
Clock Start/From:  
Clock To:  
1st Value:  
2nd Value:  
Value Percent: **20.000**  
Continuous Index:  
Within 8" of Joint: **NO**  
Remarks:

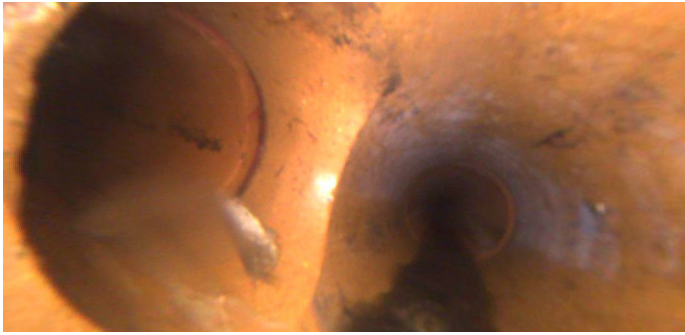
Code: **TF**  
Description: **Tap Factory**

Distance (ft): **31.3**  
Structural Grade: **0**  
O&M Grade: **0**  
Clock Start/From: **9**  
Clock To:  
1st Value: **4.000**  
2nd Value:  
Value Percent:  
Continuous Index:  
Within 8" of Joint:  
Remarks:

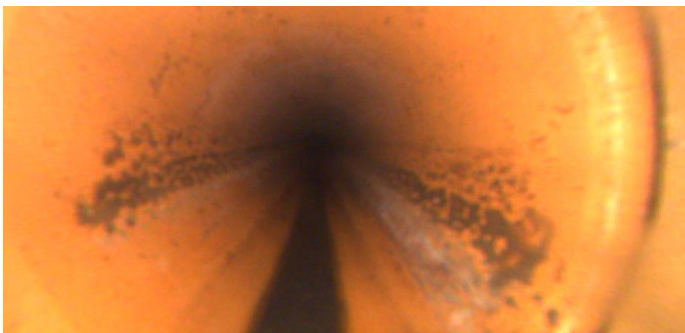
Code: **MWL**  
Description: **Water Level**

Distance (ft): **32.9**  
Structural Grade: **0**  
O&M Grade: **0**  
Clock Start/From:  
Clock To:  
1st Value:  
2nd Value:  
Value Percent: **5.000**  
Continuous Index:  
Within 8" of Joint: **NO**  
Remarks:

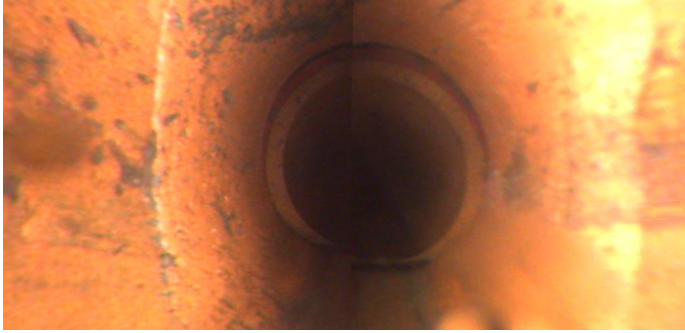
Code: **TFA**  
Description: **Tap Factory Active**

Distance (ft): **73.6**  
Structural Grade: **0**  
O&M Grade: **0**  
Clock Start/From: **9**  
Clock To:  
1st Value: **4.000**  
2nd Value:  
Value Percent:  
Continuous Index:  
Within 8" of Joint:  
Remarks:

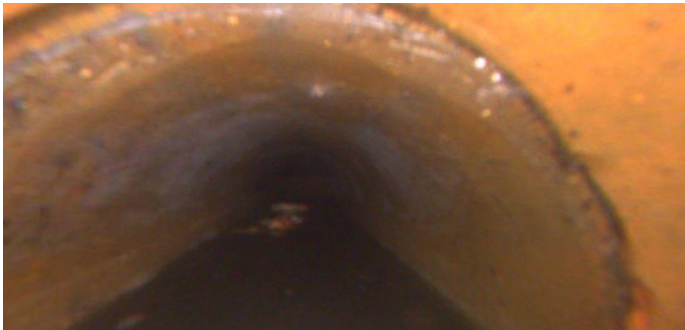
Code: **MWL**  
Description: **Water Level**

Distance (ft): **88.7**  
Structural Grade: **0**  
O&M Grade: **0**  
Clock Start/From:  
Clock To:  
1st Value:  
2nd Value:  
Value Percent: **30.000**  
Continuous Index:  
Within 8" of Joint: **NO**  
Remarks:

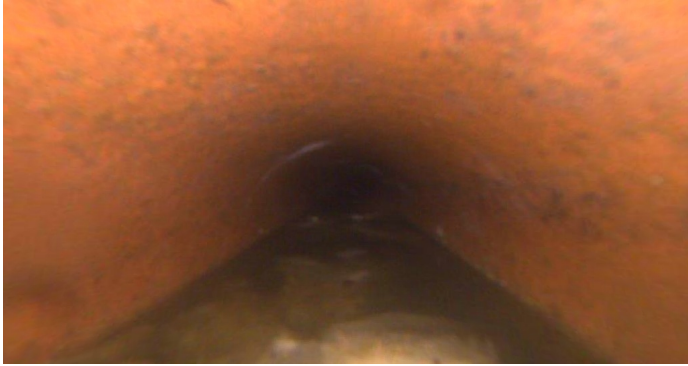
Code:	<b>MSA</b>
Description:	<b>Abandoned Survey</b>
Distance (ft):	<b>121.4</b>
Structural Grade:	<b>0</b>
O&M Grade:	<b>0</b>
Clock Start/From:	
Clock To:	
1st Value:	
2nd Value:	
Value Percent:	
Continuous Index:	
Within 8" of Joint:	<b>NO</b>
Remarks:	<b>Debris</b>
