Profile/Photo Observation Report

| Street: | Capitol | Flow Control: | Not Controlled |
| City: | Hobart, IN | Year Renewed: | |
| US MH: | M-707-023 | DS MH: | M-707-025 |

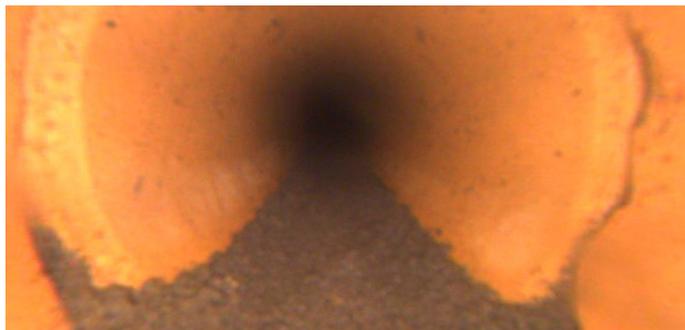
Code: **DSF**
Description: **Deposits Settled Fine**
Distance (ft): **.0**
Structural Grade: **0**
O&M Grade: **2**
Clock Start/From: **6**
Clock To:
1st Value:
2nd Value:
Value Percent: **5.000**
Continuous Index: **S01**
Within 8" of Joint: **NO**
Remarks:

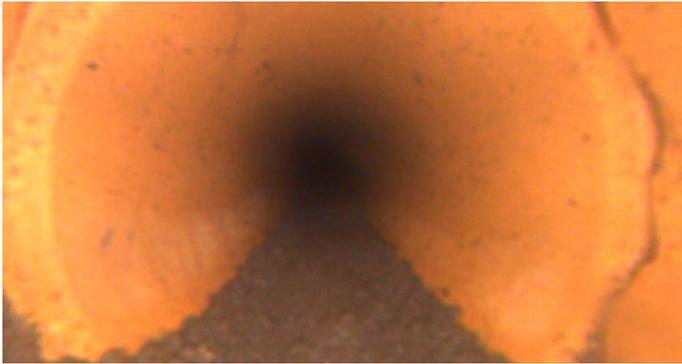
Code: **AMH**
Description: **Manhole**

Distance (ft): **.0**
Structural Grade: **0**
O&M Grade: **0**
Clock Start/From:
Clock To:
1st Value:
2nd Value:
Value Percent:
Continuous Index:
Within 8" of Joint: **NO**
Remarks: **M-707-025**

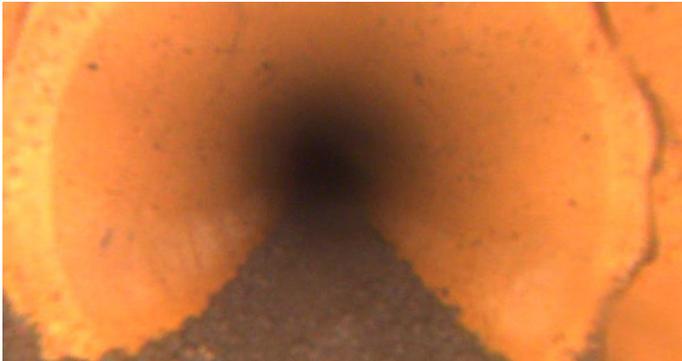
Code: **MWL**
Description: **Water Level**

Distance (ft): **.0**
Structural Grade: **0**
O&M Grade: **0**
Clock Start/From:
Clock To:
1st Value:
2nd Value:
Value Percent: **10.000**
Continuous Index:
Within 8" of Joint: **NO**
Remarks:

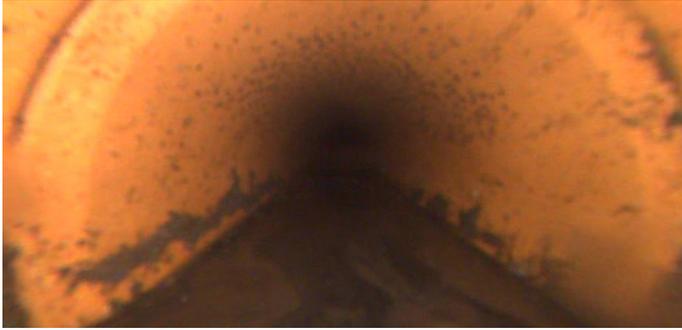
Code: **DSF**
Description: **Deposits Settled Fine**

Distance (ft): **16.0**
Structural Grade: **0**
O&M Grade: **2**
Clock Start/From: **6**
Clock To:
1st Value:
2nd Value:
Value Percent: **5.000**
Continuous Index: **F01**
Within 8" of Joint: **NO**
Remarks:

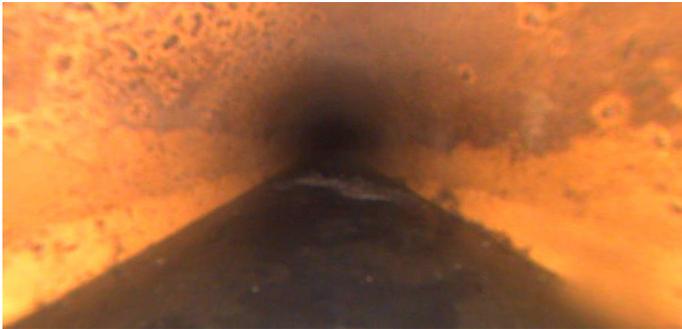
Code: **MWL**
Description: **Water Level**

Distance (ft): **22.0**
Structural Grade: **0**
O&M Grade: **0**
Clock Start/From:
Clock To:
1st Value:
2nd Value:
Value Percent: **20.000**
Continuous Index:
Within 8" of Joint: **NO**
Remarks:

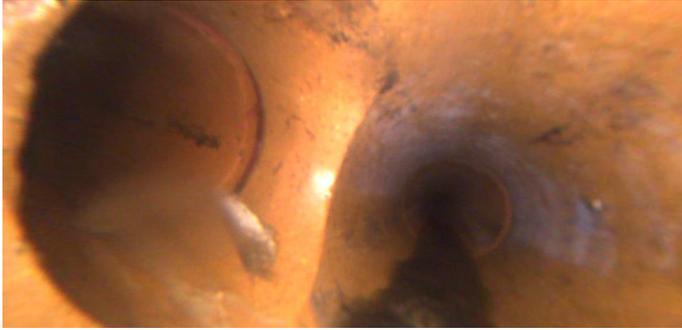
Code: **TF**
Description: **Tap Factory**

Distance (ft): **31.3**
Structural Grade: **0**
O&M Grade: **0**
Clock Start/From: **9**
Clock To:
1st Value: **4.000**
2nd Value:
Value Percent:
Continuous Index:
Within 8" of Joint:
Remarks:

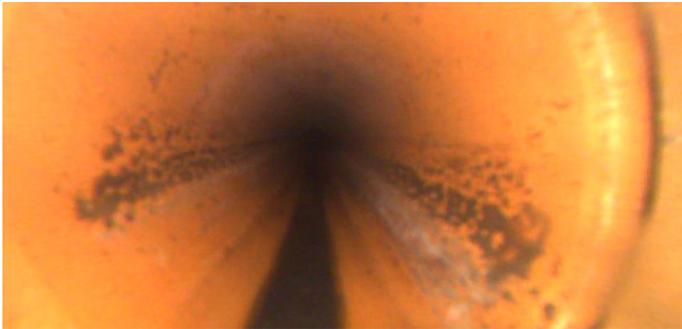
Code: **MWL**
Description: **Water Level**

Distance (ft): **32.9**
Structural Grade: **0**
O&M Grade: **0**
Clock Start/From:
Clock To:
1st Value:
2nd Value:
Value Percent: **5.000**
Continuous Index:
Within 8" of Joint: **NO**
Remarks:

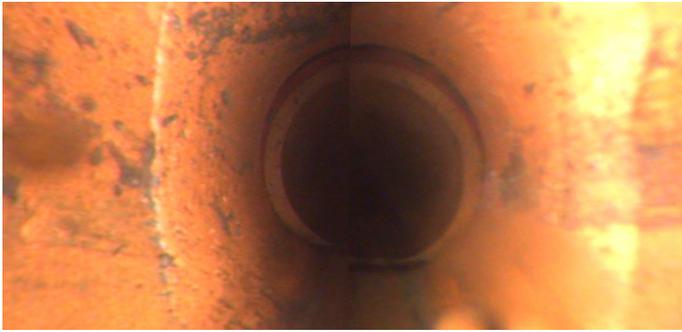
Code: **TFA**
Description: **Tap Factory Active**

Distance (ft): **73.6**
Structural Grade: **0**
O&M Grade: **0**
Clock Start/From: **9**
Clock To:
1st Value: **4.000**
2nd Value:
Value Percent:
Continuous Index:
Within 8" of Joint:
Remarks:

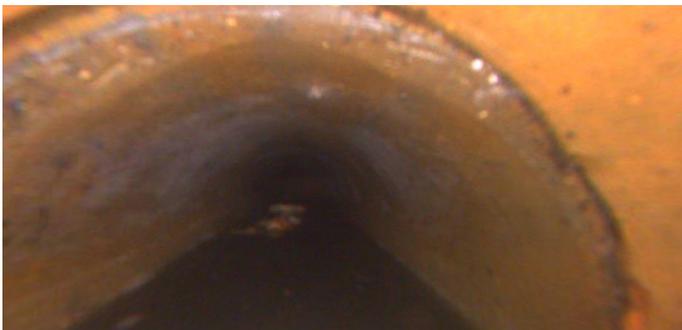
Code: **MWL**
Description: **Water Level**

Distance (ft): **88.7**
Structural Grade: **0**
O&M Grade: **0**
Clock Start/From:
Clock To:
1st Value:
2nd Value:
Value Percent: **30.000**
Continuous Index:
Within 8" of Joint: **NO**
Remarks:

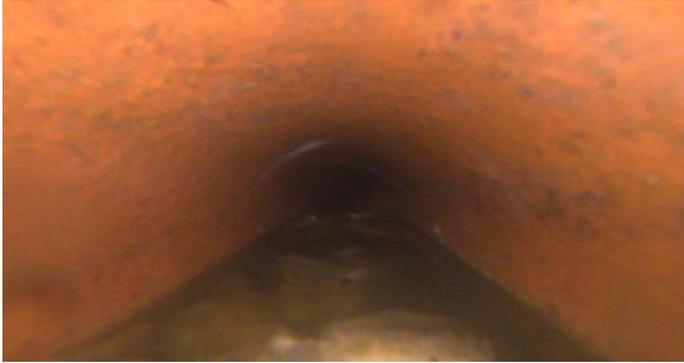
| Comment: | Reverse setup. sand and silt at 120', flow incorrect. | | |

Code: **MSA**
Description: **Abandoned Survey**

Distance (ft): **121.4**
Structural Grade: **0**
O&M Grade: **0**
Clock Start/From:
Clock To:
1st Value:
2nd Value:
Value Percent:
Continuous Index:
Within 8" of Joint: **NO**
Remarks: **Debris**
