Profile/Photo Observation Report

Date:	02/10/2022	Weather:		Coding:	PACP 7.0
Pipe Length (ft):	327.0	Owner:	City of Hobart	Pre Clean:	Heavy Cleaning
P.O.#:	YES502259	Surveyor:	S. Bucklin	PSR:	P-707-025-023
Customer:	City of Hobart	Clean Date:	02/08/2022	Shape:	C

Street:	South Lincoln Street	Flow Control:	Not Controlled
City:	Hobart, IN	Year Renewed:	
Location:	Alley	Tape/Media #:	
Purpose:	Routine Assessment	Dia/Height:	8"
Use:	Sanitary Sewage Pipe	Material:	VCP
Drain Area:		Lining:	None
Category:	NA		
Comment:			
Location Details:		Direction of Survey:	Upstream
US MH:	M-707-023	DS MH:	M-707-025
		Total Length Surveyed (ft):	326.9

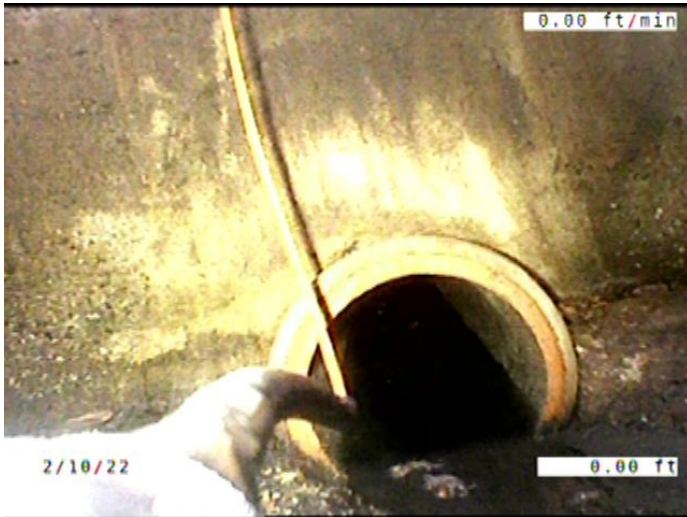
Code: **AMH**
 Description: **Manhole**

Distance (ft): **.0**
 Structural Grade: **0**
 O&M Grade: **0**
 Clock Start/From:
 Clock To:
 1st Value:
 2nd Value:
 Value Percent:
 Continuous Index:
 Within 8" of Joint: **NO**
 Remarks: **M-707-025**

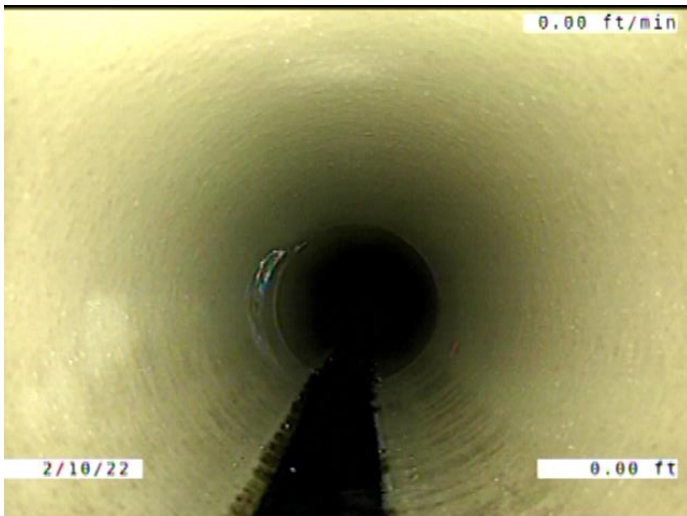
Code: **MWL**
 Description: **Miscellaneous Water Level**

Distance (ft): **.0**
 Structural Grade: **0**
 O&M Grade: **0**
 Clock Start/From:
 Clock To:
 1st Value:
 2nd Value:
 Value Percent: **5.000**
 Continuous Index:
 Within 8" of Joint: **NO**
 Remarks:

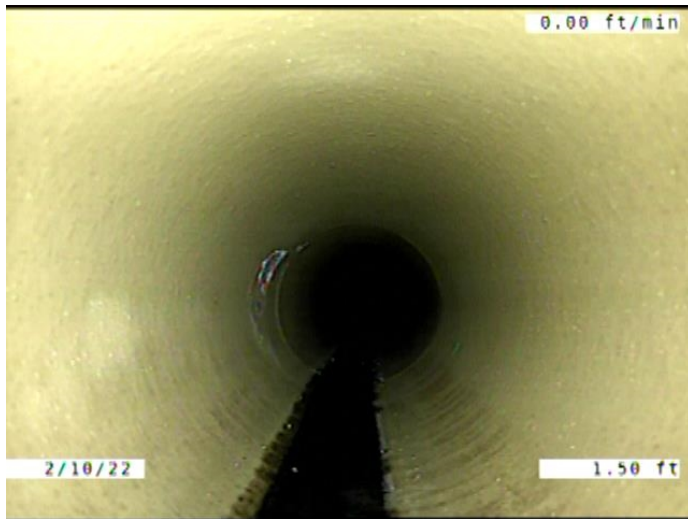
Code:	MGO
Description:	Miscellaneous General Observation
Distance (ft):	1.5
Structural Grade:	0
O&M Grade:	0
Clock Start/From:	
Clock To:	
1st Value:	
2nd Value:	
Value Percent:	
Continuous Index:	
Within 8" of Joint:	NO
Remarks:	DROP INTO THE MANHOLE. HAD TO START IN THE PIPE.

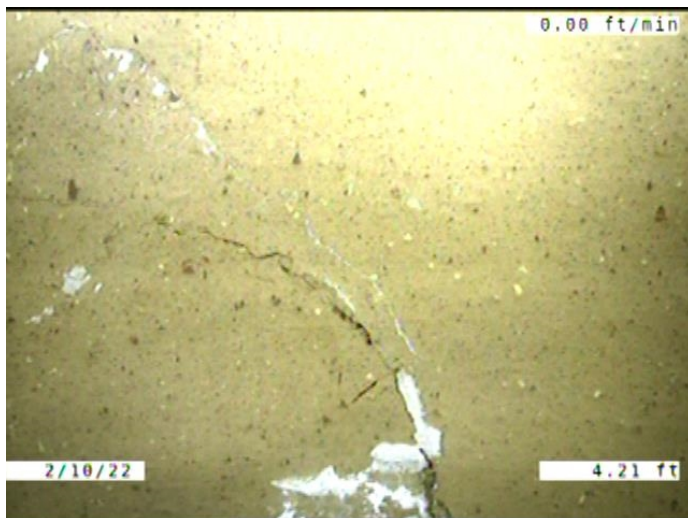
Code:	FS
Description:	Fracture Spiral
Distance (ft):	4.2
Structural Grade:	3
O&M Grade:	0
Clock Start/From:	8
Clock To:	10
1st Value:	
2nd Value:	
Value Percent:	
Continuous Index:	
Within 8" of Joint:	YES
Remarks:

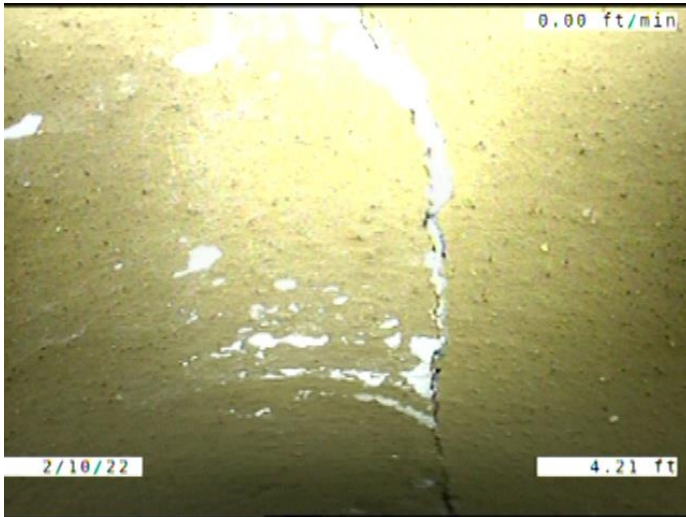
Code:	DAE
Description:	Deposits Attached Encrustation
Distance (ft):	4.2
Structural Grade:	0
O&M Grade:	2
Clock Start/From:	7
Clock To:	10
1st Value:	
2nd Value:	
Value Percent:	5.000
Continuous Index:	
Within 8" of Joint:	YES
Remarks:

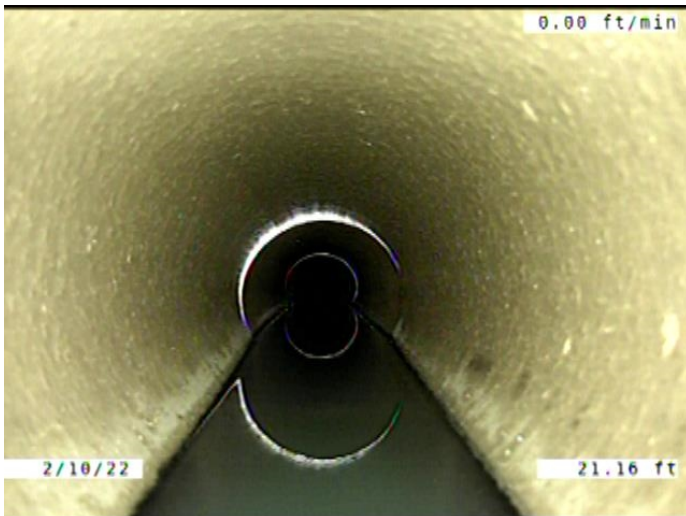
Code:	MWLS
Description:	Miscellaneous Water Level Sag
Distance (ft):	21.2
Structural Grade:	2
O&M Grade:	0
Clock Start/From:	
Clock To:	
1st Value:	
2nd Value:	
Value Percent:	30.000
Continuous Index:	S01
Within 8" of Joint:	NO
Remarks:

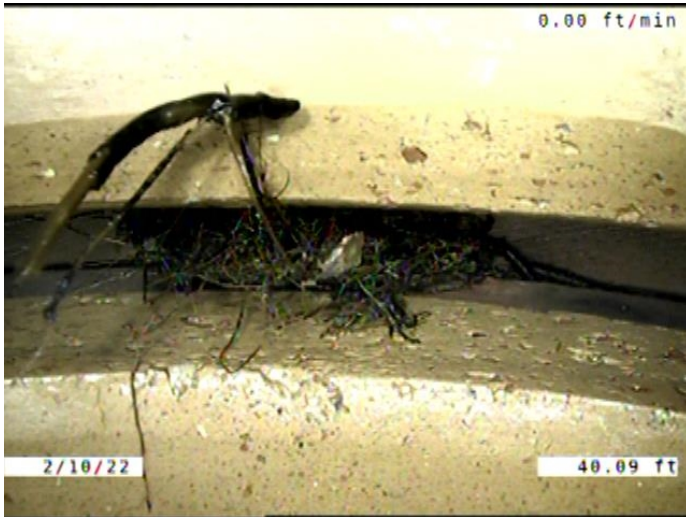
Code: **RFJ**
 Description: **Roots Fine Joint**

Distance (ft): **40.1**
 Structural Grade: **0**
 O&M Grade: **1**
 Clock Start/From: **10**
 Clock To:
 1st Value:
 2nd Value:
 Value Percent:
 Continuous Index:
 Within 8" of Joint: **YES**
 Remarks:

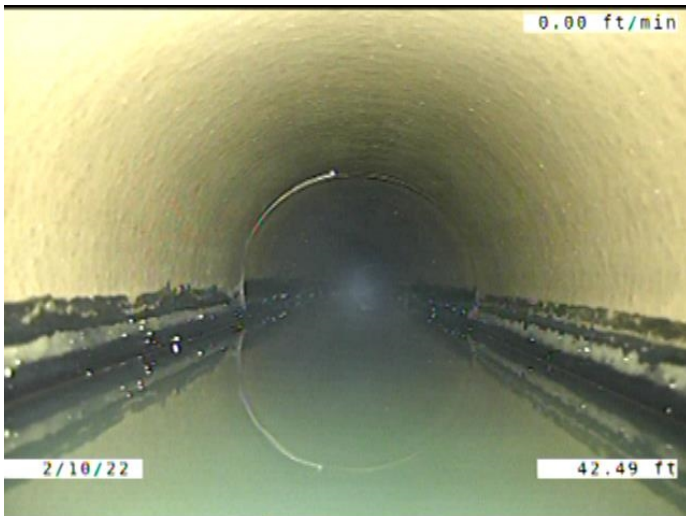
Code: **MWL**
 Description: **Miscellaneous Water Level**

Distance (ft): **42.5**
 Structural Grade: **0**
 O&M Grade: **0**
 Clock Start/From:
 Clock To:
 1st Value:
 2nd Value:
 Value Percent: **35.000**
 Continuous Index:
 Within 8" of Joint: **NO**
 Remarks:

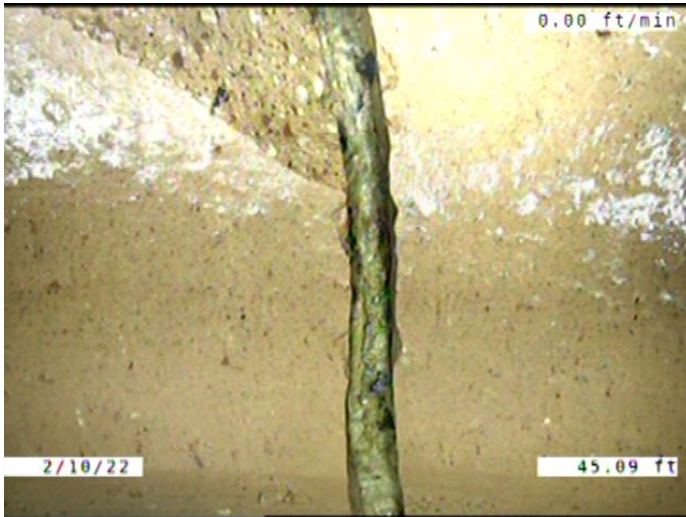
Code: **BSV**
Description: **Broken Soil Visible**

Distance (ft): **45.1**
Structural Grade: **5**
O&M Grade: **0**
Clock Start/From: **9**
Clock To: **12**
1st Value:
2nd Value:
Value Percent:
Continuous Index:
Within 8" of Joint: **YES**
Remarks:

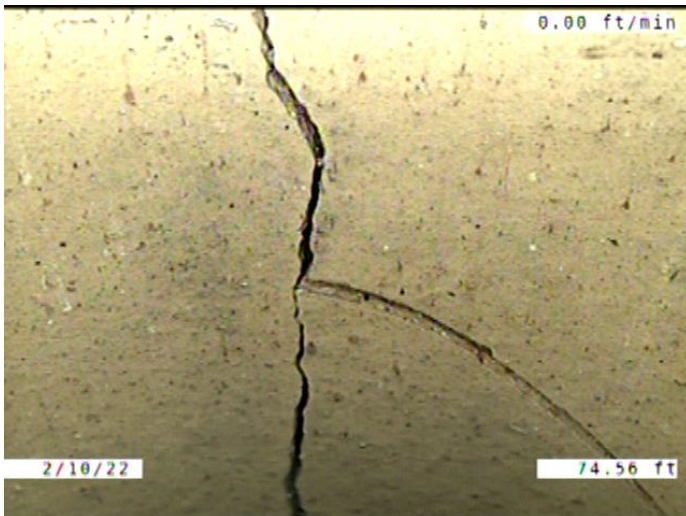
Code: **B**
Description: **Broken**

Distance (ft): **74.6**
Structural Grade: **4**
O&M Grade: **0**
Clock Start/From: **8**
Clock To: **2**
1st Value:
2nd Value:
Value Percent:
Continuous Index:
Within 8" of Joint: **YES**
Remarks:

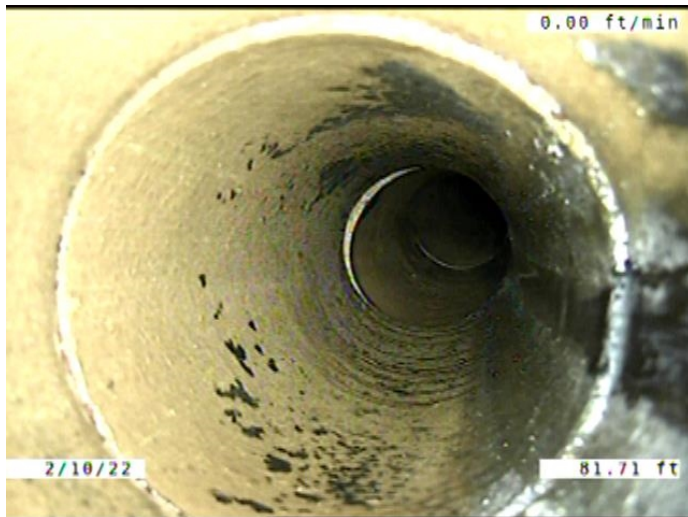
Code: **TF**
 Description: **Tap Factory**

Distance (ft): **81.7**
 Structural Grade: **0**
 O&M Grade: **0**
 Clock Start/From: **3**
 Clock To:
 1st Value: **6.000**
 2nd Value:
 Value Percent:
 Continuous Index:
 Within 8" of Joint: **YES**
 Remarks:

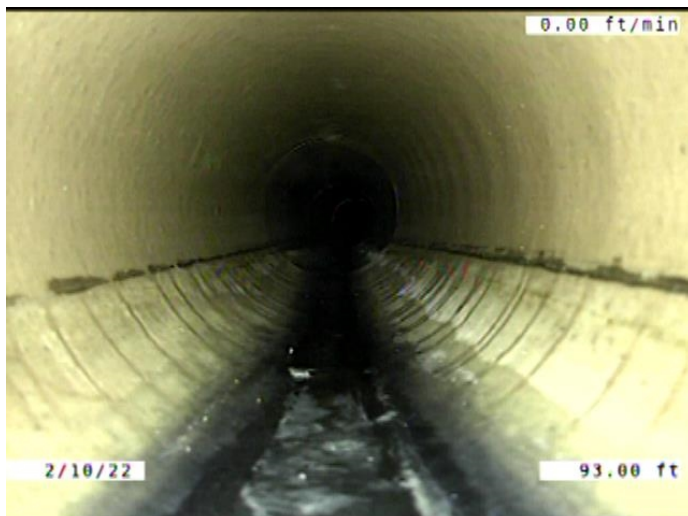
Code: **MWLS**
 Description: **Miscellaneous Water Level Sag**

Distance (ft): **93.0**
 Structural Grade: **2**
 O&M Grade: **0**
 Clock Start/From:
 Clock To:
 1st Value:
 2nd Value:
 Value Percent: **30.000**
 Continuous Index: **F01**
 Within 8" of Joint: **NO**
 Remarks:

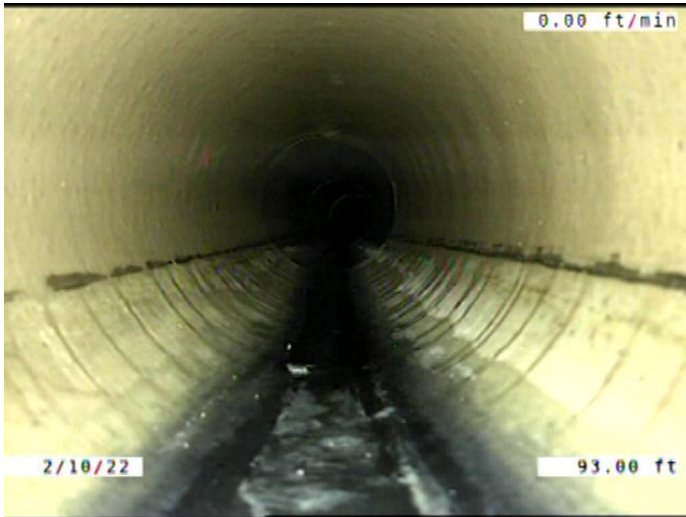
Code: **MWL**
 Description: **Miscellaneous Water Level**

Distance (ft): **93.0**
 Structural Grade: **0**
 O&M Grade: **0**
 Clock Start/From:
 Clock To:
 1st Value:
 2nd Value:
 Value Percent: **5.000**
 Continuous Index:
 Within 8" of Joint: **NO**
 Remarks:

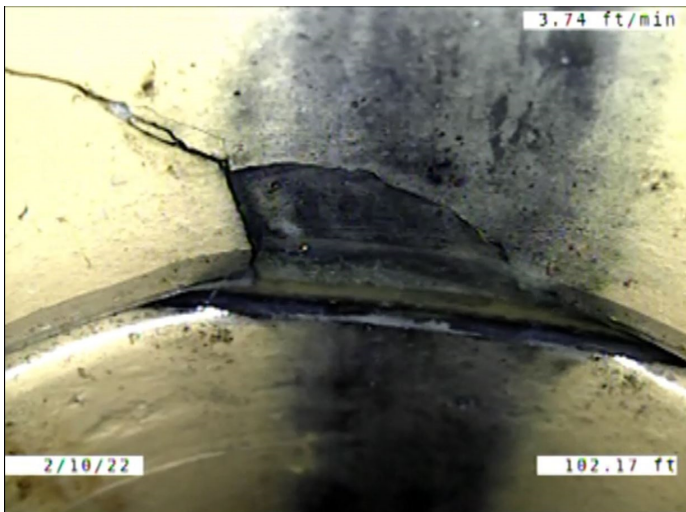
Code: **B**
 Description: **Broken**

Distance (ft): **102.2**
 Structural Grade: **4**
 O&M Grade: **0**
 Clock Start/From: **6**
 Clock To:
 1st Value:
 2nd Value:
 Value Percent:
 Continuous Index:
 Within 8" of Joint: **YES**
 Remarks:

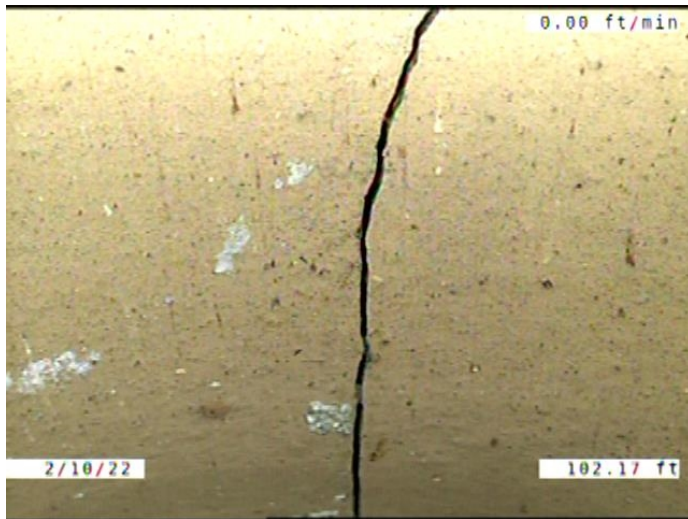
Code: **FS**
Description: **Fracture Spiral**

Distance (ft): **102.2**
Structural Grade: **3**
O&M Grade: **0**
Clock Start/From: **12**
Clock To: **5**
1st Value:
2nd Value:
Value Percent:
Continuous Index:
Within 8" of Joint: **YES**
Remarks:

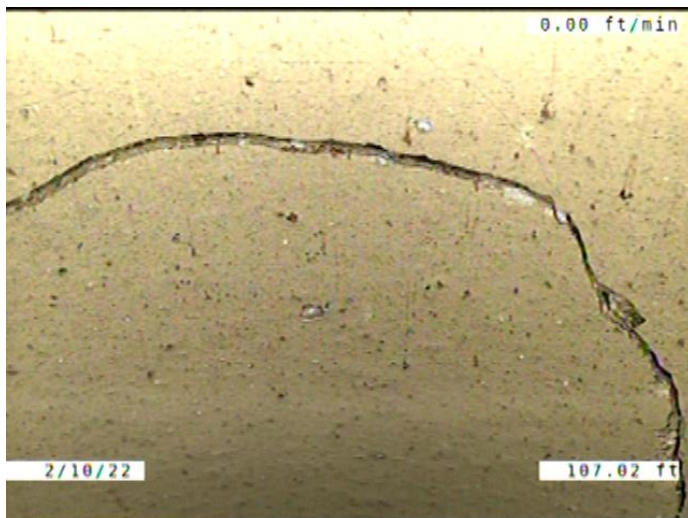
Code: **FC**
Description: **Fracture Circumferential**

Distance (ft): **107.0**
Structural Grade: **2**
O&M Grade: **0**
Clock Start/From: **10**
Clock To: **3**
1st Value:
2nd Value:
Value Percent:
Continuous Index:
Within 8" of Joint: **YES**
Remarks:

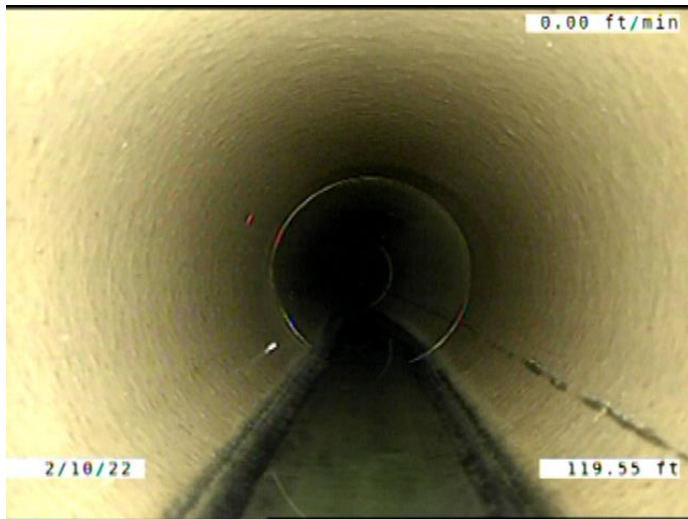
Code: **MWLS**
Description: **Miscellaneous Water Level Sag**

Distance (ft): **119.5**
Structural Grade: **2**
O&M Grade: **0**
Clock Start/From:
Clock To:
1st Value:
2nd Value:
Value Percent: **5.000**
Continuous Index: **S02**
Within 8" of Joint: **NO**
Remarks:

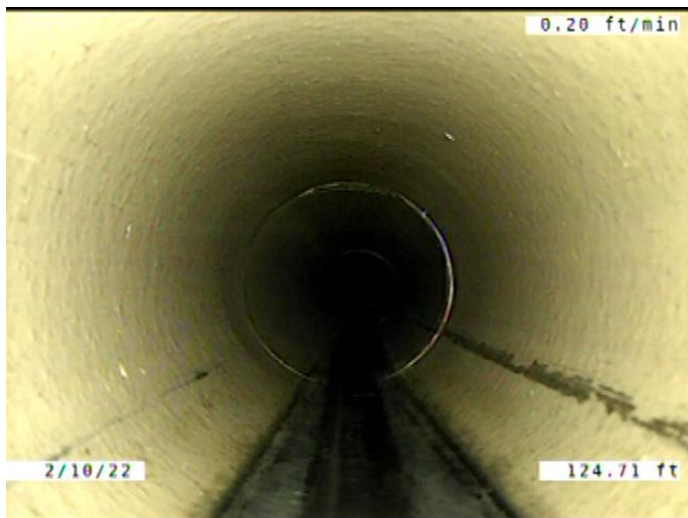
Code: **MWLS**
Description: **Miscellaneous Water Level Sag**

Distance (ft): **124.7**
Structural Grade: **2**
O&M Grade: **0**
Clock Start/From:
Clock To:
1st Value:
2nd Value:
Value Percent: **5.000**
Continuous Index: **F02**
Within 8" of Joint: **NO**
Remarks:

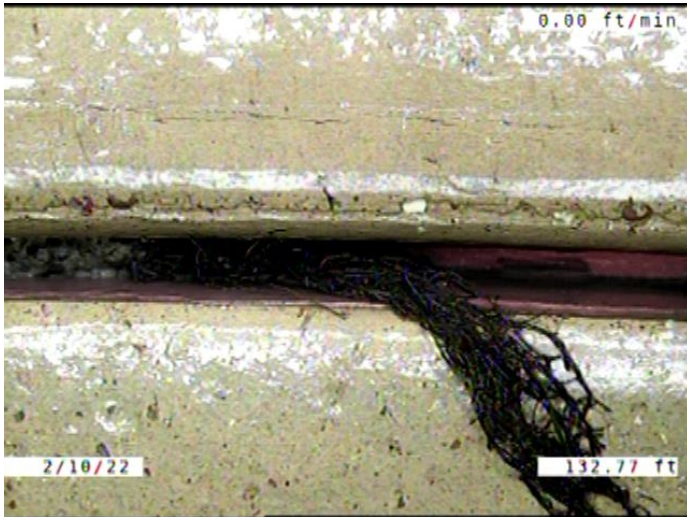
Code: **RFJ**
Description: **Roots Fine Joint**

Distance (ft): **132.8**
Structural Grade: **0**
O&M Grade: **1**
Clock Start/From: **2**
Clock To:
1st Value:
2nd Value:
Value Percent:
Continuous Index:
Within 8" of Joint: **YES**
Remarks:

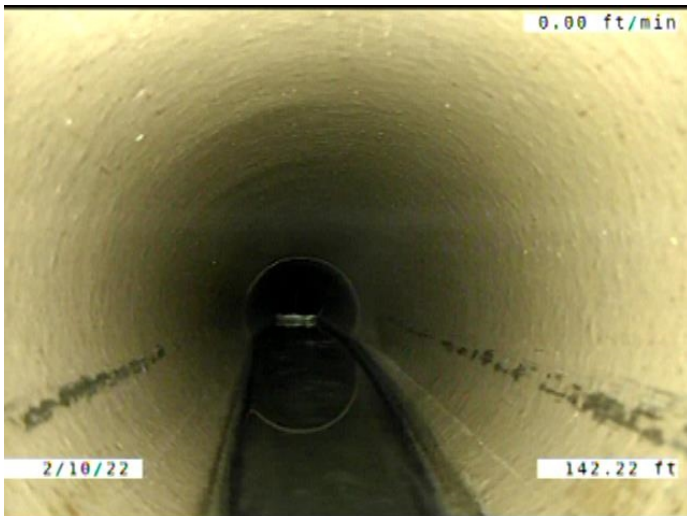
Code: **MWLS**
Description: **Miscellaneous Water Level Sag**

Distance (ft): **142.2**
Structural Grade: **2**
O&M Grade: **0**
Clock Start/From:
Clock To:
1st Value:
2nd Value:
Value Percent: **15.000**
Continuous Index: **S03**
Within 8" of Joint: **NO**
Remarks:

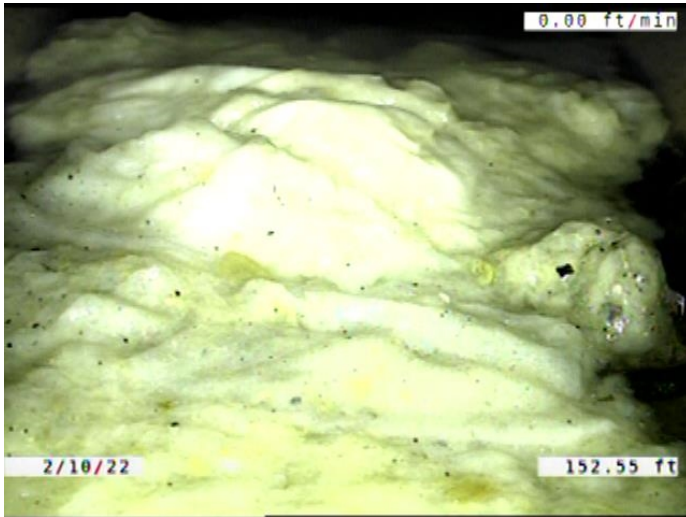
Code: **DAR**
Description: **Deposits Attached Ragging**

Distance (ft): **152.6**
Structural Grade: **0**
O&M Grade: **2**
Clock Start/From: **5**
Clock To: **7**
1st Value:
2nd Value:
Value Percent: **10.000**
Continuous Index:
Within 8" of Joint: **YES**
Remarks: **ALSO TP**

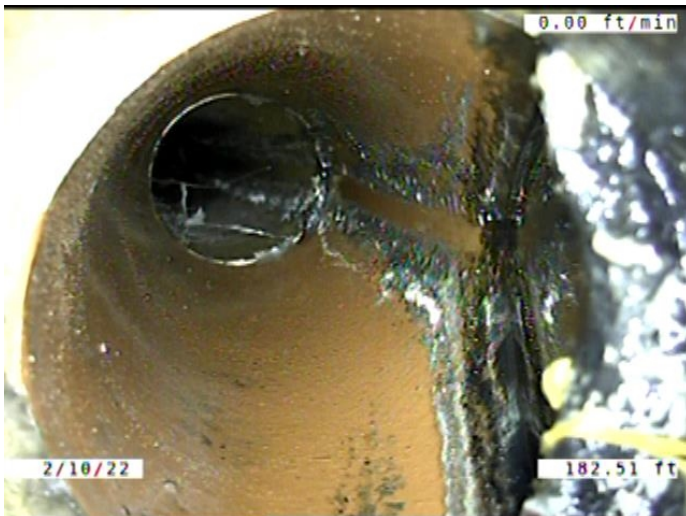
Code: **TF**
Description: **Tap Factory**

Distance (ft): **182.5**
Structural Grade: **0**
O&M Grade: **0**
Clock Start/From: **3**
Clock To:
1st Value: **6.000**
2nd Value:
Value Percent:
Continuous Index:
Within 8" of Joint: **YES**
Remarks:

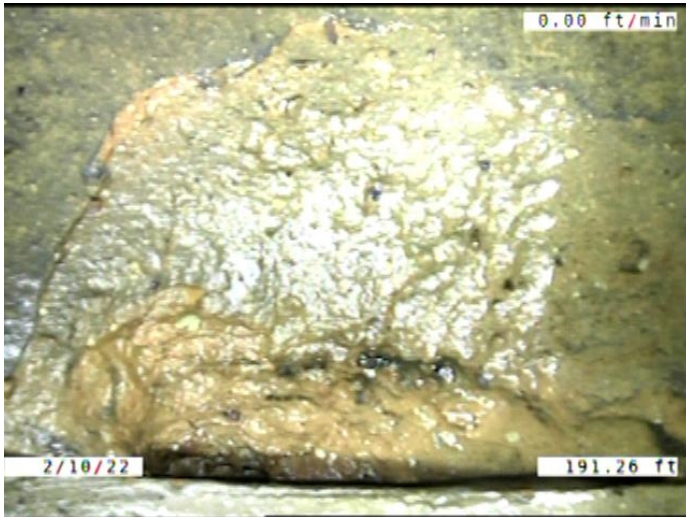
Code: **SSS**
 Description: **Surface Damage Surface Spalling**

Distance (ft): **191.3**
 Structural Grade: **2**
 O&M Grade: **0**
 Clock Start/From: **6**
 Clock To: **8**
 1st Value:
 2nd Value:
 Value Percent:
 Continuous Index:
 Within 8" of Joint: **YES**
 Remarks:

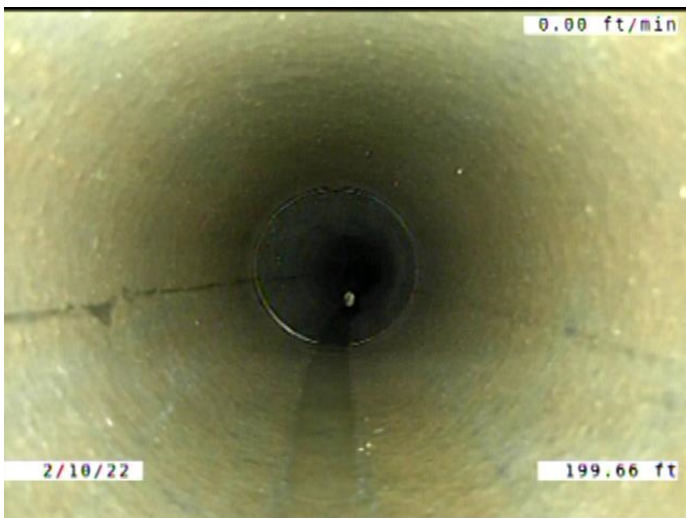
Code: **MWLS**
 Description: **Miscellaneous Water Level Sag**

Distance (ft): **199.7**
 Structural Grade: **2**
 O&M Grade: **0**
 Clock Start/From:
 Clock To:
 1st Value:
 2nd Value:
 Value Percent: **15.000**
 Continuous Index: **F03**
 Within 8" of Joint: **NO**
 Remarks:

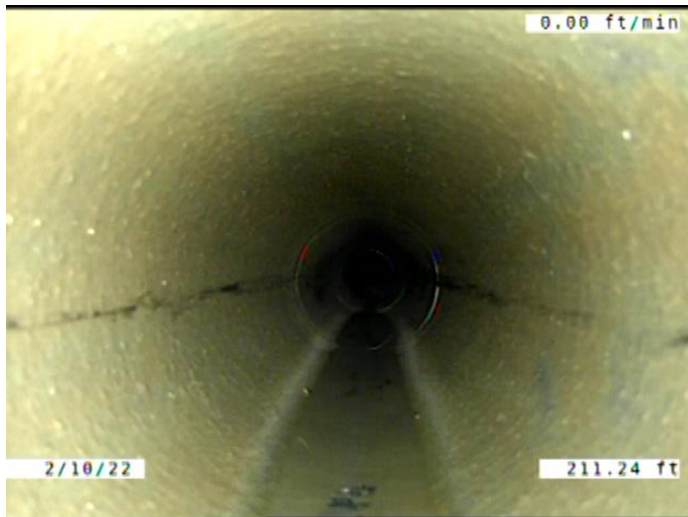
Code: **MWLS**
Description: **Miscellaneous Water Level Sag**

Distance (ft): **211.2**
Structural Grade: **2**
O&M Grade: **0**
Clock Start/From:
Clock To:
1st Value:
2nd Value:
Value Percent: **5.000**
Continuous Index: **S04**
Within 8" of Joint: **NO**
Remarks:

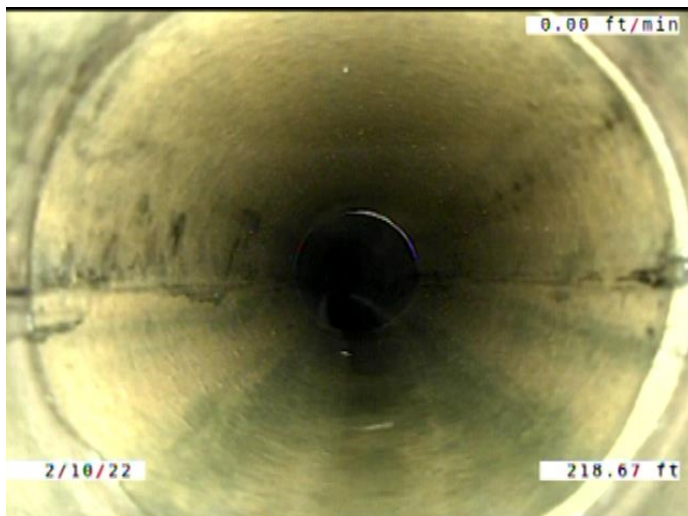
Code: **MWLS**
Description: **Miscellaneous Water Level Sag**

Distance (ft): **218.7**
Structural Grade: **2**
O&M Grade: **0**
Clock Start/From:
Clock To:
1st Value:
2nd Value:
Value Percent: **5.000**
Continuous Index: **F04**
Within 8" of Joint: **NO**
Remarks:

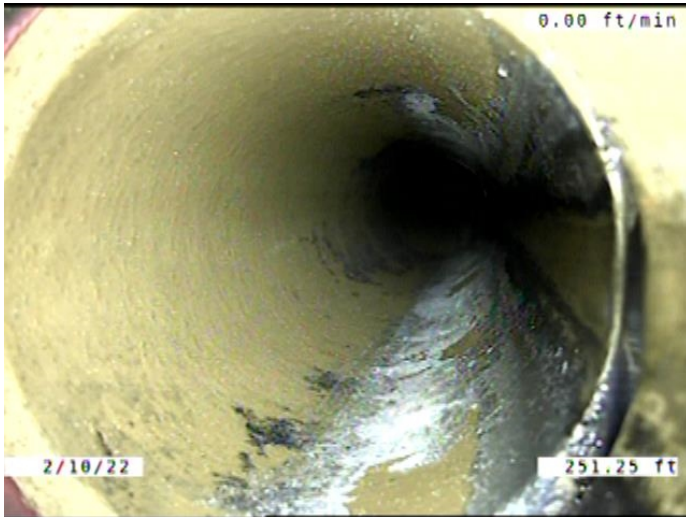
Code: **TF**
Description: **Tap Factory**

Distance (ft): **251.2**
Structural Grade: **0**
O&M Grade: **0**
Clock Start/From: **3**
Clock To:
1st Value: **6.000**

2nd Value:
Value Percent:
Continuous Index:
Within 8" of Joint: **YES**
Remarks: **ANGLED JOINT ON THE SERVICE TO MAIN CONNECTION. SOIL VISIBLE**

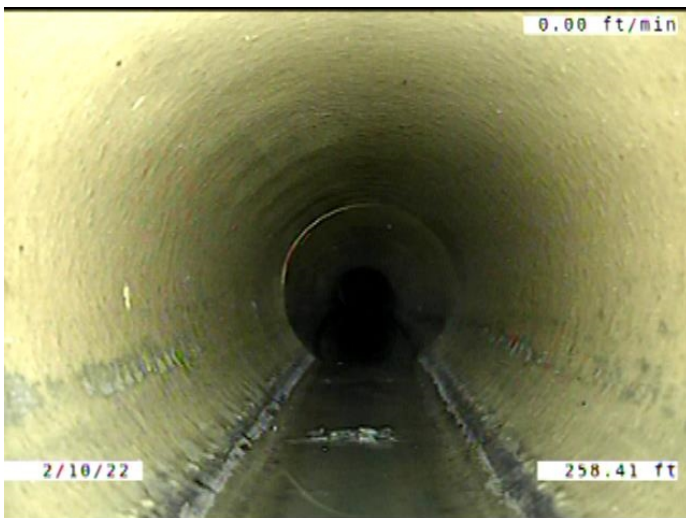
Code: **MWLS**
Description: **Miscellaneous Water Level Sag**

Distance (ft): **258.4**
Structural Grade: **2**
O&M Grade: **0**
Clock Start/From:
Clock To:
1st Value:
2nd Value:
Value Percent: **10.000**

Continuous Index: **S05**
Within 8" of Joint: **NO**
Remarks:

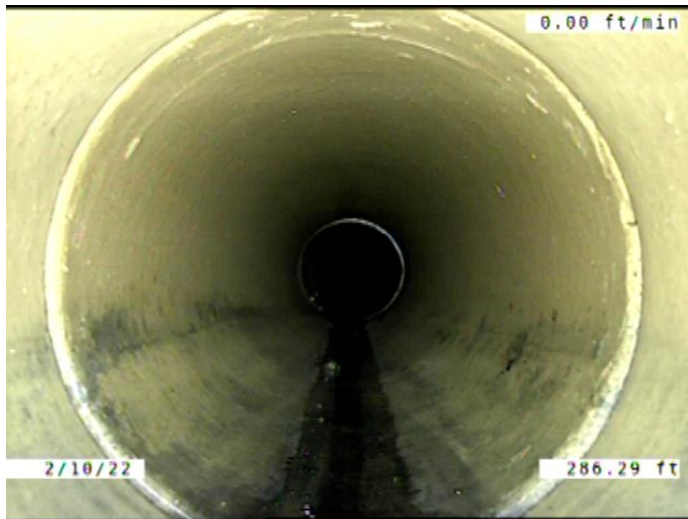
Code: **MWLS**
Description: **Miscellaneous Water Level Sag**

Distance (ft): **286.3**
Structural Grade: **2**
O&M Grade: **0**
Clock Start/From:
Clock To:
1st Value:
2nd Value:
Value Percent: **10.000**
Continuous Index: **F05**
Within 8" of Joint: **NO**
Remarks:

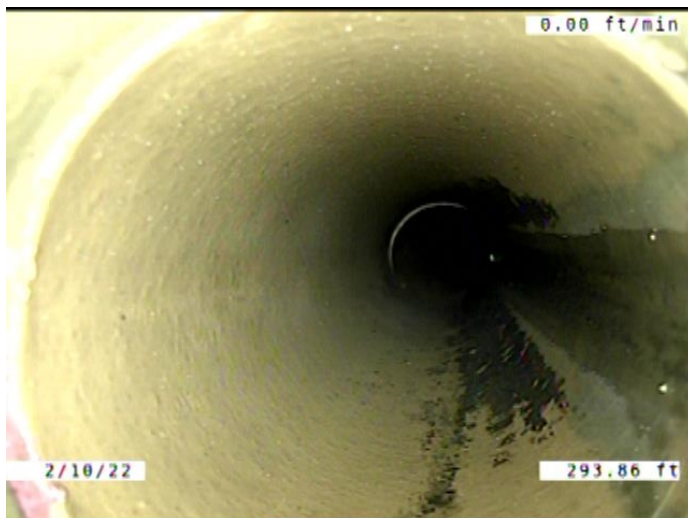
Code: **TF**
Description: **Tap Factory**

Distance (ft): **293.9**
Structural Grade: **0**
O&M Grade: **0**
Clock Start/From: **3**
Clock To:
1st Value: **6.000**
2nd Value:
Value Percent:
Continuous Index:
Within 8" of Joint: **YES**
Remarks:

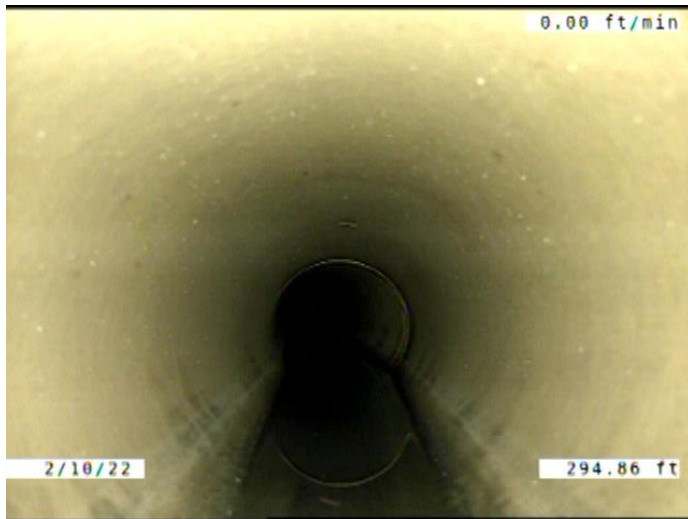
Code: **MWLS**
Description: **Miscellaneous Water Level Sag**

Distance (ft): **294.9**
Structural Grade: **2**
O&M Grade: **0**
Clock Start/From:
Clock To:
1st Value:
2nd Value:
Value Percent: **10.000**
Continuous Index: **S06**
Within 8" of Joint: **NO**
Remarks:

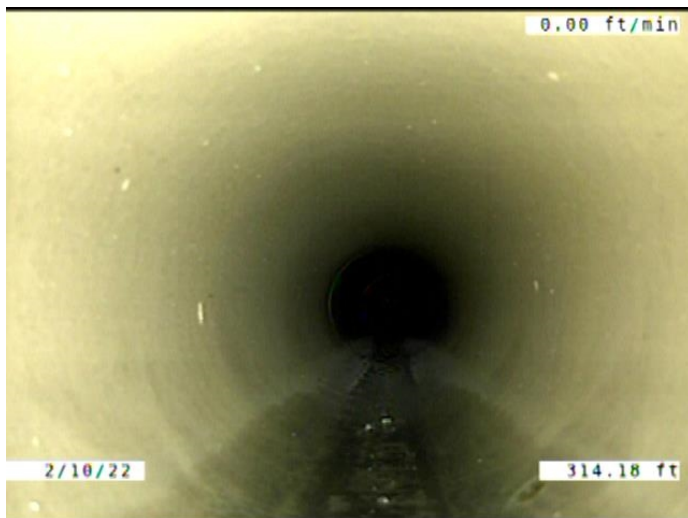
Code: **MWLS**
Description: **Miscellaneous Water Level Sag**

Distance (ft): **314.2**
Structural Grade: **2**
O&M Grade: **0**
Clock Start/From:
Clock To:
1st Value:
2nd Value:
Value Percent: **10.000**
Continuous Index: **F06**
Within 8" of Joint: **NO**
Remarks:

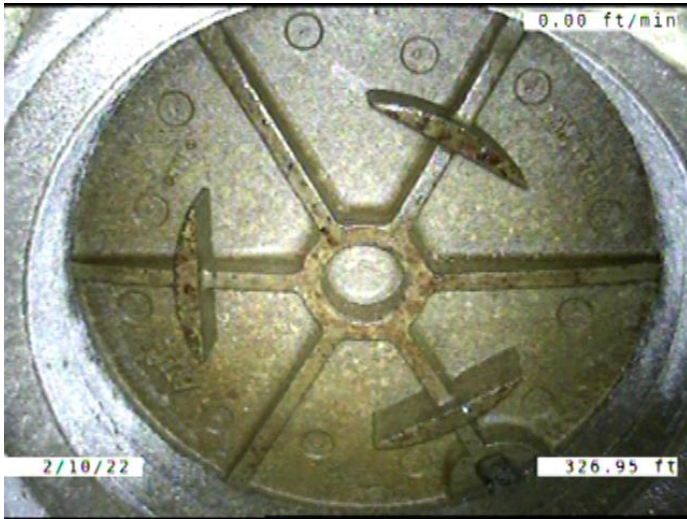
Code:	AMH
Description:	Manhole
Distance (ft):	326.9
Structural Grade:	0
O&M Grade:	0
Clock Start/From:	
Clock To:	
1st Value:	
2nd Value:	
Value Percent:	
Continuous Index:	
Within 8" of Joint:	NO
Remarks:	M-707-023
