Profile/Photo Observation Report

Street:	Capitol	Flow Control:	Not Controlled
City:	Hobart, IN	Year Renewed:	
Location:	Light Highway	Tape/Media #:	
Purpose:	Maintenance Related	Dia/Height:	8"
Use:	Sanitary	Material:	PVC
Drain Area:	NA	Lining:	Cured in Place
Category:	NA		
Comment:	blk silt at 13'-flow incorrect.

Location Details:		Direction of Survey:	Upstream
US MH:	M-707-026	DS MH:	M-707-022
		Total Length Surveyed (ft):	14.8

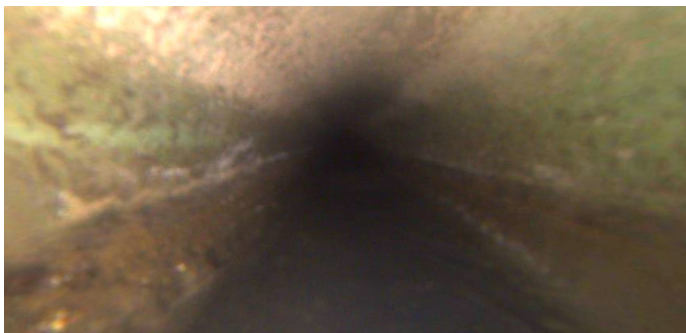
Code: **AMH**
Description: **Manhole**

Distance (ft): **.0**
Structural Grade: **0**
O&M Grade: **0**
Clock Start/From:
Clock To:
1st Value:
2nd Value:
Value Percent:
Continuous Index:
Within 8" of Joint: **NO**
Remarks: **M-707-022**

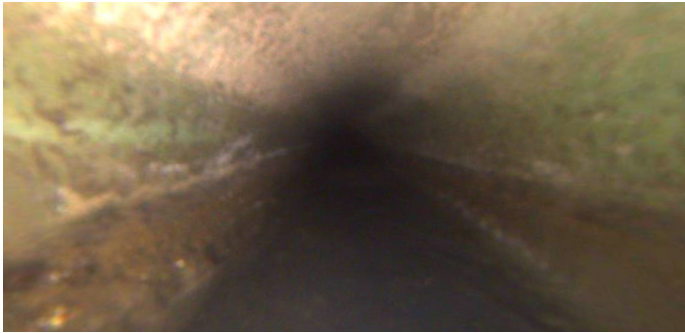
Code:	MWL
Description:	Water Level

Distance (ft):	.0
Structural Grade:	0
O&M Grade:	0
Clock Start/From:	
Clock To:	
1st Value:	
2nd Value:	
Value Percent:	10.000
Continuous Index:	
Within 8" of Joint:	NO
Remarks:

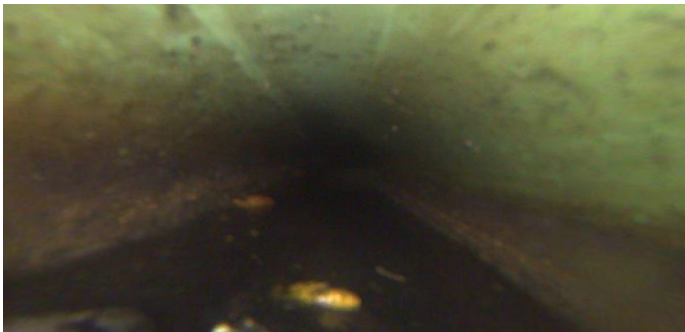
Code:	MSA
Description:	Abandoned Survey

Distance (ft):	14.8
Structural Grade:	0
O&M Grade:	0
Clock Start/From:	
Clock To:	
1st Value:	
2nd Value:	
Value Percent:	
Continuous Index:	
Within 8" of Joint:	NO
Remarks:	debris under water
