## Profile/Photo Observation Report

Date:	<b>04/09/2018</b>	Weather:		Coding:	<b>PACP 6.0</b>
Pipe Length (ft):	<b>249.3</b>	Owner:	<b>NA</b>	Pre Clean:	<b>Not Known</b>
P.O.#:		Surveyor:	<b>Jen Costello</b>	PSR:	<b>P-707-026-027</b>
Customer:		Clean Date:	<b>01/01/1900</b>	Shape:	<b>C</b>

Street:	<b>Capitol</b>	Flow Control:	<b>Not Controlled</b>
City:	<b>Hobart, IN</b>	Year Renewed:	
Location:	<b>Light Highway</b>	Tape/Media #:	
Purpose:	<b>Maintenance Related</b>	Dia/Height:	<b>8"</b>
Use:	<b>Sanitary</b>	Material:	<b>PVC</b>
Drain Area:	<b>NA</b>	Lining:	<b>Cured in Place</b>
Category:	<b>NA</b>		
Comment:	<b>blk silt at 89', flow incorrect.</b>		
Location Details:		Direction of Survey:	<b>Upstream</b>
US MH:	<b>M-707-027</b>	DS MH:	<b>M-707-026</b>
		Total Length Surveyed (ft):	<b>90.3</b>

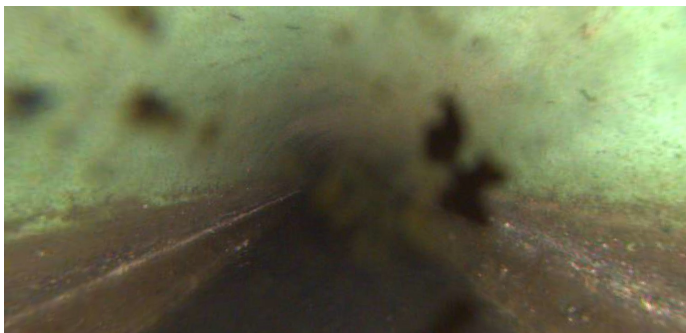
Code: **AMH**  
Description: **Manhole**

Distance (ft): **.0**  
Structural Grade: **0**  
O&M Grade: **0**  
Clock Start/From:  
Clock To:  
1st Value:  
2nd Value:  
Value Percent:  
Continuous Index:  
Within 8" of Joint: **NO**  
Remarks: **M-707-026**

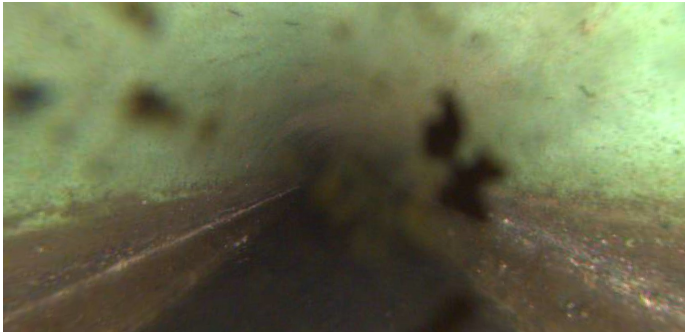
Code:	<b>MWL</b>
Description:	<b>Water Level</b>

Distance (ft):	<b>.0</b>
Structural Grade:	<b>0</b>
O&M Grade:	<b>0</b>
Clock Start/From:	
Clock To:	
1st Value:	
2nd Value:	
Value Percent:	<b>10.000</b>
Continuous Index:	
Within 8" of Joint:	<b>NO</b>
Remarks:

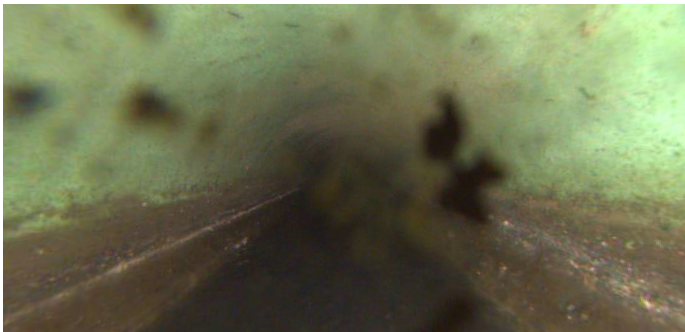
Code:	<b>DAGS</b>
Description:	<b>Deposits Attached Grease</b>

Distance (ft):	<b>.0</b>
Structural Grade:	<b>0</b>
O&M Grade:	<b>2</b>
Clock Start/From:	<b>7</b>
Clock To:	<b>5</b>
1st Value:	
2nd Value:	
Value Percent:	<b>5.000</b>
Continuous Index:	<b>S01</b>
Within 8" of Joint:	<b>NO</b>
Remarks:

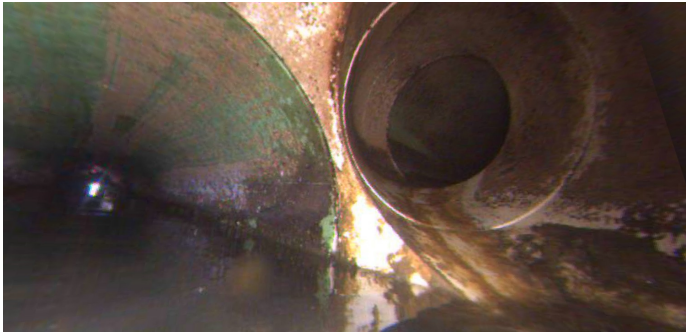
Code: **TF**  
Description: **Tap Factory**

Distance (ft): **43.7**  
Structural Grade: **0**  
O&M Grade: **0**  
Clock Start/From: **9**  
Clock To:  
1st Value: **4.000**  
2nd Value:  
Value Percent:  
Continuous Index:  
Within 8" of Joint:  
Remarks:

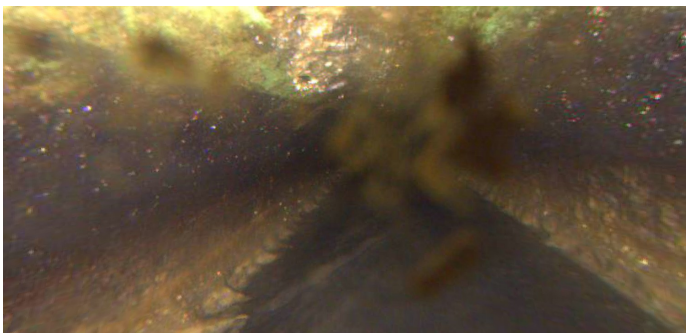
Code: **DAGS**  
Description: **Deposits Attached Grease**

Distance (ft): **90.3**  
Structural Grade: **0**  
O&M Grade: **2**  
Clock Start/From: **7**  
Clock To: **5**  
1st Value:  
2nd Value:  
Value Percent: **5.000**  
Continuous Index: **F01**  
Within 8" of Joint: **NO**  
Remarks:

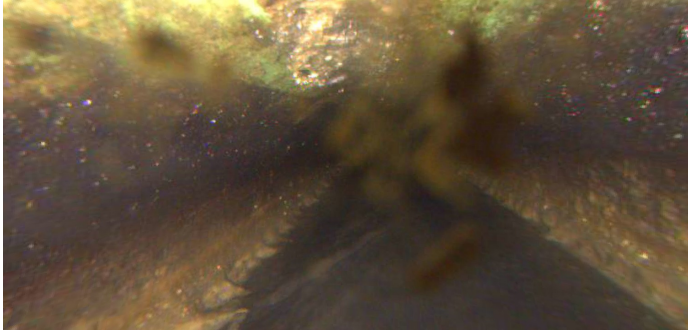
Code:	<b>MSA</b>
Description:	<b>Abandoned Survey</b>
Distance (ft):	<b>90.3</b>
Structural Grade:	<b>0</b>
O&M Grade:	<b>0</b>
Clock Start/From:	
Clock To:	
1st Value:	
2nd Value:	
Value Percent:	
Continuous Index:	
Within 8" of Joint:	<b>NO</b>
Remarks:	<b>dags</b>
