## Profile/Photo Observation Report

Date:	<b>04/09/2018</b>	Weather:		Coding:	<b>PACP 6.0</b>
Pipe Length (ft):	<b>167.5</b>	Owner:	<b>NA</b>	Pre Clean:	<b>Not Known</b>
P.O.#:		Surveyor:	<b>Byrd Fitzgerald</b>	PSR:	<b>P-707-028-027</b>
Customer:		Clean Date:	<b>01/01/1900</b>	Shape:	<b>C</b>

Street:	<b>LINCOLN ST &amp; E 12TH ST</b>	Flow Control:	<b>Not Controlled</b>
City:	<b>Hobart, IN</b>	Year Renewed:	
Location:	<b>Alley</b>	Tape/Media #:	
Purpose:	<b>Maintenance Related</b>	Dia/Height:	<b>8"</b>
Use:	<b>Sanitary</b>	Material:	<b>VCP</b>
Drain Area:	<b>NA</b>	Lining:	<b>Cured in Place</b>
Category:	<b>NA</b>		
Comment:	<b>heavy grit/sand at 29'.</b>		
Location Details:		Direction of Survey:	<b>Upstream</b>
US MH:	<b>M-707-027</b>	DS MH:	<b>M-707-028</b>
		Total Length Surveyed (ft):	<b>30.3</b>

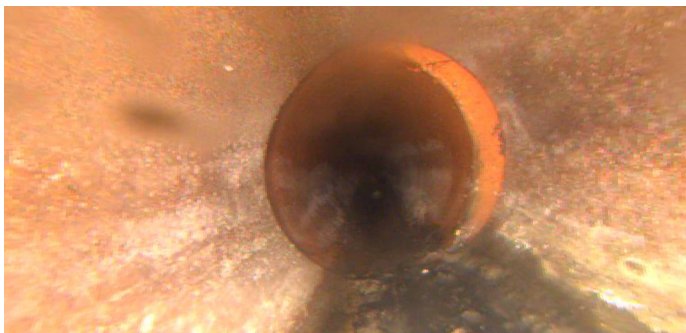
Code: **AMH**  
Description: **Manhole**

Distance (ft): **.0**  
Structural Grade: **0**  
O&M Grade: **0**  
Clock Start/From:  
Clock To:  
1st Value:  
2nd Value:  
Value Percent:  
Continuous Index:  
Within 8" of Joint: **NO**  
Remarks: **M-707-028**

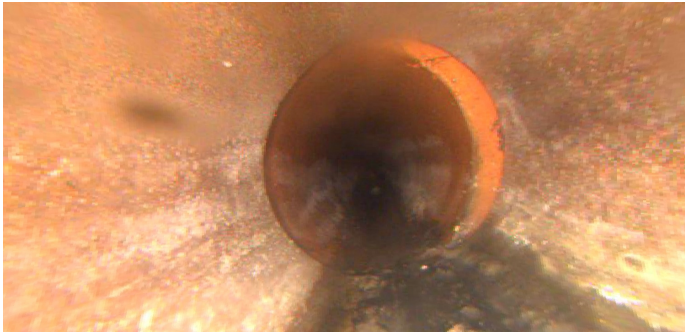
Code:	<b>MWL</b>
Description:	<b>Water Level</b>

Distance (ft):	<b>.0</b>
Structural Grade:	<b>0</b>
O&M Grade:	<b>0</b>
Clock Start/From:	
Clock To:	
1st Value:	
2nd Value:	
Value Percent:	<b>5.000</b>
Continuous Index:	
Within 8" of Joint:	<b>NO</b>
Remarks:

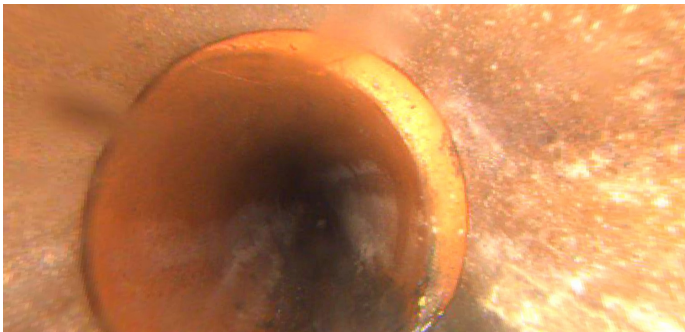
Code:	<b>CS</b>
Description:	<b>Crack Spiral</b>

Distance (ft):	<b>1.6</b>
Structural Grade:	<b>2</b>
O&M Grade:	<b>0</b>
Clock Start/From:	<b>11</b>
Clock To:	<b>1</b>
1st Value:	
2nd Value:	
Value Percent:	
Continuous Index:	
Within 8" of Joint:	<b>YES</b>
Remarks:

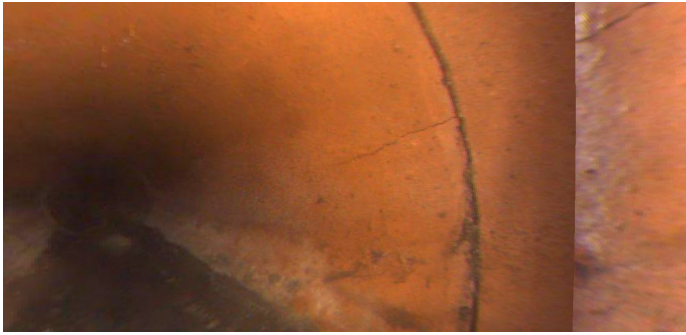
Code: **CM**  
Description: **Crack Multiple**

Distance (ft): **5.0**  
Structural Grade: **3**  
O&M Grade: **0**  
Clock Start/From: **9**  
Clock To: **3**  
1st Value:  
2nd Value:  
Value Percent:  
Continuous Index: **S01**  
Within 8" of Joint: **YES**  
Remarks: **wandering**

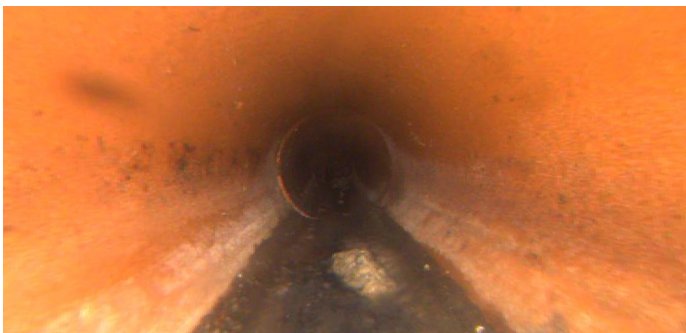
Code: **DSZ**  
Description: **Deposits Settled Other**

Distance (ft): **6.3**  
Structural Grade: **0**  
O&M Grade: **2**  
Clock Start/From: **6**  
Clock To:  
1st Value:  
2nd Value:  
Value Percent: **5.000**  
Continuous Index: **S02**  
Within 8" of Joint: **NO**  
Remarks: **debris**

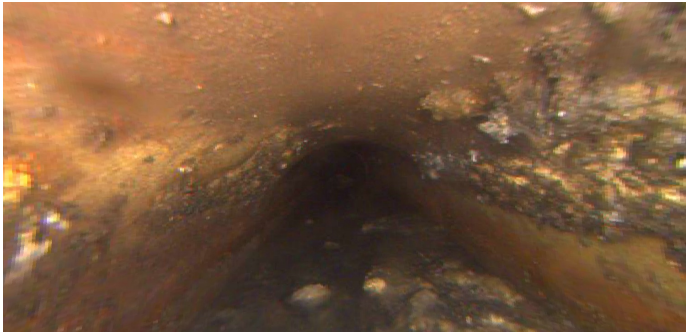
Code: **DAGS**  
Description: **Deposits Attached Grease**

Distance (ft): **22.3**  
Structural Grade: **0**  
O&M Grade: **2**  
Clock Start/From: **9**  
Clock To: **3**  
1st Value:  
2nd Value:  
Value Percent: **5.000**  
Continuous Index: **S03**  
Within 8" of Joint: **NO**  
Remarks:

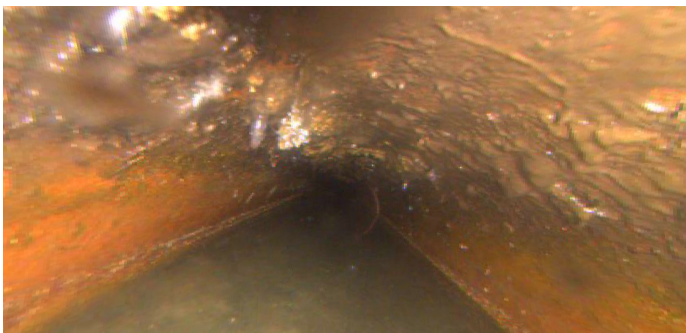
Code: **MSA**  
Description: **Abandoned Survey**

Distance (ft): **30.3**  
Structural Grade: **0**  
O&M Grade: **0**  
Clock Start/From:  
Clock To:  
1st Value:  
2nd Value:  
Value Percent:  
Continuous Index:  
Within 8" of Joint: **NO**  
Remarks: **no blockage**

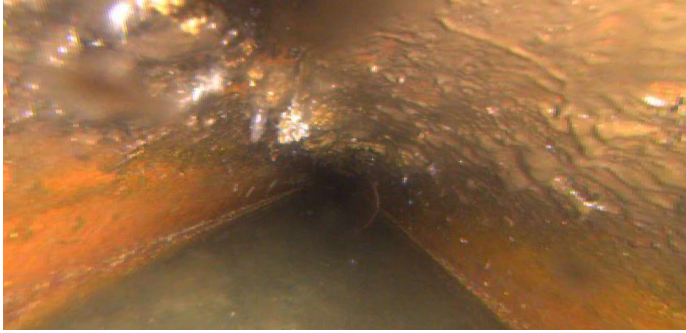
Code: **DAGS**  
Description: **Deposits Attached Grease**

Distance (ft): **30.3**  
Structural Grade: **0**  
O&M Grade: **2**  
Clock Start/From: **9**  
Clock To: **3**  
1st Value:  
2nd Value:  
Value Percent: **5.000**  
Continuous Index: **F03**  
Within 8" of Joint: **NO**  
Remarks:

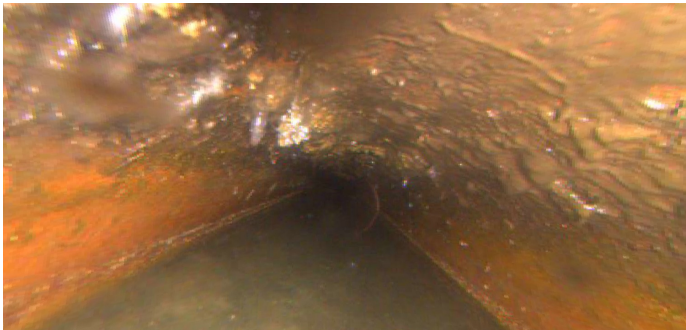
Code: **DSZ**  
Description: **Deposits Settled Other**

Distance (ft): **30.3**  
Structural Grade: **0**  
O&M Grade: **2**  
Clock Start/From: **6**  
Clock To:  
1st Value:  
2nd Value:  
Value Percent: **5.000**  
Continuous Index: **F02**  
Within 8" of Joint: **NO**  
Remarks: **debris**

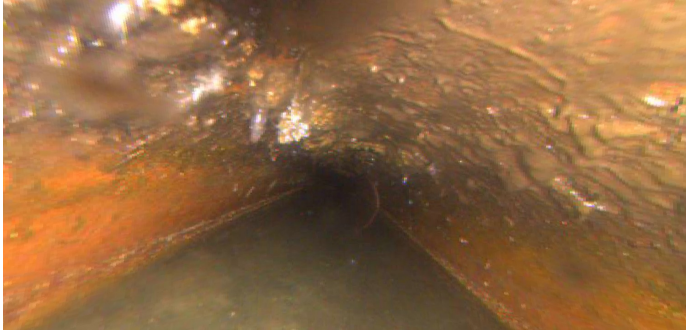
Code:	<b>CM</b>
Description:	<b>Crack Multiple</b>
Distance (ft):	<b>30.3</b>
Structural Grade:	<b>3</b>
O&M Grade:	<b>0</b>
Clock Start/From:	<b>9</b>
Clock To:	<b>3</b>
1st Value:	
2nd Value:	
Value Percent:	
Continuous Index:	<b>F01</b>
Within 8" of Joint:	<b>YES</b>
Remarks:	<b>wandering</b>
