Profile/Photo Observation Report

Date:	04/09/2018	Weather:		Coding:	PACP 6.0
Pipe Length (ft):	167.5	Owner:	NA	Pre Clean:	Not Known
P.O.#:		Surveyor:	Byrd Fitzgerald	PSR:	P-707-028-027
Customer:		Clean Date:	01/01/1900	Shape:	C

Street:	Capitol	Flow Control:	Not Controlled
City:	Hobart, IN	Year Renewed:	
Location:	Alley	Tape/Media #:	
Purpose:	Maintenance Related	Dia/Height:	8"
Use:	Sanitary	Material:	VCP
Drain Area:	NA	Lining:	Cured in Place
Category:	NA		
Comment:	heavy grit/sand at 29'.		
Location Details:		Direction of Survey:	Upstream
US MH:	M-707-027	DS MH:	M-707-028
		Total Length Surveyed (ft):	30.3

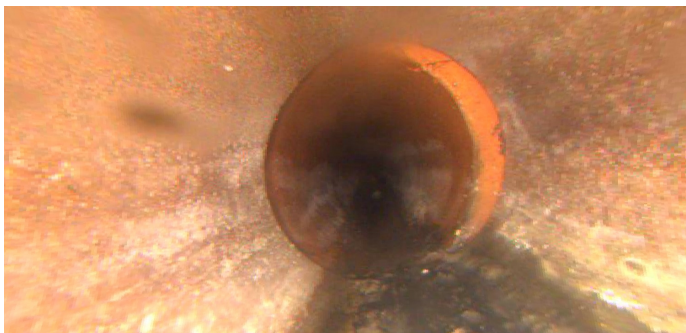
Code: **AMH**
Description: **Manhole**

Distance (ft): **.0**
Structural Grade: **0**
O&M Grade: **0**
Clock Start/From:
Clock To:
1st Value:
2nd Value:
Value Percent:
Continuous Index:
Within 8" of Joint: **NO**
Remarks: **M-707-028**

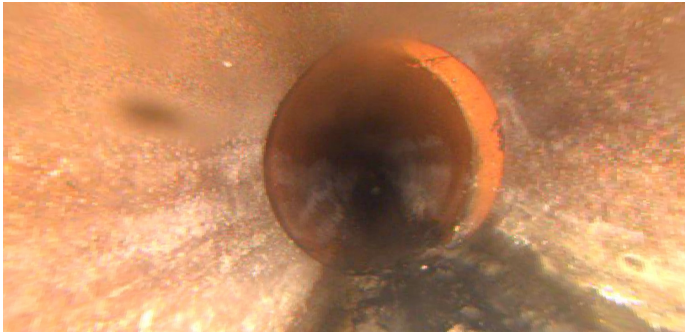
Code:	MWL
Description:	Water Level

Distance (ft):	.0
Structural Grade:	0
O&M Grade:	0
Clock Start/From:	
Clock To:	
1st Value:	
2nd Value:	
Value Percent:	5.000
Continuous Index:	
Within 8" of Joint:	NO
Remarks:

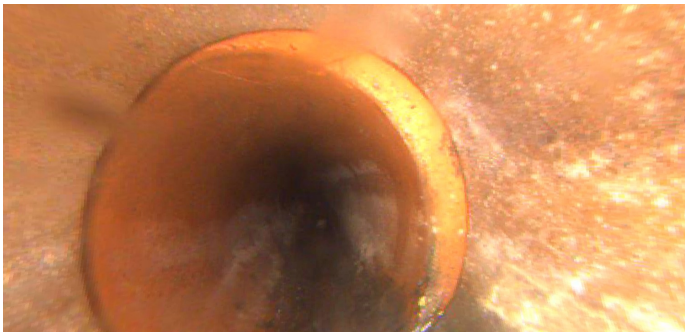
Code:	CS
Description:	Crack Spiral

Distance (ft):	1.6
Structural Grade:	2
O&M Grade:	0
Clock Start/From:	11
Clock To:	1
1st Value:	
2nd Value:	
Value Percent:	
Continuous Index:	
Within 8" of Joint:	YES
Remarks:

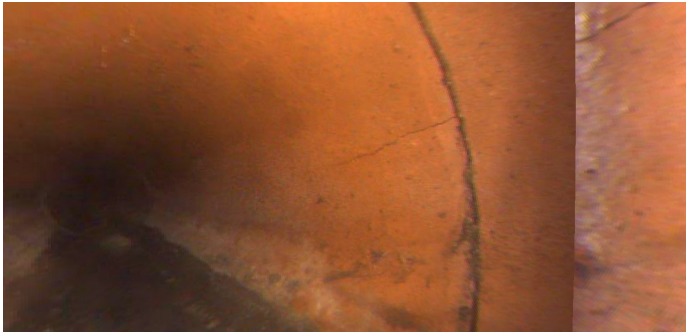
Code: **CM**
Description: **Crack Multiple**

Distance (ft): **5.0**
Structural Grade: **3**
O&M Grade: **0**
Clock Start/From: **9**
Clock To: **3**
1st Value:
2nd Value:
Value Percent:
Continuous Index: **S01**
Within 8" of Joint: **YES**
Remarks: **wandering**

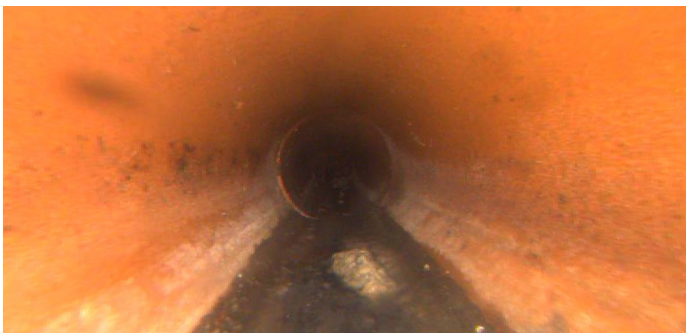
Code: **DSZ**
Description: **Deposits Settled Other**

Distance (ft): **6.3**
Structural Grade: **0**
O&M Grade: **2**
Clock Start/From: **6**
Clock To:
1st Value:
2nd Value:
Value Percent: **5.000**
Continuous Index: **S02**
Within 8" of Joint: **NO**
Remarks: **debris**

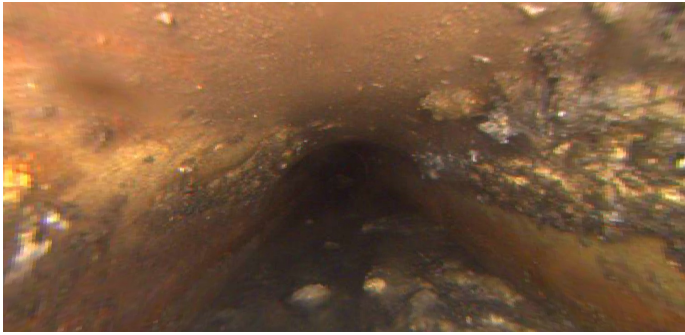
Code: **DAGS**
Description: **Deposits Attached Grease**

Distance (ft): **22.3**
Structural Grade: **0**
O&M Grade: **2**
Clock Start/From: **9**
Clock To: **3**
1st Value:
2nd Value:
Value Percent: **5.000**
Continuous Index: **S03**
Within 8" of Joint: **NO**
Remarks:

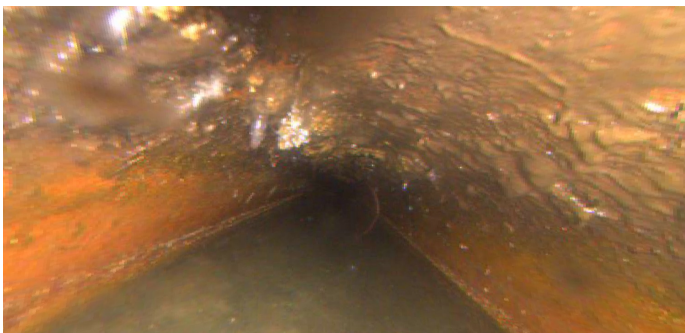
Code: **MSA**
Description: **Abandoned Survey**

Distance (ft): **30.3**
Structural Grade: **0**
O&M Grade: **0**
Clock Start/From:
Clock To:
1st Value:
2nd Value:
Value Percent:
Continuous Index:
Within 8" of Joint: **NO**
Remarks: **no blockage**

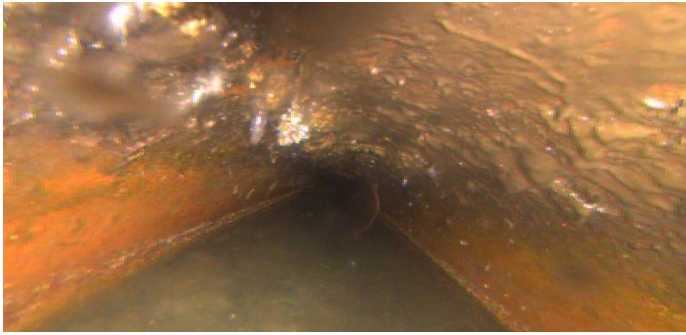
Code: **DAGS**
Description: **Deposits Attached Grease**

Distance (ft): **30.3**
Structural Grade: **0**
O&M Grade: **2**
Clock Start/From: **9**
Clock To: **3**
1st Value:
2nd Value:
Value Percent: **5.000**
Continuous Index: **F03**
Within 8" of Joint: **NO**
Remarks:

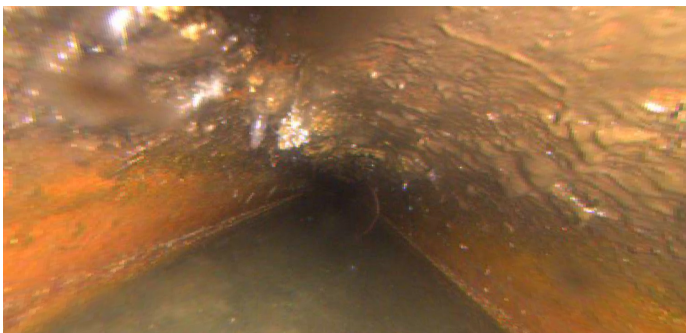
Code: **DSZ**
Description: **Deposits Settled Other**

Distance (ft): **30.3**
Structural Grade: **0**
O&M Grade: **2**
Clock Start/From: **6**
Clock To:
1st Value:
2nd Value:
Value Percent: **5.000**
Continuous Index: **F02**
Within 8" of Joint: **NO**
Remarks: **debris**

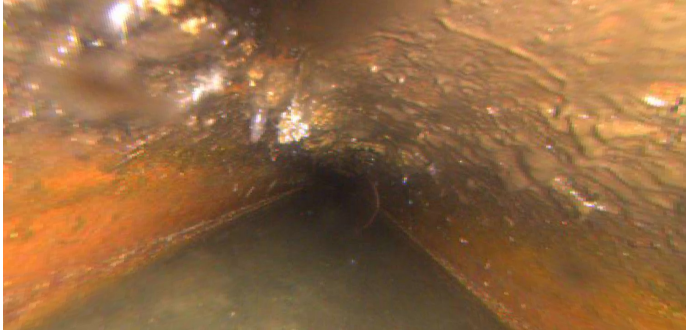
Code:	CM
Description:	Crack Multiple
Distance (ft):	30.3
Structural Grade:	3
O&M Grade:	0
Clock Start/From:	9
Clock To:	3
1st Value:	
2nd Value:	
Value Percent:	
Continuous Index:	F01
Within 8" of Joint:	YES
Remarks:	wandering
