Profile/Photo Observation Report

Street:	LINCOLN ST & E 12TH ST	Flow Control:	Not Controlled
City:	Hobart, IN	Year Renewed:	
Location:	Light Highway	Tape/Media #:	
Purpose:	Maintenance Related	Dia/Height:	8"
Use:	Sanitary	Material:	VCP
Drain Area:	NA	Lining:	Cured in Place
Category:	NA		
Comment:	Reverse setup. heavy blk silt at 15'- flow incorrect.		
Location Details:		Direction of Survey:	Downstream
US MH:	M-707-027	DS MH:	M-707-028
		Total Length Surveyed (ft):	16.9

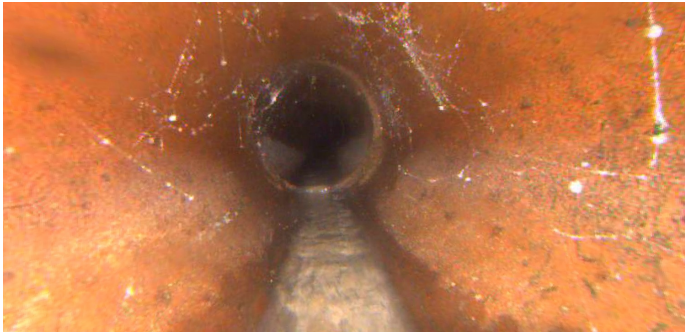
Code:	MWL
Description:	Water Level

Distance (ft):	.0
Structural Grade:	0
O&M Grade:	0
Clock Start/From:	
Clock To:	
1st Value:	
2nd Value:	
Value Percent:	5.000
Continuous Index:	
Within 8" of Joint:	NO
Remarks:

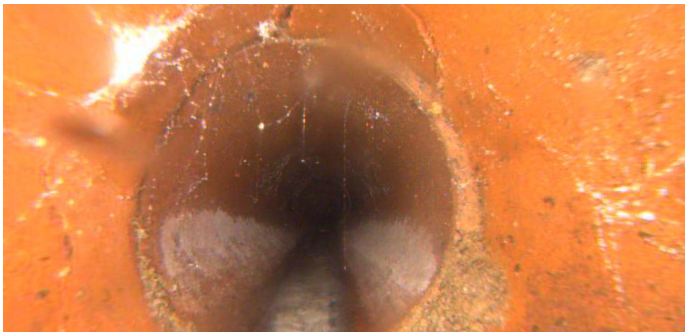
Code:	FM
Description:	Fracture Multiple

Distance (ft):	1.5
Structural Grade:	4
O&M Grade:	0
Clock Start/From:	8
Clock To:	4
1st Value:	
2nd Value:	
Value Percent:	
Continuous Index:	
Within 8" of Joint:	YES
Remarks:

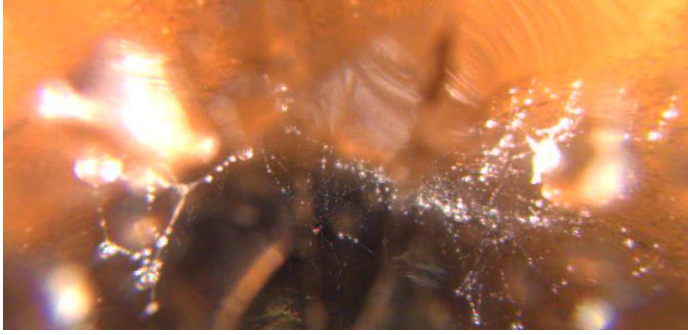
Code:	MSA
Description:	Abandoned Survey
Distance (ft):	16.9
Structural Grade:	0
O&M Grade:	0
Clock Start/From:	
Clock To:	
1st Value:	
2nd Value:	
Value Percent:	
Continuous Index:	
Within 8" of Joint:	NO
Remarks:	DEBRIS UNDER WATER
