Profile/Photo Observation Report

Date:	04/10/2018	Weather:		Coding:	PACP 6.0
Pipe Length (ft):	167.5	Owner:	NA	Pre Clean:	Not Known
P.O.#:		Surveyor:	Jen Costello	PSR:	P-707-028-027
Customer:		Clean Date:	01/01/1900	Shape:	C

Street:	Capitol	Flow Control:	Not Controlled
City:	Hobart, IN	Year Renewed:	
Location:	Light Highway	Tape/Media #:	
Purpose:	Maintenance Related	Dia/Height:	8"
Use:	Sanitary	Material:	VCP
Drain Area:	NA	Lining:	Cured in Place
Category:	NA		
Comment:	Reverse setup. heavy blk silt at 15'- flow incorrect.		
Location Details:		Direction of Survey:	Downstream
US MH:	M-707-027	DS MH:	M-707-028
		Total Length Surveyed (ft):	16.9

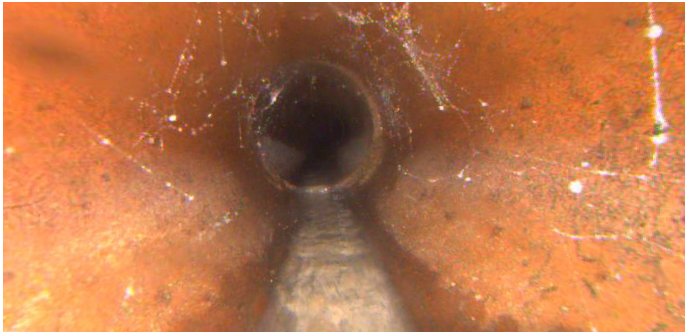
Code:	MWL
Description:	Water Level

Distance (ft):	.0
Structural Grade:	0
O&M Grade:	0
Clock Start/From:	
Clock To:	
1st Value:	
2nd Value:	
Value Percent:	5.000
Continuous Index:	
Within 8" of Joint:	NO
Remarks:

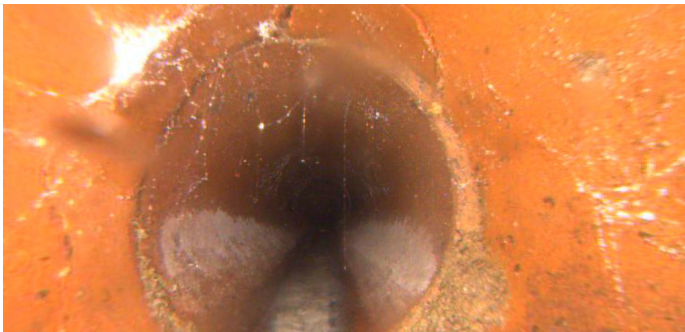
Code:	FM
Description:	Fracture Multiple

Distance (ft):	1.5
Structural Grade:	4
O&M Grade:	0
Clock Start/From:	8
Clock To:	4
1st Value:	
2nd Value:	
Value Percent:	
Continuous Index:	
Within 8" of Joint:	YES
Remarks:

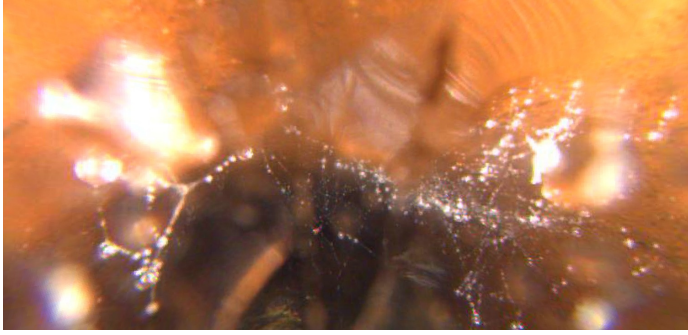
Code:	MSA
Description:	Abandoned Survey
Distance (ft):	16.9
Structural Grade:	0
O&M Grade:	0
Clock Start/From:	
Clock To:	
1st Value:	
2nd Value:	
Value Percent:	
Continuous Index:	
Within 8" of Joint:	NO
Remarks:	DEBRIS UNDER WATER
