Profile/Photo Observation Report

Date:	04/10/2018	Weather:		Coding:	PACP 6.0
Pipe Length (ft):	229.2	Owner:	NA	Pre Clean:	Not Known
P.O.#:		Surveyor:	Mark Ruby	PSR:	P-707-027-029
Customer:		Clean Date:	01/01/1900	Shape:	C

Street:	LINCOLN ST & E 12TH ST	Flow Control:	Not Controlled
City:	Hobart, IN	Year Renewed:	
Location:	Light Highway	Tape/Media #:	
Purpose:	Maintenance Related	Dia/Height:	8"
Use:	Sanitary	Material:	PVC
Drain Area:	NA	Lining:	Cured in Place
Category:	NA		
Comment:	heavy silt/underwater at 94'.-flow incorrect.		
Location Details:		Direction of Survey:	Downstream
US MH:	M-707-029	DS MH:	M-707-027
		Total Length Surveyed (ft):	96.0

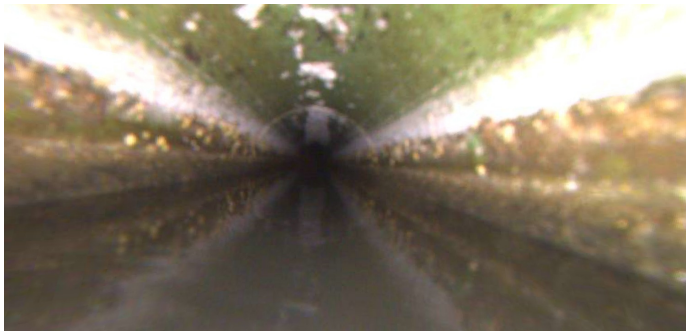
Code: **DAGS**
Description: **Deposits Attached Grease**

Distance (ft): **.0**
Structural Grade: **0**
O&M Grade: **2**
Clock Start/From: **8**
Clock To: **4**
1st Value:
2nd Value:
Value Percent: **5.000**
Continuous Index: **S01**
Within 8" of Joint: **NO**
Remarks:

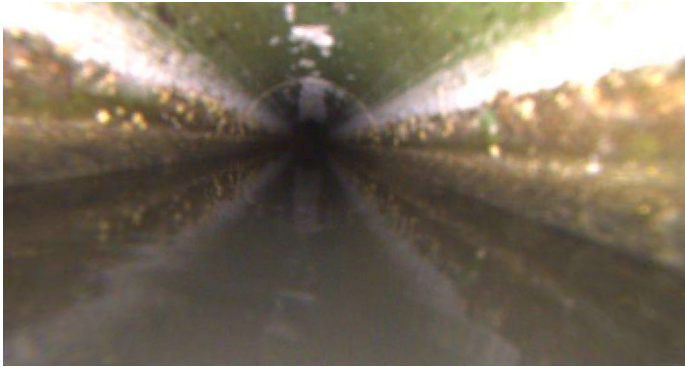
Code:	AMH
Description:	Manhole

Distance (ft):	.0
Structural Grade:	0
O&M Grade:	0
Clock Start/From:	
Clock To:	
1st Value:	
2nd Value:	
Value Percent:	
Continuous Index:	
Within 8" of Joint:	NO
Remarks:	M-707-029

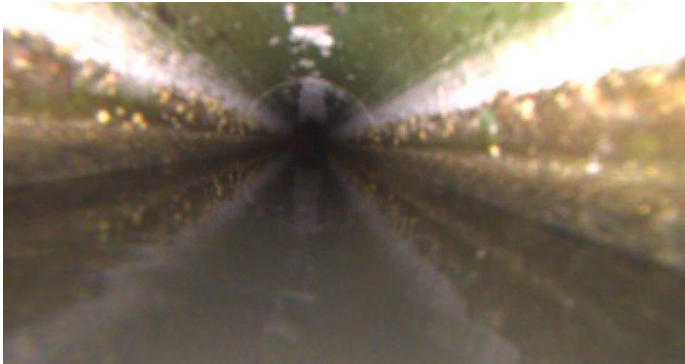
Code:	MWL
Description:	Water Level

Distance (ft):	.0
Structural Grade:	0
O&M Grade:	0
Clock Start/From:	
Clock To:	
1st Value:	
2nd Value:	
Value Percent:	10.000
Continuous Index:	
Within 8" of Joint:	NO
Remarks:

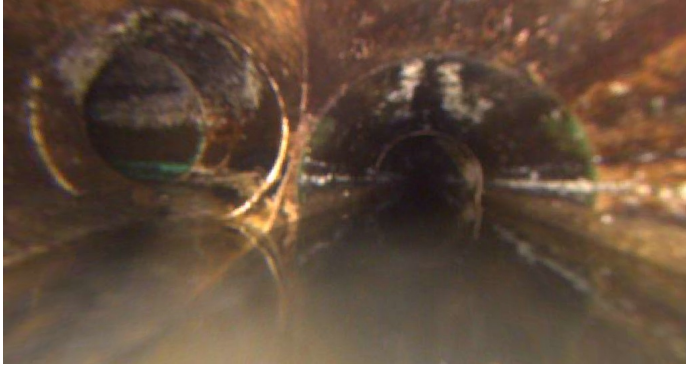
Code: **TF**
Description: **Tap Factory**

Distance (ft): **35.1**
Structural Grade: **0**
O&M Grade: **0**
Clock Start/From: **8**
Clock To:
1st Value: **4.000**
2nd Value:
Value Percent:
Continuous Index:
Within 8" of Joint:
Remarks:

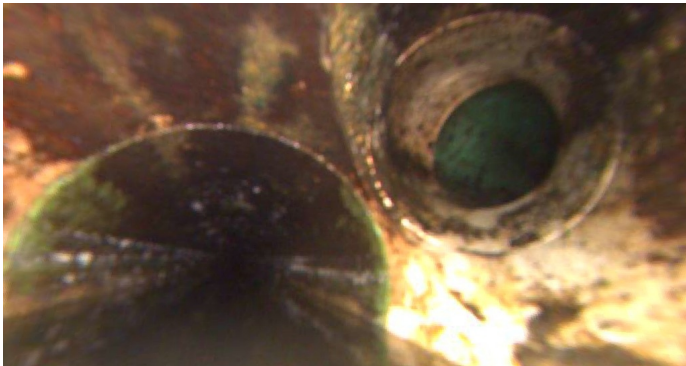
Code: **TF**
Description: **Tap Factory**

Distance (ft): **37.2**
Structural Grade: **0**
O&M Grade: **0**
Clock Start/From: **2**
Clock To:
1st Value: **4.000**
2nd Value:
Value Percent:
Continuous Index:
Within 8" of Joint:
Remarks:

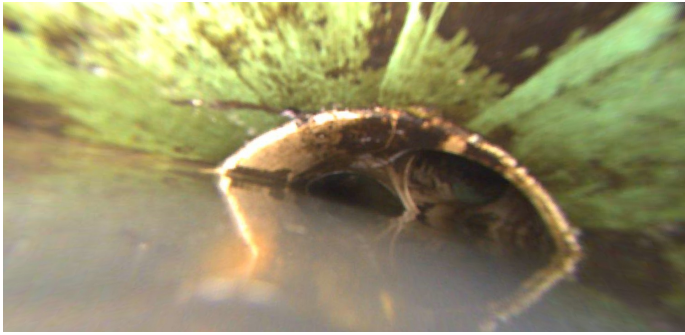
Code: **DAGS**
Description: **Deposits Attached Grease**

Distance (ft): **94.4**
Structural Grade: **0**
O&M Grade: **2**
Clock Start/From: **8**
Clock To: **4**
1st Value:
2nd Value:
Value Percent: **5.000**
Continuous Index: **F01**
Within 8" of Joint: **NO**
Remarks:

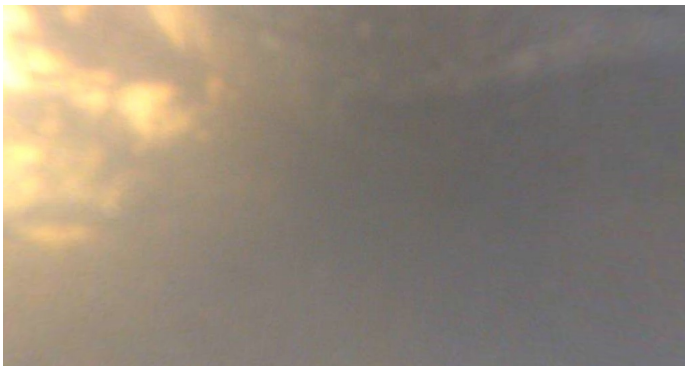
Code: **TF**
Description: **Tap Factory**

Distance (ft): **94.8**
Structural Grade: **0**
O&M Grade: **0**
Clock Start/From: **4**
Clock To:
1st Value: **4.000**
2nd Value:
Value Percent:
Continuous Index:
Within 8" of Joint:
Remarks:

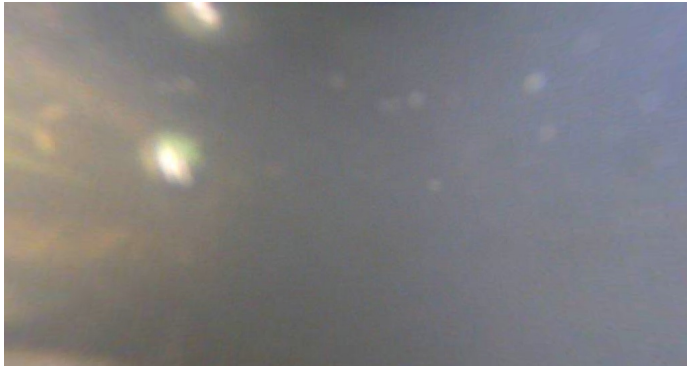
Code:	MCU
Description:	Camera Underwater
Distance (ft):	96.0
Structural Grade:	0
O&M Grade:	4
Clock Start/From:	
Clock To:	
1st Value:	
2nd Value:	
Value Percent:	
Continuous Index:	
Within 8" of Joint:	NO
Remarks:
